Design Guide

for Improving Hospital Safety
in Earthquakes, Floods, and High Winds

FEMA 577 / June 2007

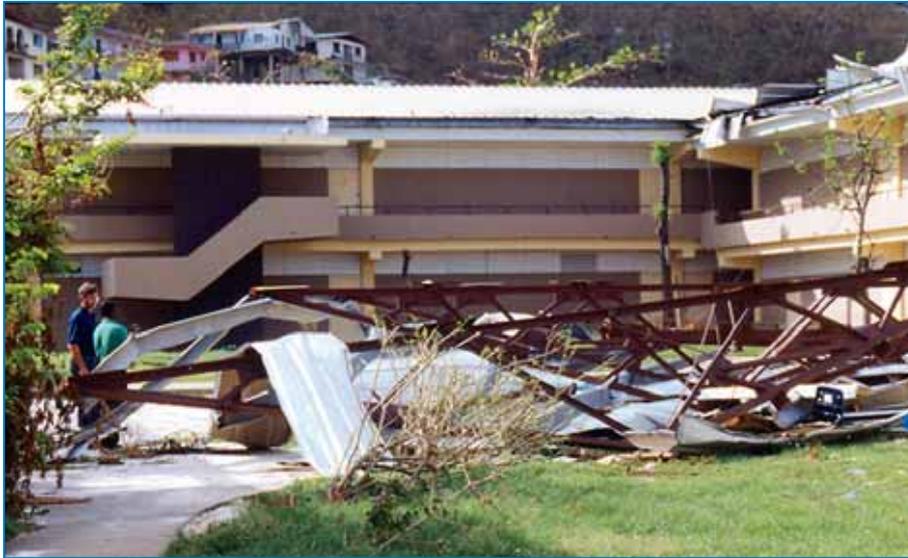
Figure 4-113:
The steel truss superstructure installed as part of a steep-slope conversion blew away because of inadequate attachment. Hurricane Marilyn (U.S. Virgin Islands, 1995)

If a low-slope roof is converted to a steep-slope roof, the new support structure should be engineered and constructed to resist the wind loads and avoid the kind of damage shown in Figure 4-113.

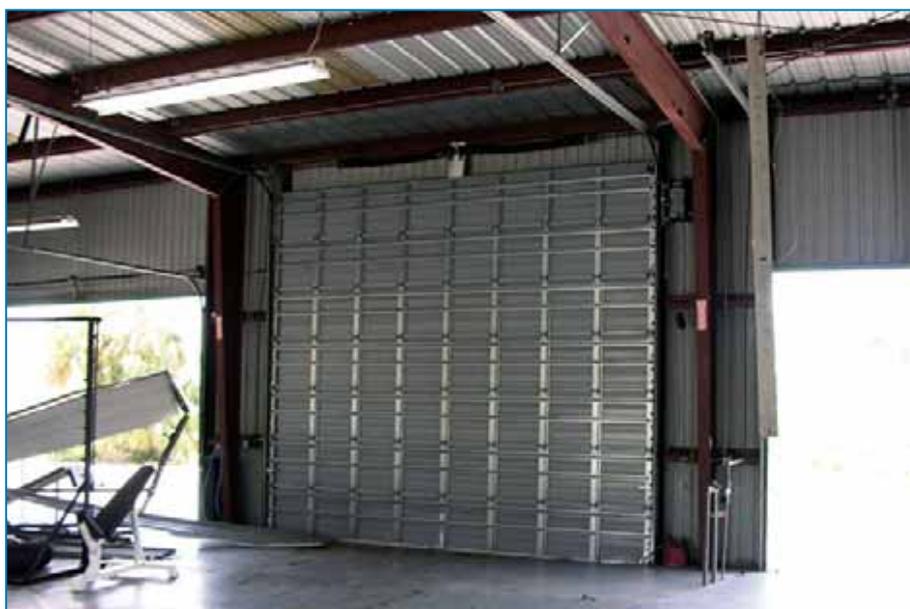
Figure 4-114:
The new door in the center performed very well, but the older doors on either side of it were blown away. Hurricane Charley (Florida, 2004)

If a facility has more than one sectional or rolling door, all doors should be replaced, rather than just replacing one of the doors. The building shown in Figure 4-114 had six sectional doors. One door had been replaced before a hurricane. It performed very well, but three of the older doors were blown away and two of the older doors remained in place but had some wind damage.

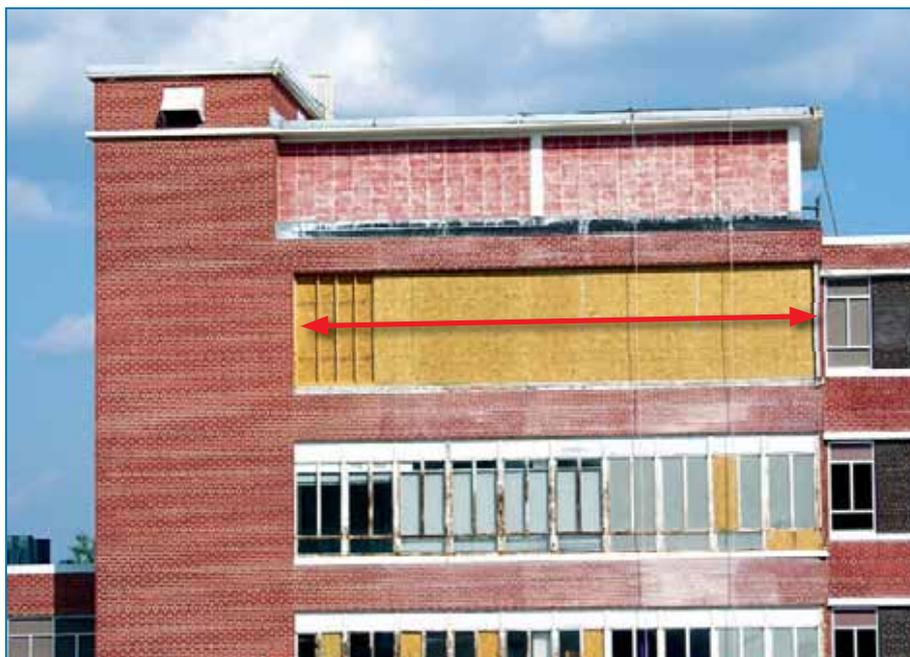
Figure 4-115: Wind pressure caused the window frames on the upper floor to fail (red arrow). Hurricane Katrina (Mississippi, 2005)

Windows in older facilities may possess inadequate resistance to wind pressure. Window failures are typically caused by wind-borne debris, however, glazing or window frames may fail as a result of wind pressure (see Figure 4-115). Failure can be caused by inadequate resistance of the glazing, inadequate anchorage of the glazing to the frame, failure of the frame itself, or inadequate attachment of the frame to the wall. For older windows that are too weak to resist the current design pressures, window assembly replacement is recommended. Some older window assemblies have sufficient strength to resist the design pressure, but are inadequate to resist wind-driven rain. If the lack of water resistance is due to worn glazing gaskets or sealants, replacing the gaskets or sealant may be viable. In other situations, replacing the existing assemblies with new, higher-performance assemblies may be necessary.

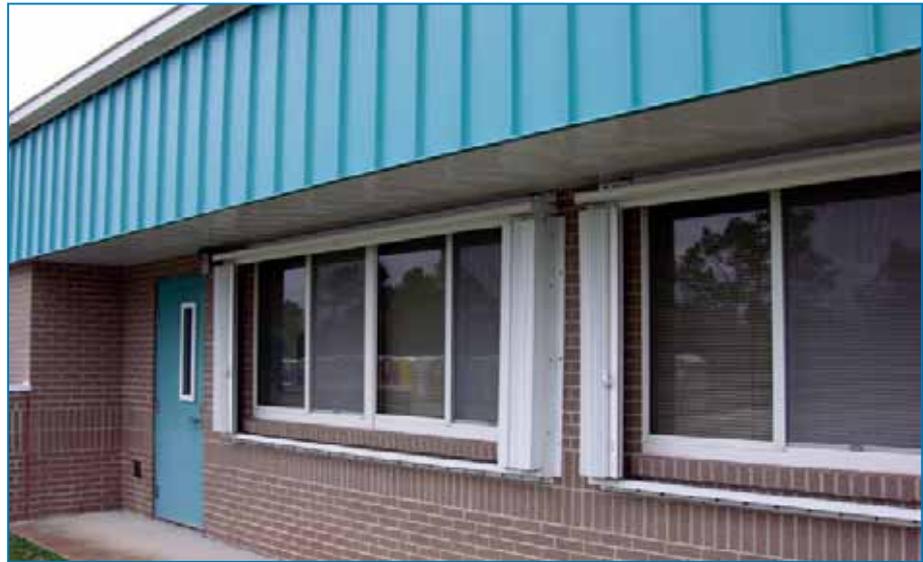
Figure 4-116:
This building has
accordion shutters.
Hurricane Ivan
(Florida, 2004)

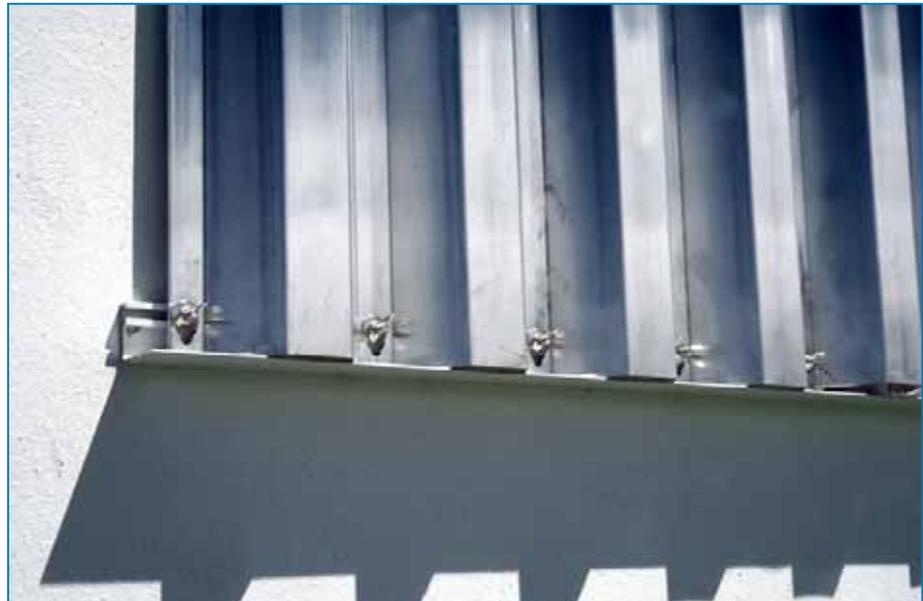
Figure 4-117:
A metal panel shutter.
Hurricane Georges
(Puerto Rico, 1998)

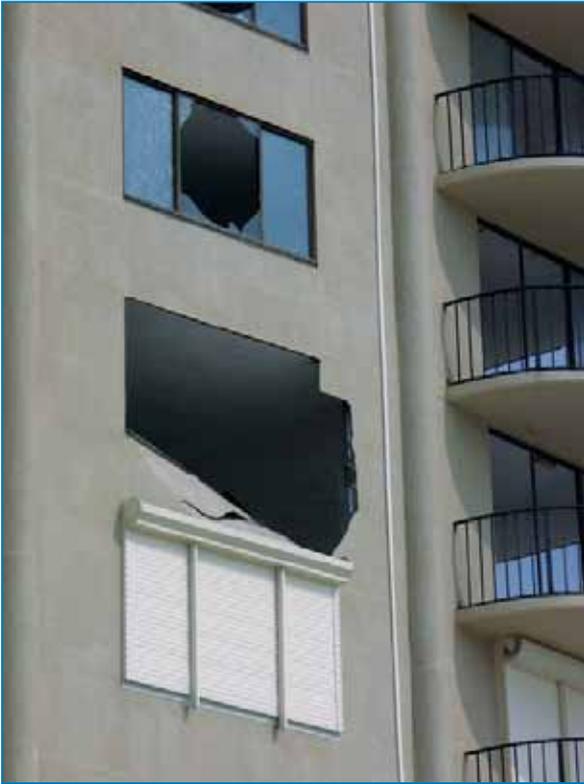
Figure 4-118:
The lower window assembly was protected with a motorized shutter. Hurricane Ivan (Florida, 2004)

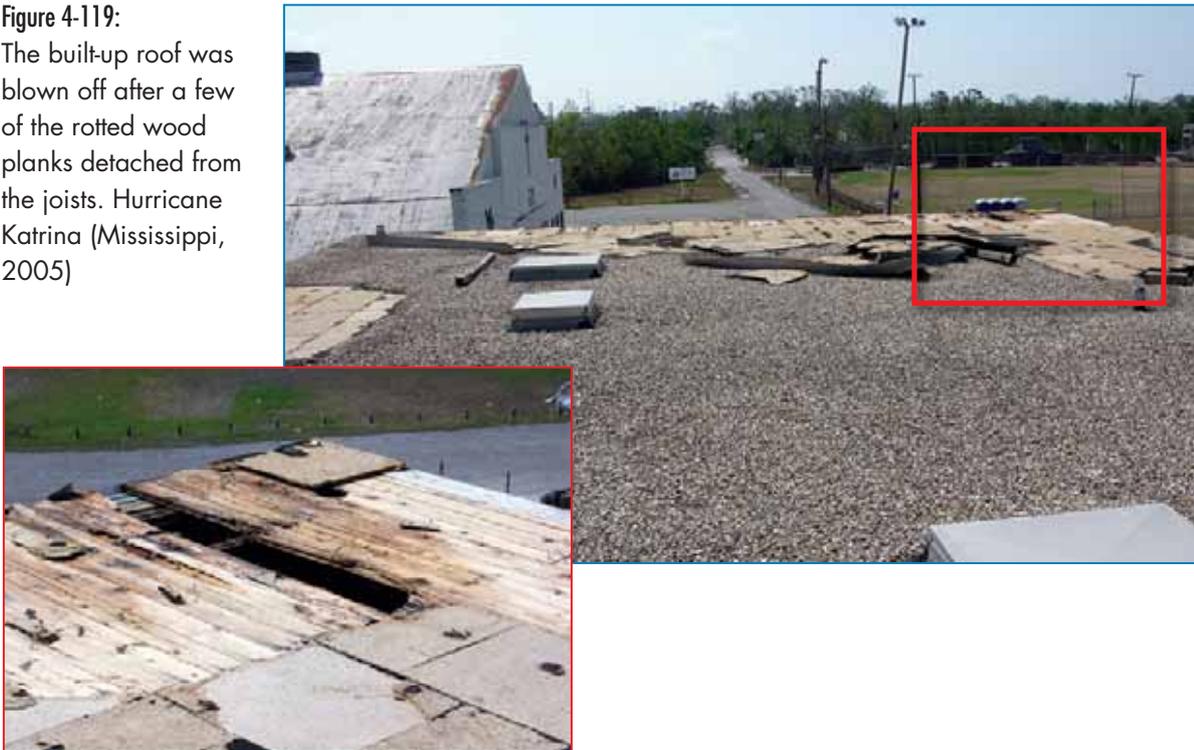
Figure 4-119:

The built-up roof was blown off after a few of the rotted wood planks detached from the joists. Hurricane Katrina (Mississippi, 2005)

When planning the replacement of a roof covering, it is recommended that all existing roof covering be removed down to the deck rather than simply re-covering the roof. Tearing off the covering provides an opportunity to evaluate the structural integrity of the deck and correct deck attachment and other problems. For example, if a roof deck was deteriorated due to roof leakage (see Figure 4-119), the deterioration would likely not be identified if the roof was simply re-covered. By tearing off

down to the deck, deteriorated decking like that shown in Figure 4-119 can be found and replaced. In addition, it is recommended that the attachment of the wood nailers at the top of parapets and roof edges be evaluated and strengthened where needed, to avoid blow-off and progressive lifting and peeling of the new roof membrane (see Figure 4-126).

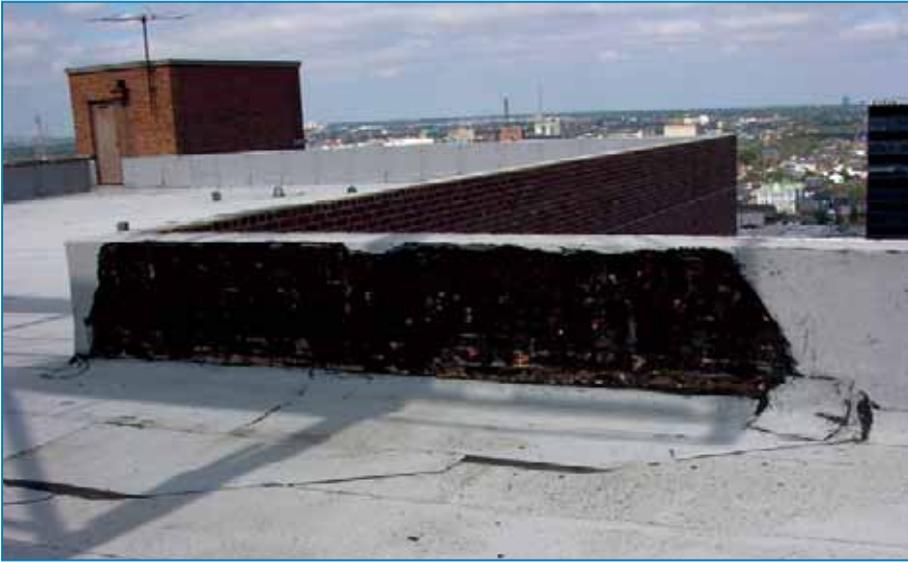
Figure 4-120:
Failed base flashing
adhered directly to
the brick parapet.
Hurricane Katrina
(Louisiana, 2005)

If the roof has a parapet, it is recommended that the inside of the parapet be properly prepared to receive the new base flashing. In many instances, it is prudent to re-skin the parapet with sheathing to provide a suitable substrate. Base flashing should not be applied directly to brick parapets because they have irregular surfaces that inhibit good bonding of the base flashing to the brick (see Figure 4-120). Also, if moisture drives into the wall from the exterior side of the parapet with base flashing attached directly to brick, the base flashing can inhibit drying of the wall. Therefore, rather than totally sealing the parapet with membrane base flashing, the upper portion of the brick can be protected by metal panels (as shown in Figure 4-79), which permit drying of the brick.

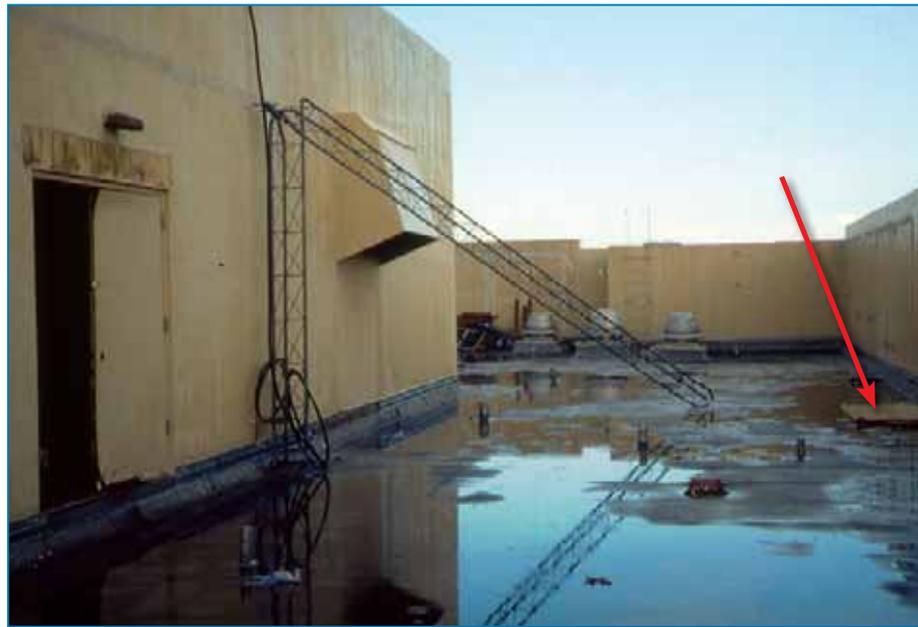
Figure 4-121:
The antenna at this hospital collapsed and was whipped back and forth across the roof membrane. Hurricane Andrew (Florida, 1992)

Antenna collapse is very common. Besides loss of communications, collapsed masts can puncture roof membranes or cause other building damage as shown in Figure 4-121. This case also demonstrates the benefits of a high parapet. Although the roof still experienced high winds that blew off this penthouse door, the parapet prevented the door from blowing off the roof (red arrow in Figure 4-121).

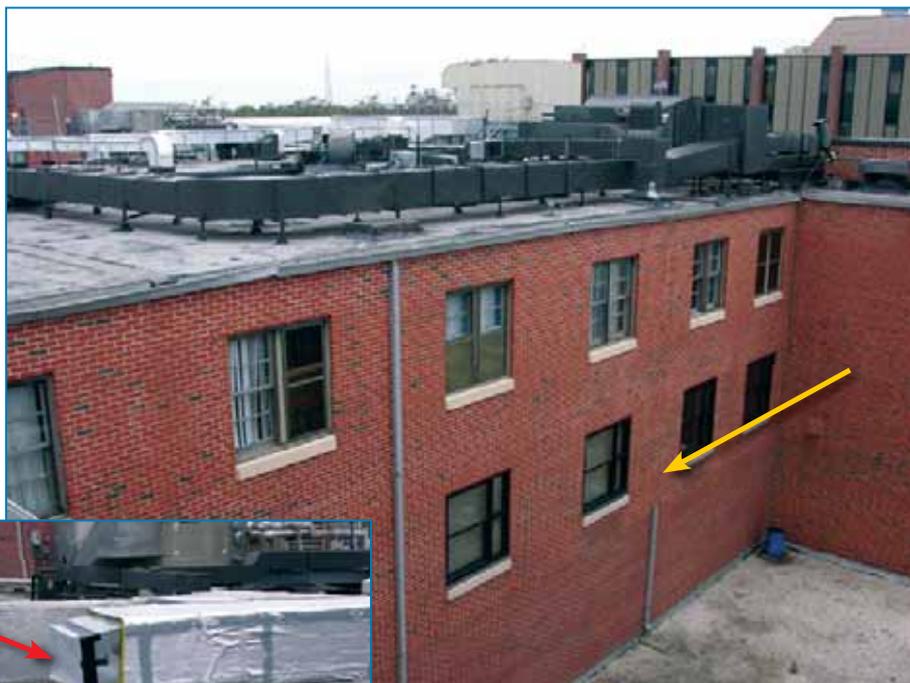
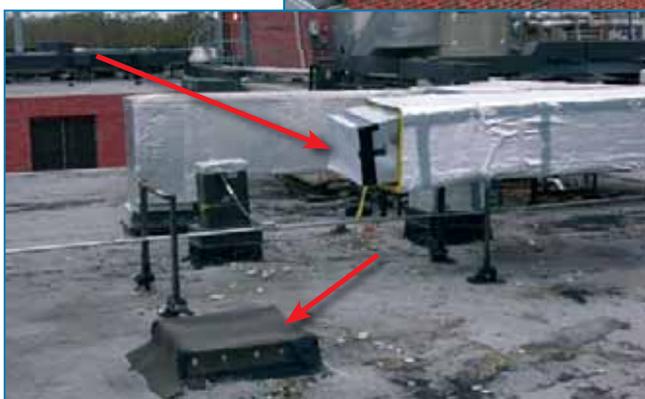
Figure 4-124:

This hospital had a substantial amount of rooftop ductwork. Ductwork and fan units were damaged in several locations (see inset). Some of the windows in this area were also broken. Note the missing downspout (yellow arrow).

Water entered the hospital at damaged rooftop equipment (Figure 4-124), and at areas where the roof membrane blew off (Figures 4-125 and 4-126) and where it was punctured. The roof failure shown in Figure 4-126 was caused by an inadequately attached edge nailer anchored to the brick wall. Failure of the nailer caused a progressive lifting and peeling of the roof membrane. Gutters and downspouts were blown off and a few windows were broken. The elevator penthouse roof was damaged at the psychiatric hospital (Figure 4-127) and the MOBs (Figure 4-125).

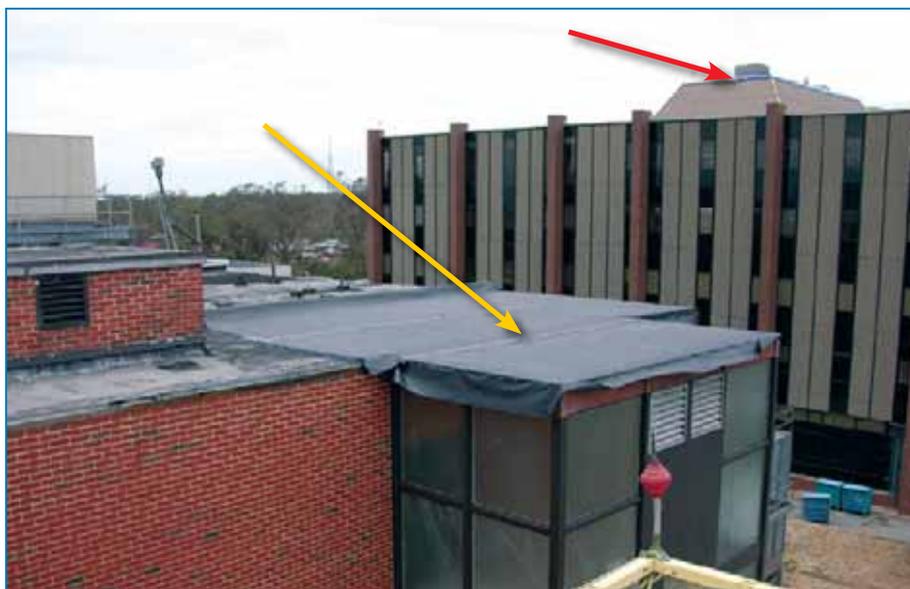
Figure 4-125:

The roof covering blew off – an emergency roof covering had been installed (yellow arrow). Note the damaged MOB penthouse beyond (red arrow).

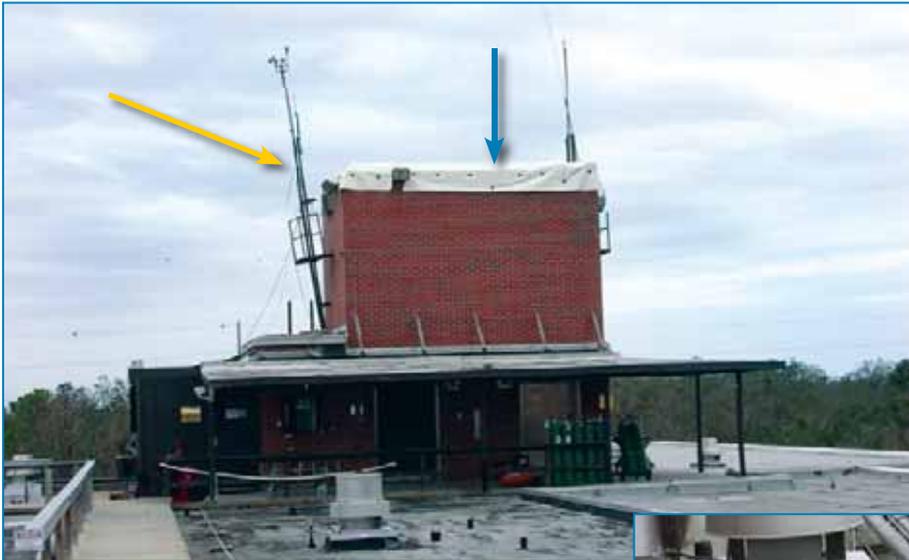
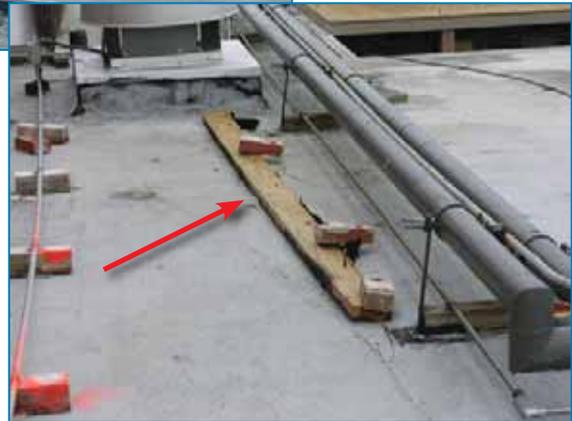
Figure 4-126:

The roof covering blew off – an emergency roof covering had been installed (blue arrow). The failure was caused by the inadequately attached nailer (see inset). The leaning mast at the right is a ladder (yellow arrow), with an extension for communications and an anemometer for the nearby heliport.

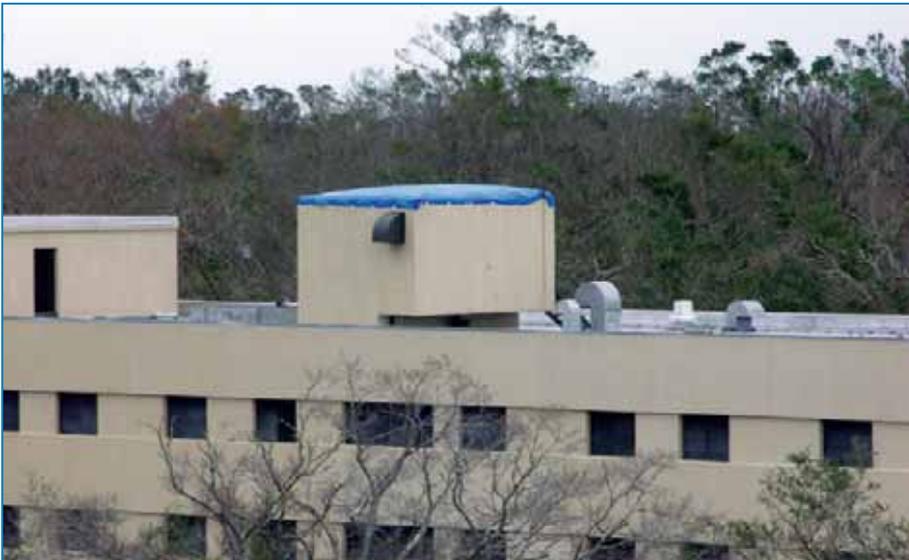
Figure 4-127:

An emergency roof covering had been installed over the elevator penthouse at the psychiatric hospital.

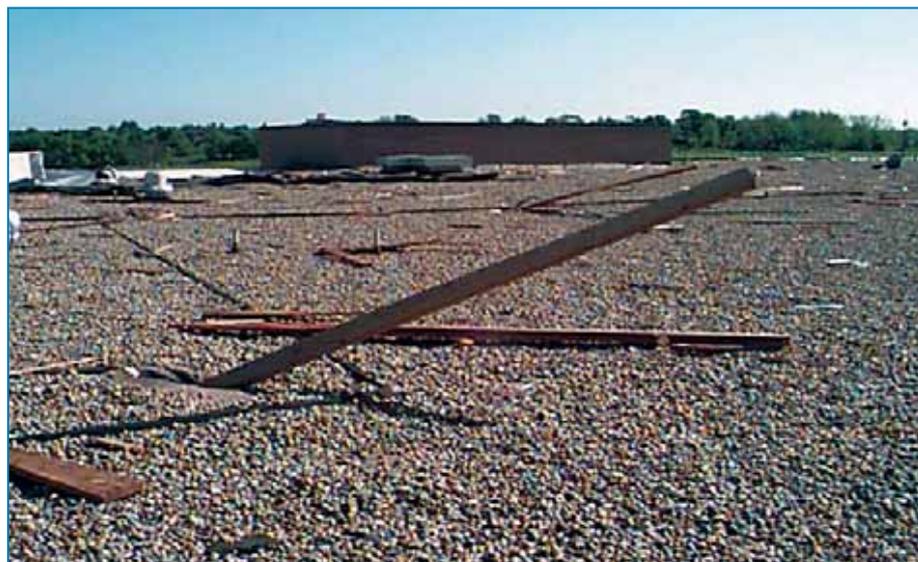
Figure 4-128:
A violent tornado showered the roof with missiles. (Oklahoma, 1999)

Strong and violent tornadoes can generate very powerful missiles. Experience shows that large and heavy objects, including vehicles, can be hurled into buildings at high speeds. The missile sticking out of the roof in the foreground of Figure 4-128 is a double 2-inch by 6-inch wood member. The portion sticking out of the roof is 13 feet long. It penetrated a ballasted ethylene propylene diene monomer (EPDM) membrane, approximately 3 inches of polyisocyanurate roof insulation, and the steel roof deck. The missile lying on the roof just beyond is a 2-inch by 10-inch by 16-foot long wood member.

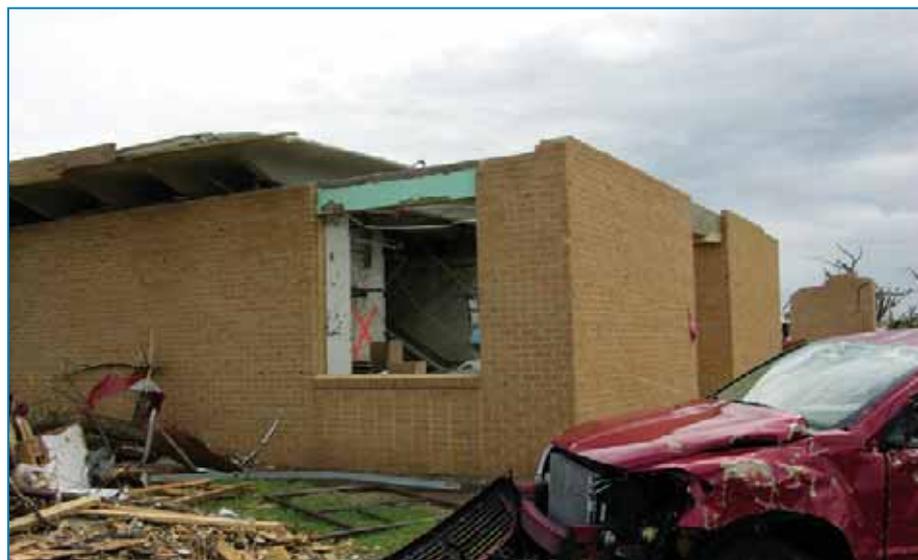
Figure 4-132:

View of the end of the patient wing where the twin-tee blew off. Note the missing window.

One of the precast twin-tees from the original building blew off and flew approximately 80 feet (Figures 4-132 and 4-133). Where the tees rested on the bearing wall, steel bearing plates were embedded in the tee's beams, and bearing plates were embedded on top of the wall. At the wall in the foreground of Figure 4-132, the bearing plates had not been welded together. Hence, at that end of the tee, no uplift resistance was provided other than the tee's dead load. At the opposite bearing wall, the bearing plates were welded, but the bolts anchoring the plates to the wall failed in tension as the tee lifted. Both of the bearing plates had two small anchor bolts (about $\frac{3}{8}$ -inch diameter).

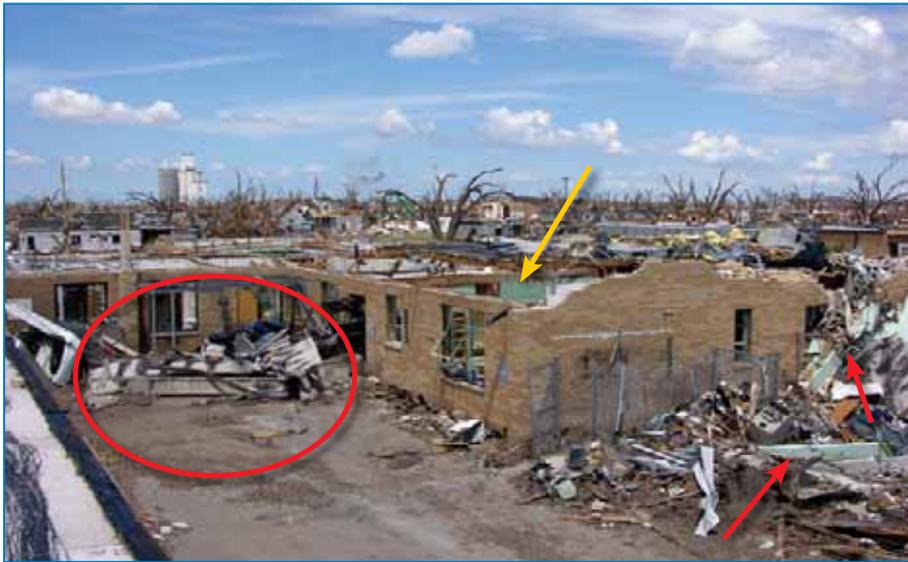
Figure 4-133:
The missing tee shown in Figure 4-132 landed about 80 feet away (red oval). The red arrows show tees that were blown from the ambulance garage. Note the missing wood roof structure on the 1982 addition (yellow arrow).

The precast twin-tees on the ambulance garage blew off and landed against the wall of the 1982 addition (Figures 4-133 and inset at 4-141). The garage door and virtually all of the exterior unreinforced brick/CMU bearing walls collapsed (Figure 4-141). Where the tees rested on the bearing wall, steel bearing plates were embedded in the tee's beams. However, bearing plates had not been embedded on top of the support walls. Rather, where

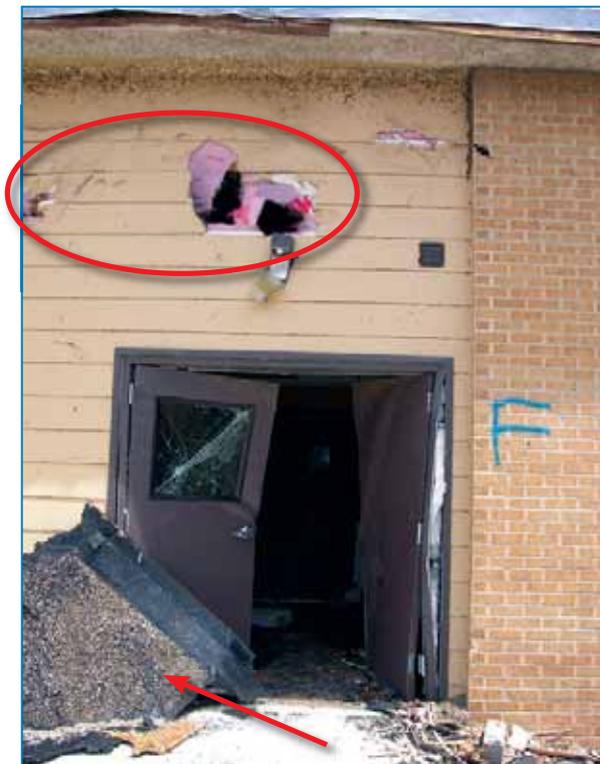
Figure 4-134:
The BUR missile (red arrow) struck the right door. Missiles also punctured the siding and wood sheathing (red oval).

The hospital complex was struck with a very large number of missiles. Virtually all of the hospital's exterior glazing was broken. Figure 4-134 shows a damaged door at the kitchen facility. A piece of built-up roof (BUR) membrane struck the right door. Although the doors were out-swinging, the missile pushed the door inward. The lower right hinge was broken, and the right side of the door frame buckled and pulled from the rough opening. The laminated glass in the door was broken, but remained in place.

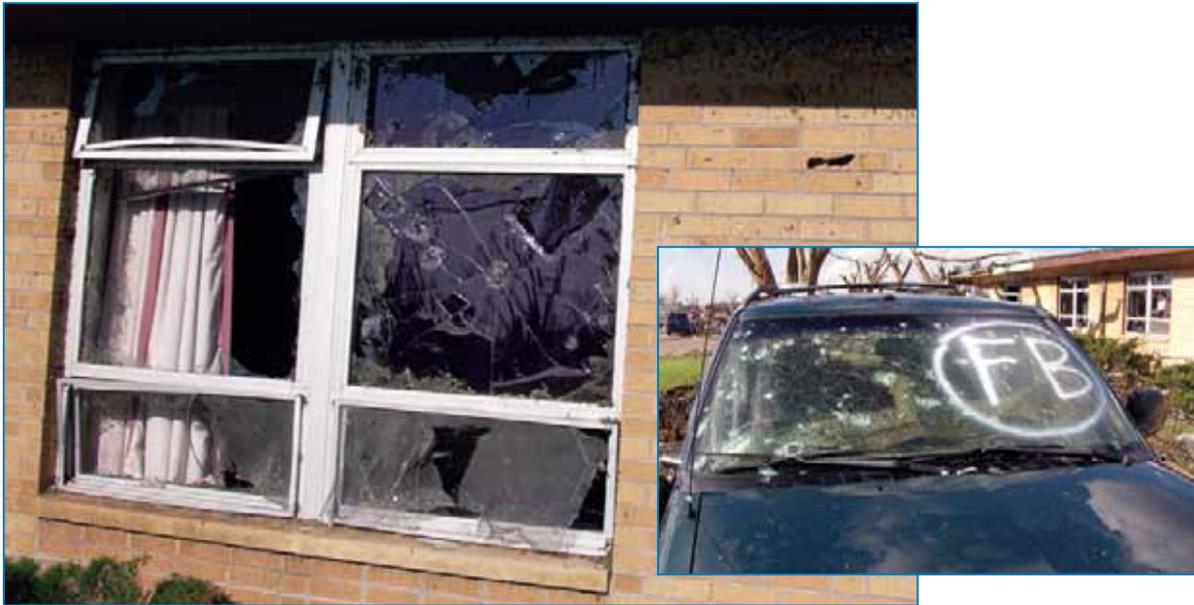
Figure 4-135:

All six panes of glass were broken. The craters shown in the right center pane and at the vehicle windshield were caused by the large aggregate blown from the ballasted single-ply membranes.

Aggregate from the ballasted single-ply membrane roofs broke several windows (Figure 4-135), and pieces of the large aggregate (1½-inches in diameter, nominal) were found inside the building. Windows were also broken by 2x wood framing (Figure 4-136).

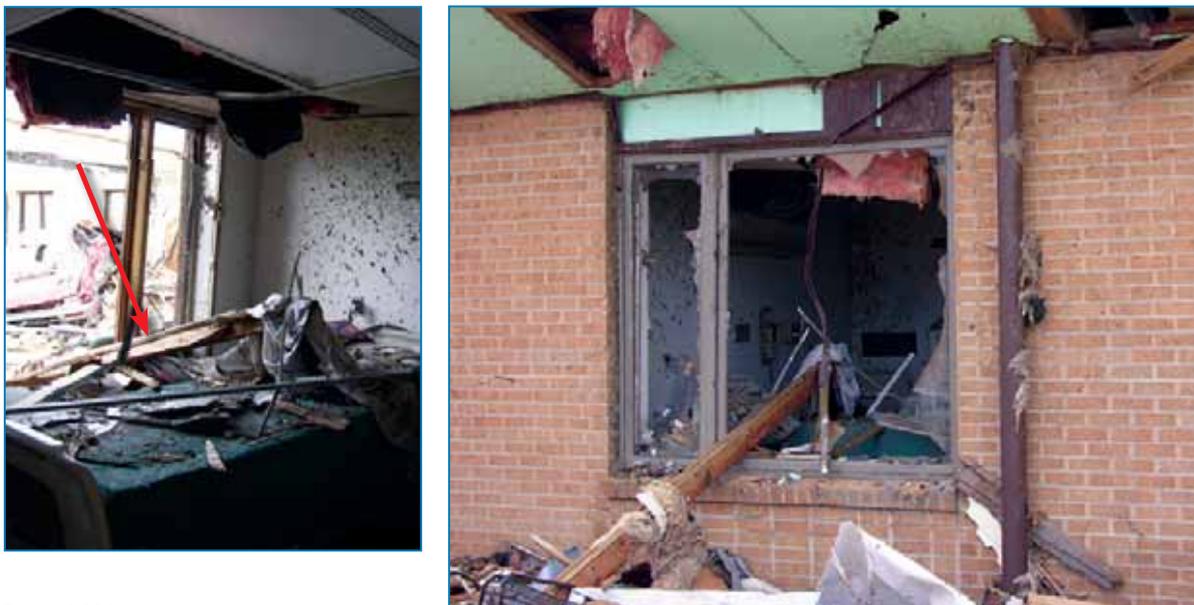
Figure 4-136:

A large missile (2x framing) penetrated this patient room. Note the debris on the bed in the inset (the arrow shows the same 2x missile).

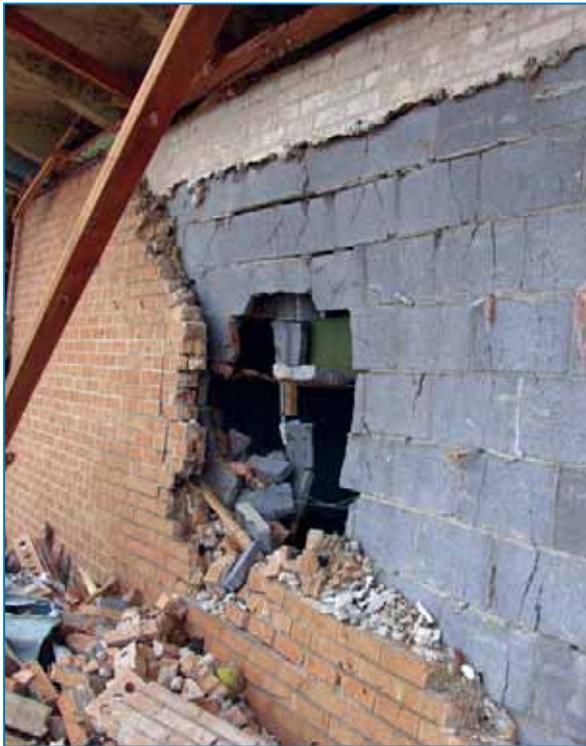
Figure 4-137:

A missile impact created an opening in the brick veneer and unreinforced CMU.

Figure 4-137 illustrates an opening through the entire exterior wall.

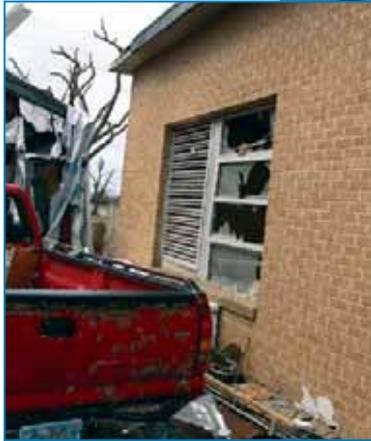
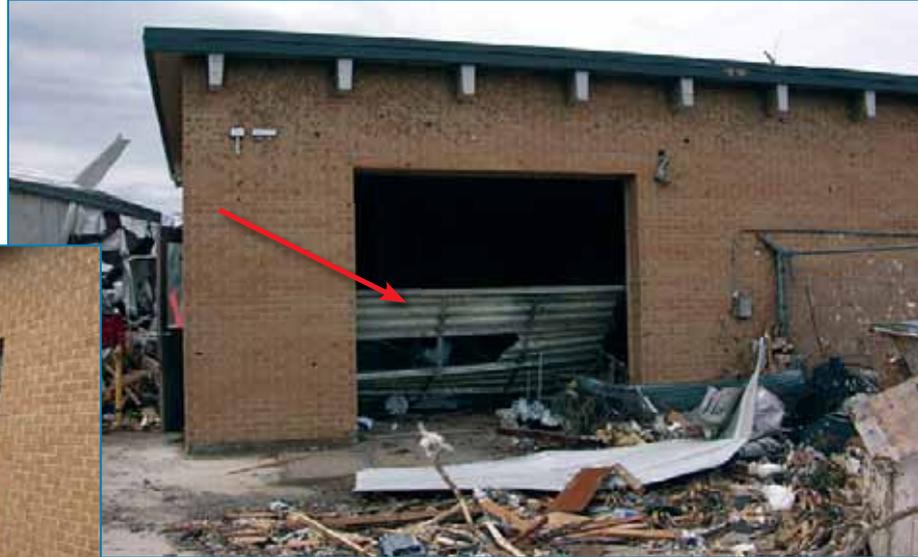
Figure 4-138:

The sectional door (red arrow) at the generator building was blown in and windows were broken by debris.

The building shown in Figure 4-131 (yellow arrow) and in Figure 4-138 housed the emergency generator. The sectional door collapsed and allowed wind-borne debris to strike the generator. All window panes in the wall adjacent to the sectional door were broken (see inset at Figure 4-138). The wall louver adjacent to the window, which served the generator room, escaped damage.

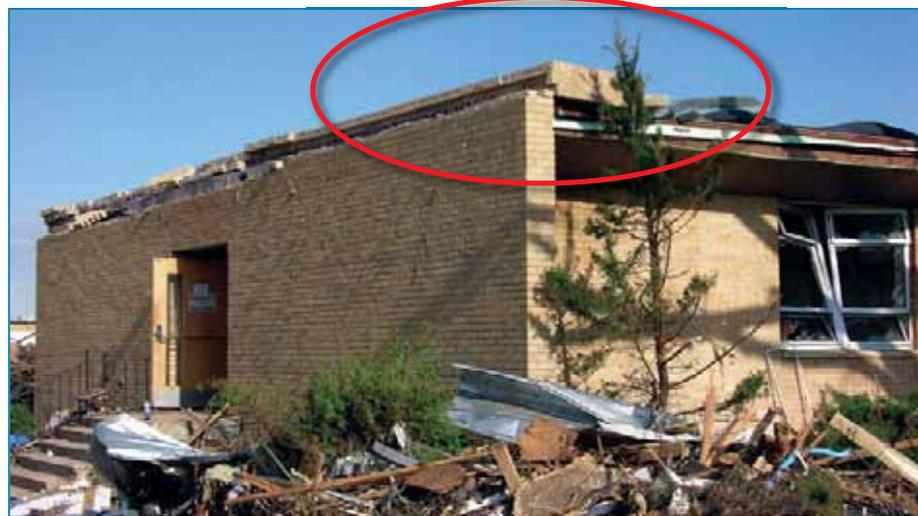
Figure 4-139:

Collapsed unreinforced masonry parapet. Note the broken windows.

If the parapet is constructed of masonry, it is recommended that its wind resistance be evaluated and strengthened if found to be inadequate. The masonry parapet shown in Figure 4-139 fell onto the roof. Had it fallen in the other direction, it would have blocked the entry and would have had the potential to cause injury.

There was no apparent structural damage to the 1965 addition. However, the unreinforced brick/CMU parapet shown in Figure 4-139 fell onto the roof, rather than in the other direction, where it would have blocked the entry and possibly could have caused injuries. Virtually all of the exterior windows were broken (see Figures 4-135 and 4-136). The roof insulation and aggregate-ballasted single-ply roof membrane were blown off. The wood roof structure blew off the majority of the 1982 addition (Figures 4-133 and 4-140), and virtually all of the exterior windows were broken.

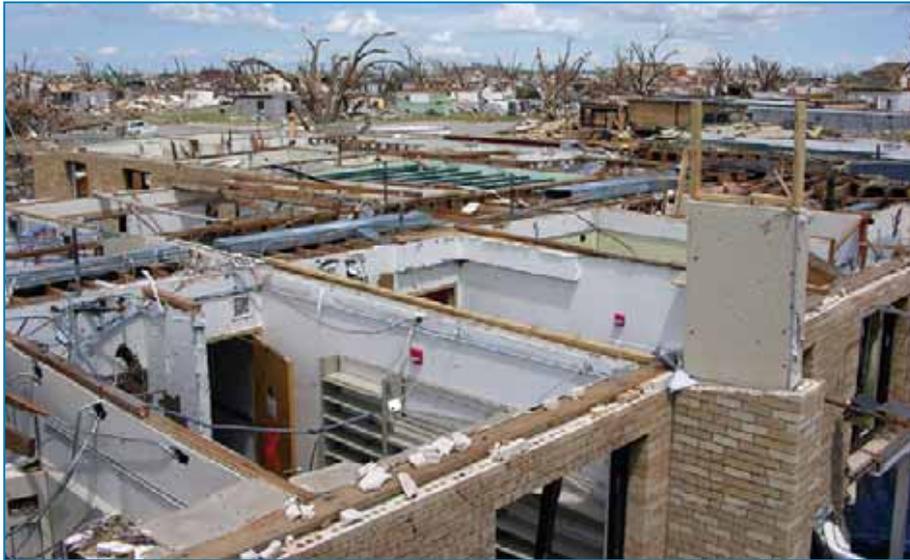
Figure 4-140:
Loss of the wood roof structure at the 1982 addition.

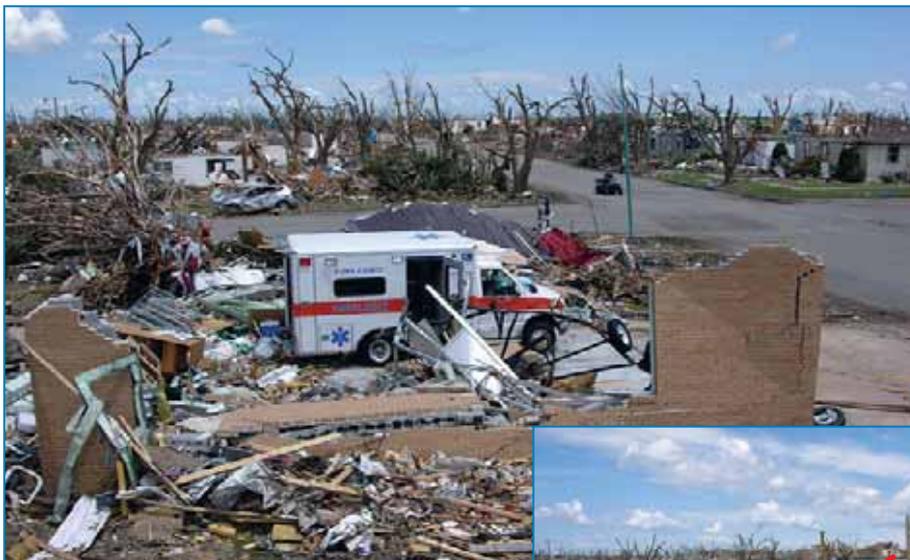
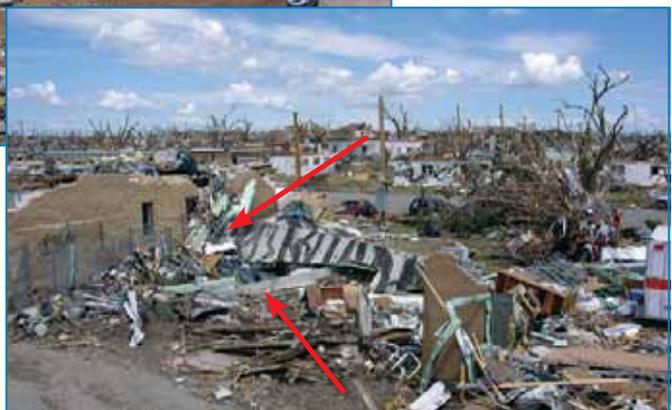
Figure 4-141:
View of the collapsed ambulance garage. The twin-tees (red arrows) flew to the left, as shown in the inset.

uation was completed by around 2:45 a.m. (about 5 hours after the tornado). None of the occupants were injured during the storm or evacuation. The ambulance shown in Figure 4-141 was not usable because of missile damage. Even though some portions of the facility could be salvaged, significant demolition and reconstruction will be necessary.

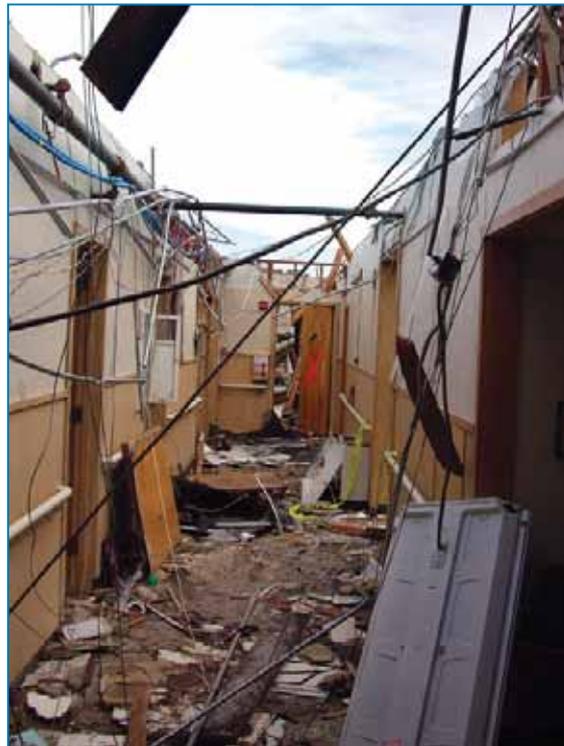
Figure 4-142:
View of a main
corridor in the 1982
addition

in a particular facility; by that time, it will be too late. If refuge areas have not been identified beforehand, occupants will take cover wherever they can, frequently in very dangerous places. Corridors, as shown in Figure 4-142, sometimes provide protection, but they can also be death traps.

The loss of life and avoidance of injuries was attributed to three factors. 1) A tornado warning was issued by the National Weather Service about 20 minutes before the tornado struck, and the hospital's staff was aware of the warning. 2) The hospital had a tornado evacuation plan and there was sufficient time to execute the plan. 3) Although it is believed that the basement was not specifically designed as a tornado shelter, it provided a safe area of refuge for patients and staff. For hospitals located in tornado-prone regions, the experience from this tornado demonstrates the importance of having a pre-identified, best available refuge area (or preferably a FEMA 361-compliant shelter). Although small interior rooms and corridors sometimes provide adequate protection during tornadoes, unless specifically designed as a tornado shelter, they often provide inadequate protection, as shown in Figure 4-142.

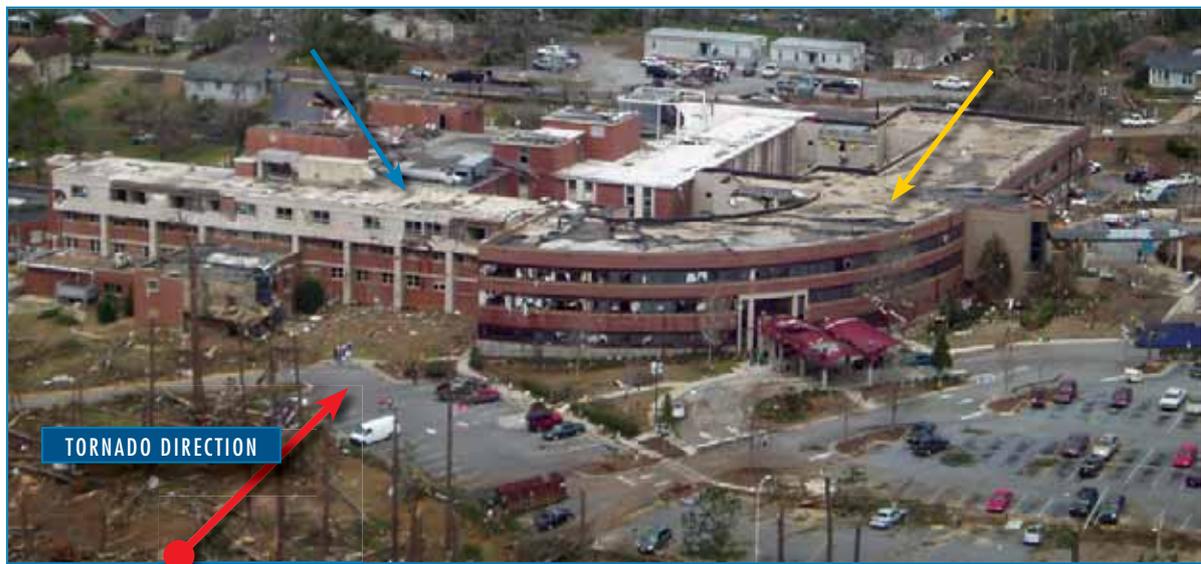
Figure 4-143:

Aerial view of the facility after it was struck by the tornado. The red arrow indicates the general direction of the tornado. The blue arrow shows the 1953 building, and the yellow arrow shows the 1999 building. The 1975 and 1983 additions are adjacent to and behind the 1953 and 1999 buildings.

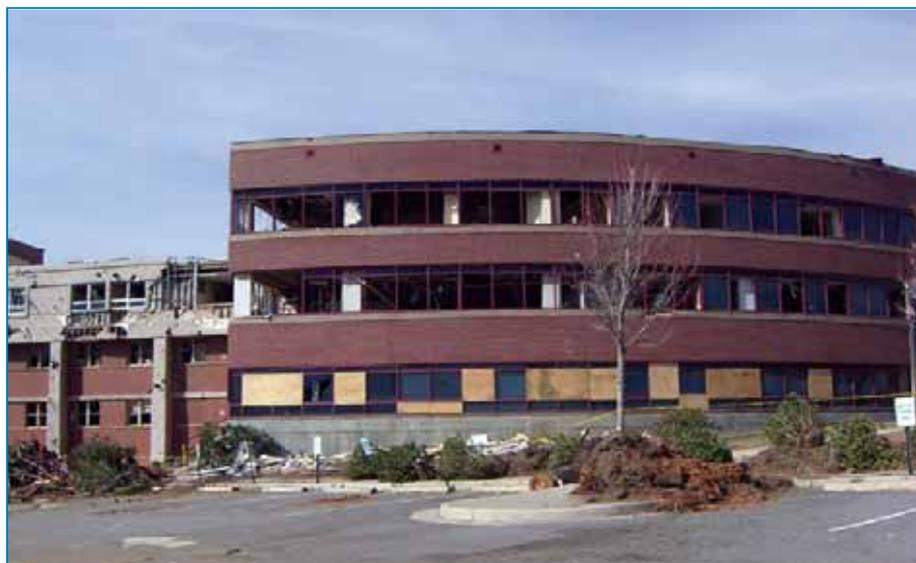
Figure 4-144:

The 1999 addition is on the right, and the 1953 building is to the left. Virtually all of the glass on these facades was broken.

As the tornado approached the southwest side of the hospital, numerous tree branches from trees in front of the hospital were thrown against the building. Missiles broke virtually all of the glass in the southwest walls (Figures 4-144 and 4-145), and missiles penetrated the EIFS and landed inside the building. Roof decking and steel joists were blown off of portions of the 1953 building, and the roof

The right (curved) portion of the building in Figure 4-144 is the 1999 addition. This portion of the first floor housed waiting and exam rooms. Offices were on the second floor, and medical offices were on the third floor. Figures 4-144 and 4-146 also show part of the 1953 building. Offices were on the first floor, and patient rooms were on the second and third floors.

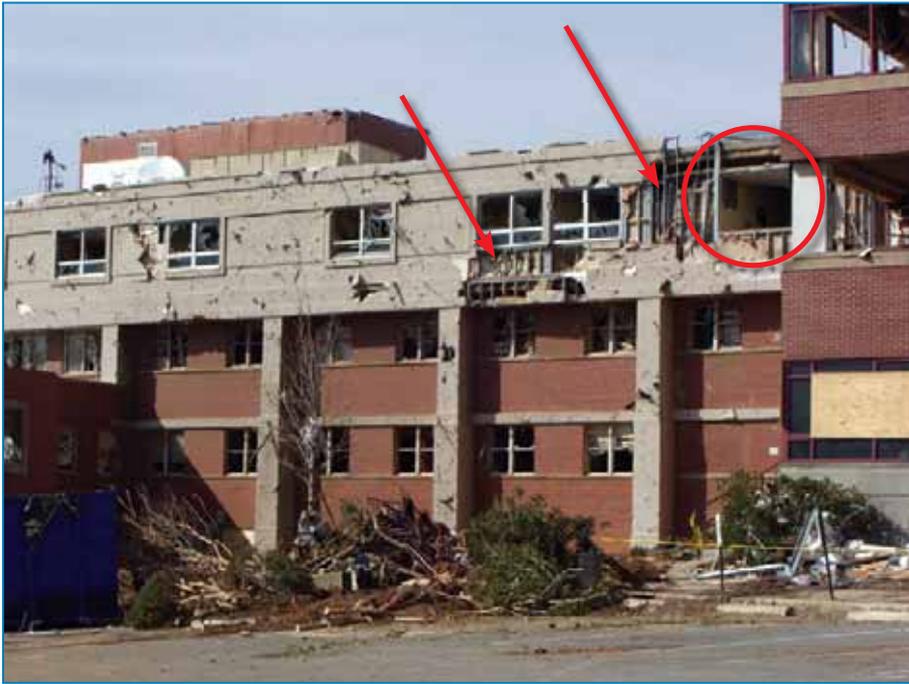
Figure 4-145: One window frame was blown away (red circle). The EIFS was penetrated by many missiles, and in some areas, the entire wall (except the studs) was blown away (arrows).

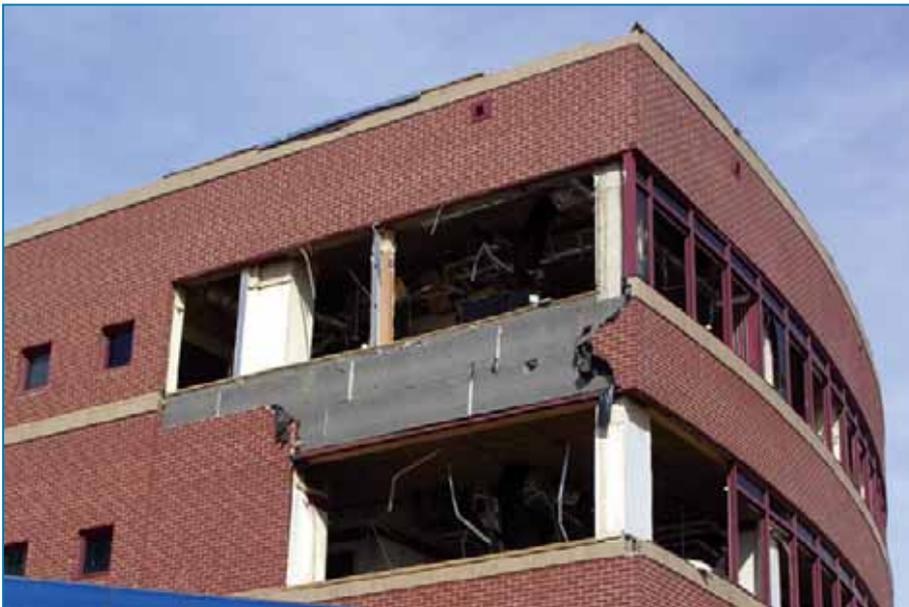
Figure 4-146: Several of the window frames were blown away, along with some of the brick veneer (1999 addition).

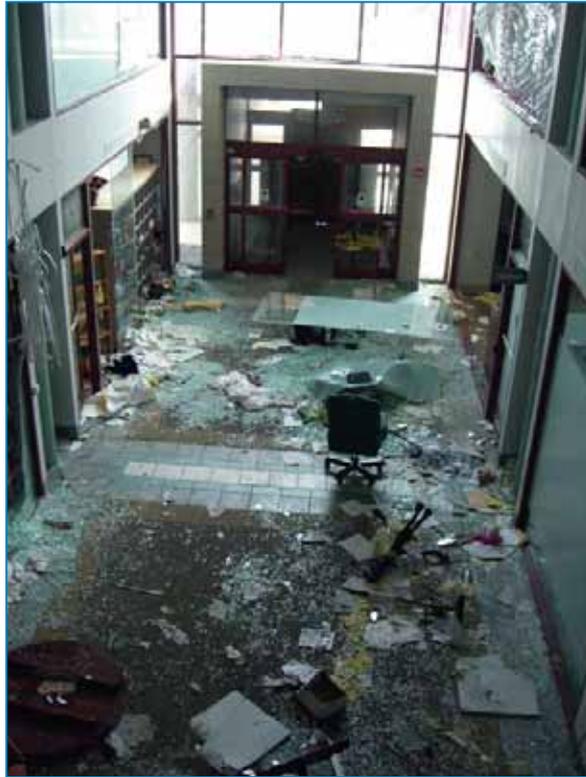
Figure 4-147:
Glass shards and other debris in the lobby area housing retail shops and offices.

Broken glass showered the rooms along the exterior walls. The breach of the building envelope allowed strong winds to enter the rooms and corridors, which led to the collapse of suspended acoustical ceilings and light fixtures. Figure 4-147 illustrates the extent of the interior damage.
