Hydrogen Sulfide Release at Waterflood Station in Odessa, Texas

Professional Development Hours (PDH) or Continuing Education Hours (CE) Online PDH or CE course

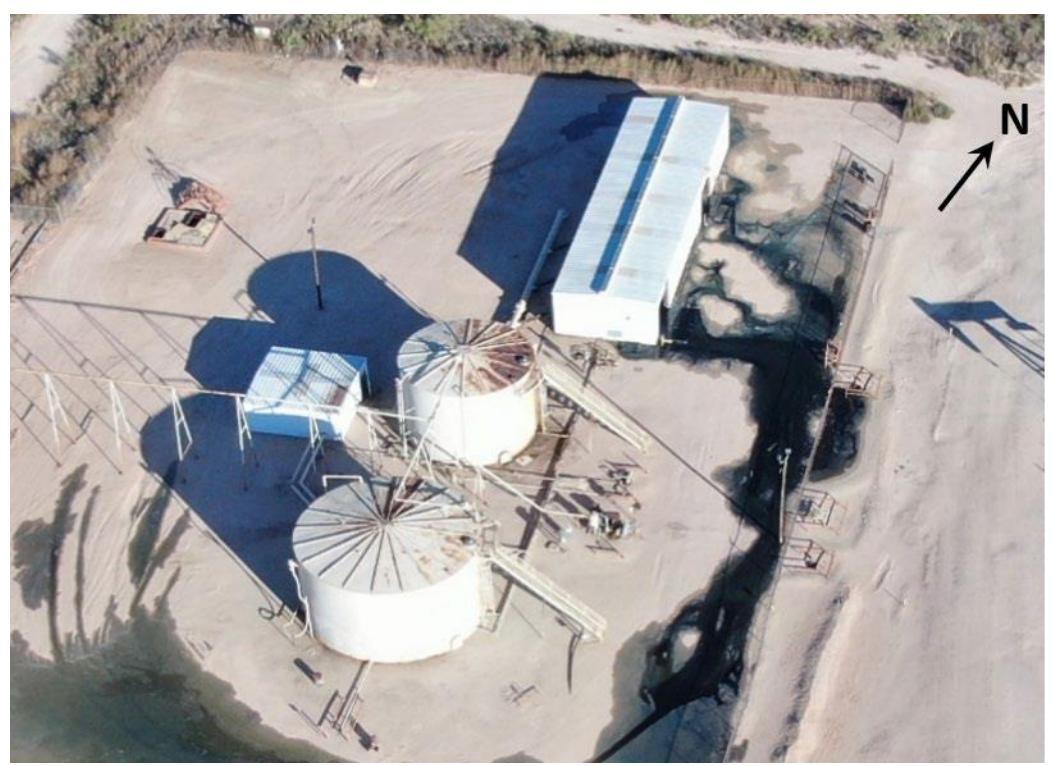
Figure 1. Aghorn Foster D waterflood station in Odessa, Texas. (Credit: Ector County Sheriff's Office)

The incident occurred at the Foster D waterflood station, operated by Aghorn Operating Inc. (Aghorn) in Odessa, Texas (**Figure 1**). The waterflood station receives *produced water*, a by-product of oil extraction in the area, from approximately 68 crude oil wells in the Foster Field of the Permian Basin.^a The station is used to inject produced water back into the oil-bearing formation to improve the extraction of oil from underground oil reservoirs.

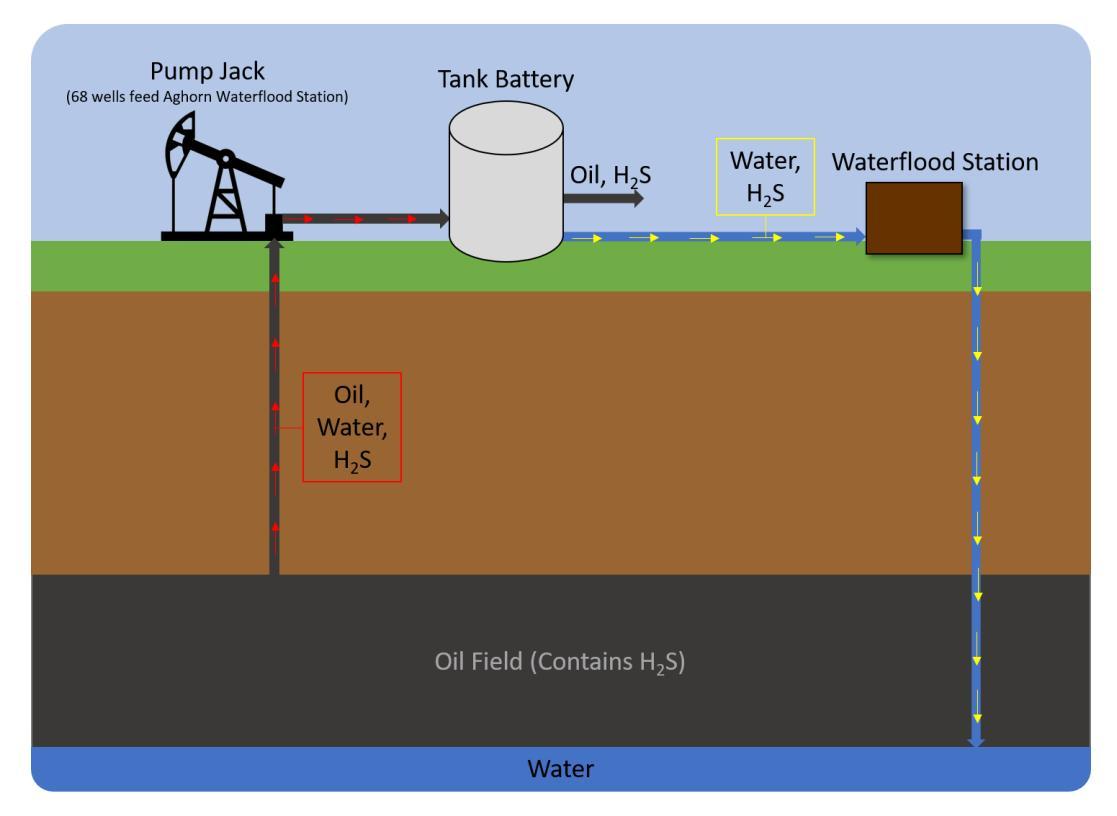
Figure 2. Simplified illustration of the Aghorn waterflooding process. (Credit: CSB)

Figure 2 illustrates the Aghorn oil extraction and waterflooding processes. Large pumps, called *pump jacks*, extract oil from underground oil reservoirs and transfer the oil to a tank battery^a through pipes. At the tank battery, the oil is stored in large tanks, where produced water separates from the oil.^b Produced water typically contains other components, including hydrogen sulfide (H₂S), a toxic gas known to be present in oil and gas reservoirs in the area.^c After it is separated from the oil, other pipes transfer the produced water from several tank batteries to a waterflood station. The waterflood station pumps the produced water back into the oil reservoir.

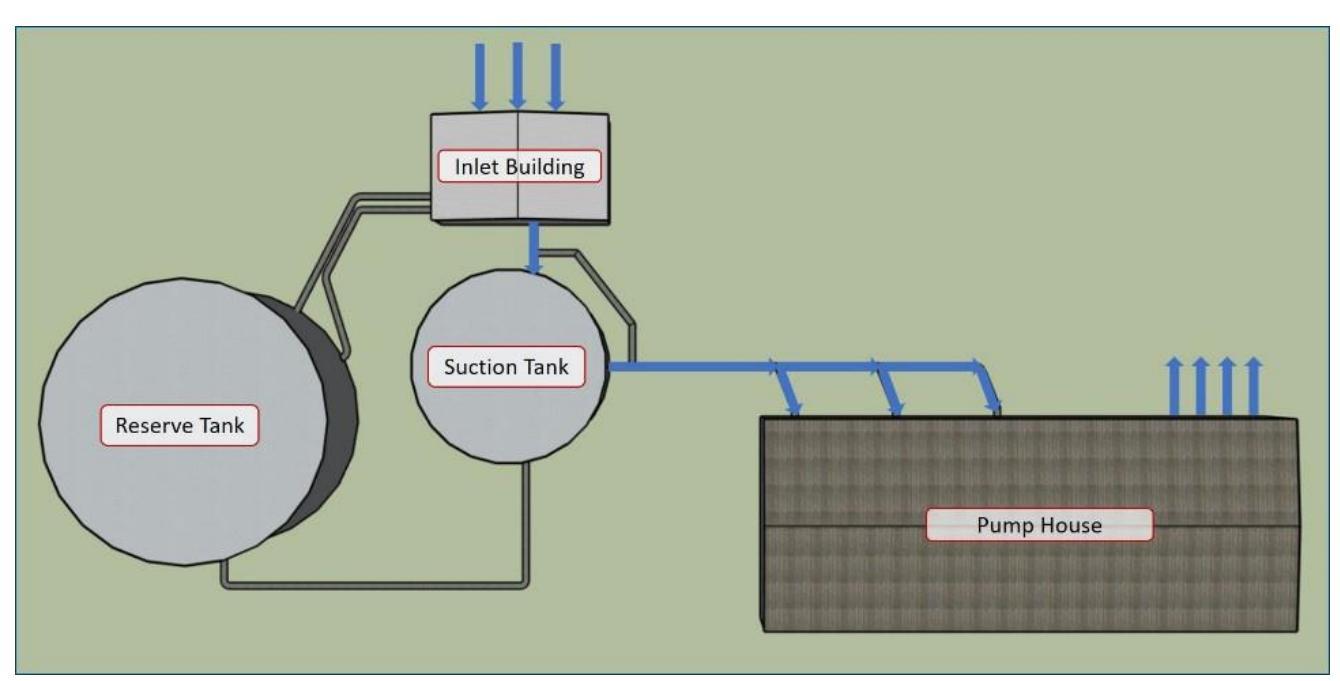
Figure 3. Illustration of the Foster D waterflood station. (Credit: CSB)

The produced water from several tank batteries first enters the waterflood station at the *inlet building*. The produced water is then routed to a temporary storage tank called the *suction tank*. From there, the water flows through a pipe to the *pump house*, where positive displacement pumps pressurize the water to approximately 900 pounds per square inch gauge (psig). The produced water then exits the facility through a series of pipes and is injected back into the oil reservoir. The *reserve tank* is typically used as an overflow during maintenance and is not part of the normal process flow.

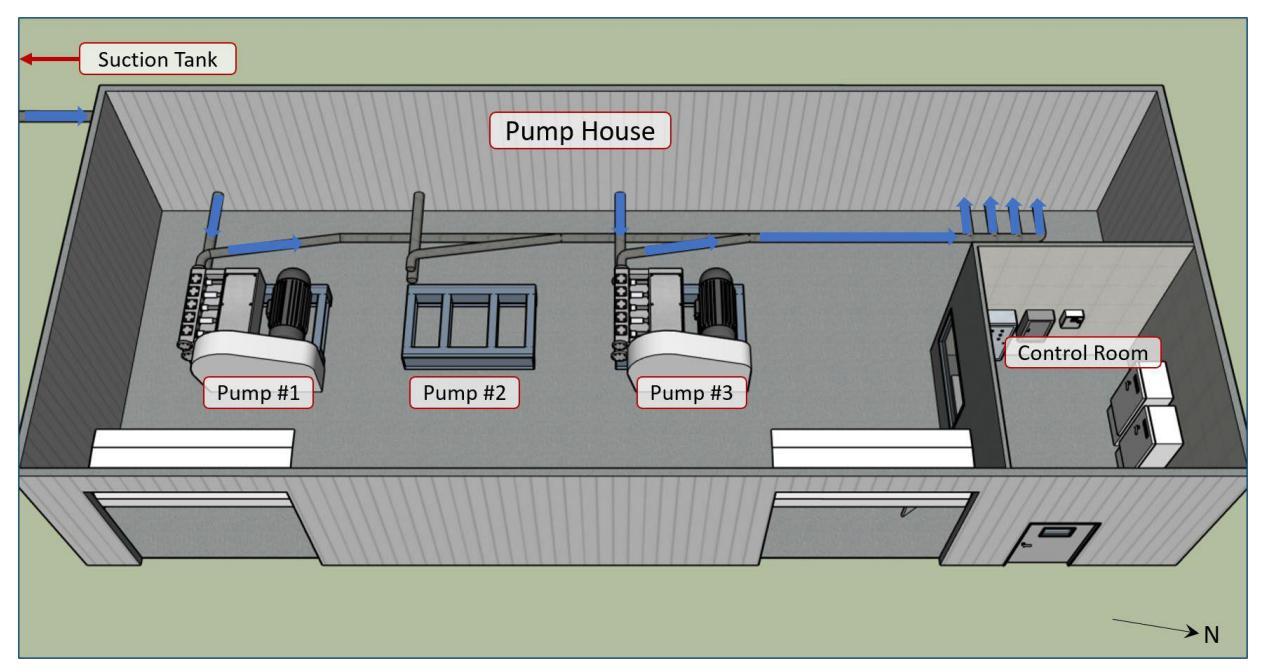
Figure 4. Depiction of pump house. (Credit: CSB)

The waterflood station's control room is in the northeast corner of the pump house (**Figure 4**). A programmable logic controller (PLC) monitors all process equipment on a control board inside the control room (**Figure 5**) and automatically operates pumps based on the liquid level in the suction tank. The power switch on the control board has three positions: "hand," meaning the pump is turned on manually by a person; "off," which turns the pump off; and "automatic," which causes the pumps to be controlled by the PLC. Aghorn communicated to the CSB that at the time of the incident, the PLC was programmed to turn on Pump #1 and Pump #3 when the liquid level in the suction tank reached a preset level. According to Aghorn, when the liquid reached the preset level, Pump #1 would automatically turn on and, approximately 15 seconds later, Pump #3 would automatically turn on.

The pump house is equipped with large bay doors, exhaust fans on the west wall opposite of the bay doors, and natural vents on each of the four outside walls. The bay doors and exhaust fans were the primary means of ventilating the pump house. Aghorn did not have an associated procedure to ensure ventilation of the pump house. Via an interview with an Aghorn employee and written communication with the company, CSB investigators were informed that these overhead doors were typically kept between 50 percent and 75 percent open (**Figure 6**). Due to the limitations of the available evidence, the CSB was unable to confirm whether the exhaust fans were operational at the time of the incident.

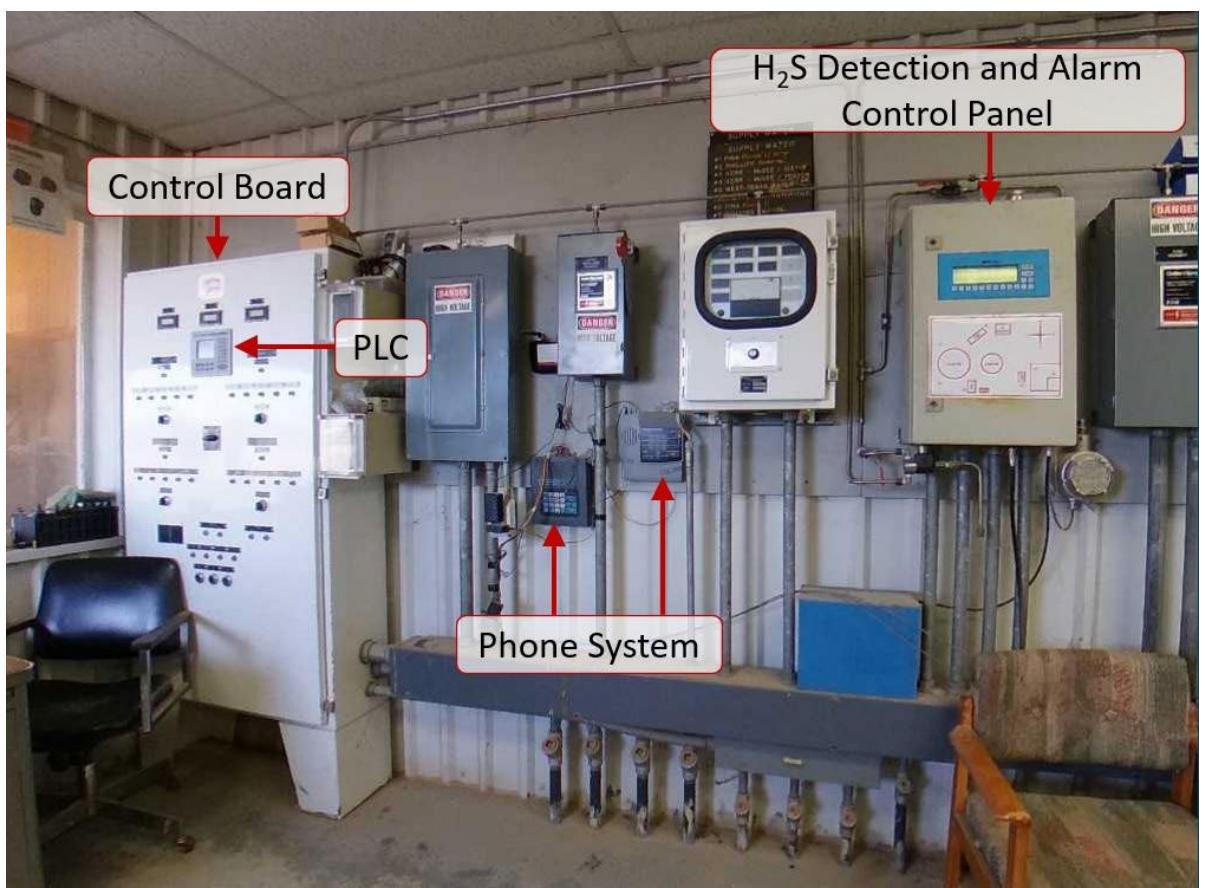
Figure 5. Control room layout. (Credit: CSB)

Employees use a touch pad on the PLC to adjust operational parameters and alarm set points. In the event operating conditions deviate from the normal range and reach an alarm set point, the PLC system activates an alarm. An automatic phone notification system then calls the pumper on duty to alert them of the deviation.

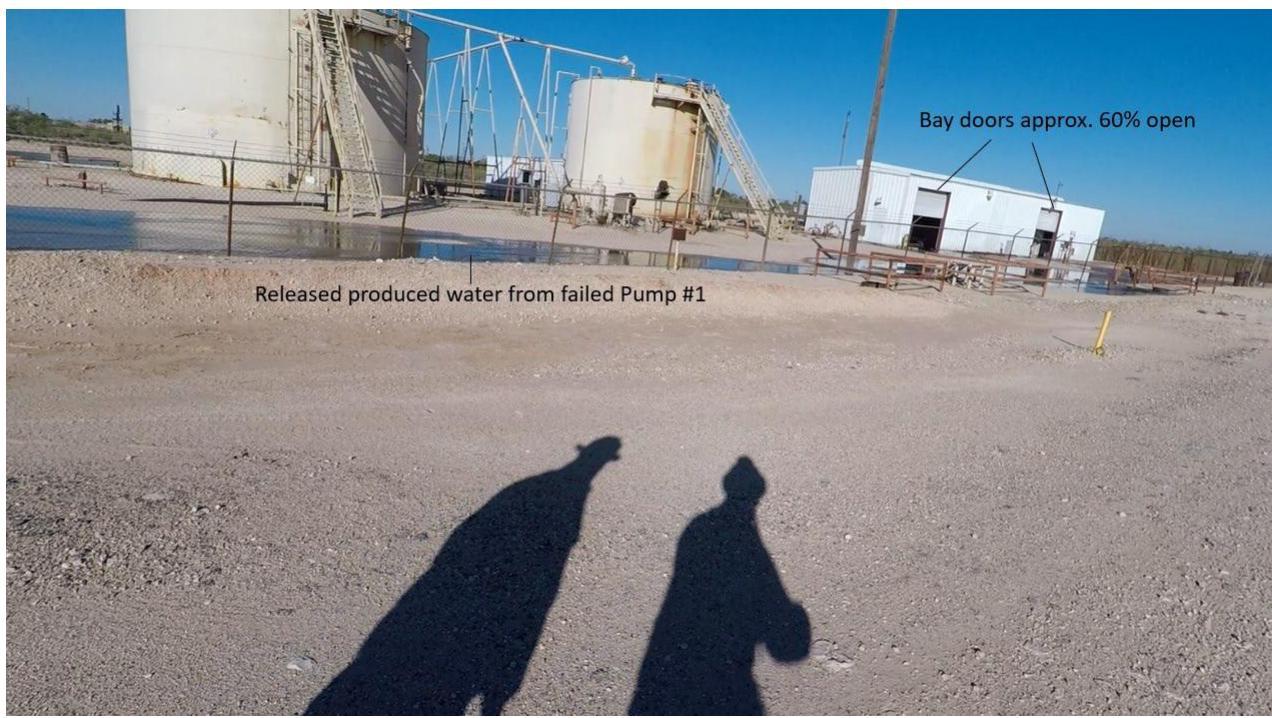
Figure 6. Video still showing bay door positions and released produced water. (Credit: Ector County Sheriff's Office)

- 3. The H_2S warning signs to the left of the gate entrance at the public road were corroded;
- 4. Produced water was observed spilling out of Pump #1 (**Figure 17**). Water was also present exterior to the pump house (**Figure 6**). Such water presence is abnormal at the facility and indicative of an equipment malfunction;

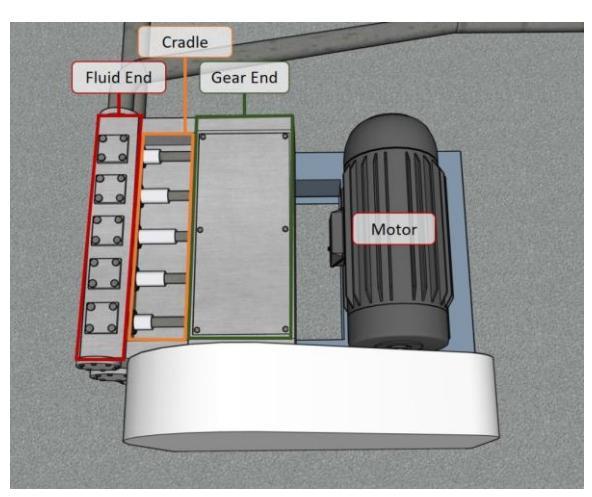
Figure 7. Major components of a plunger pump. (Credit: CSB)

Pump #1 is a National-Oilwell type J-275 quintaplex plunger pump. The pump is a positive displacement pump. Shown in **Figure 7**, the primary components of plunger pumps are

- the motor, which provides the driving force for the pump;
- the gear end, which converts the rotational motion of the motor to the horizontal motion of the pump;
- the cradle, an open section in the pump between the fluid end and the gear end; and
- the fluid end, which contains valving and seals required for the pump to pressurize water.

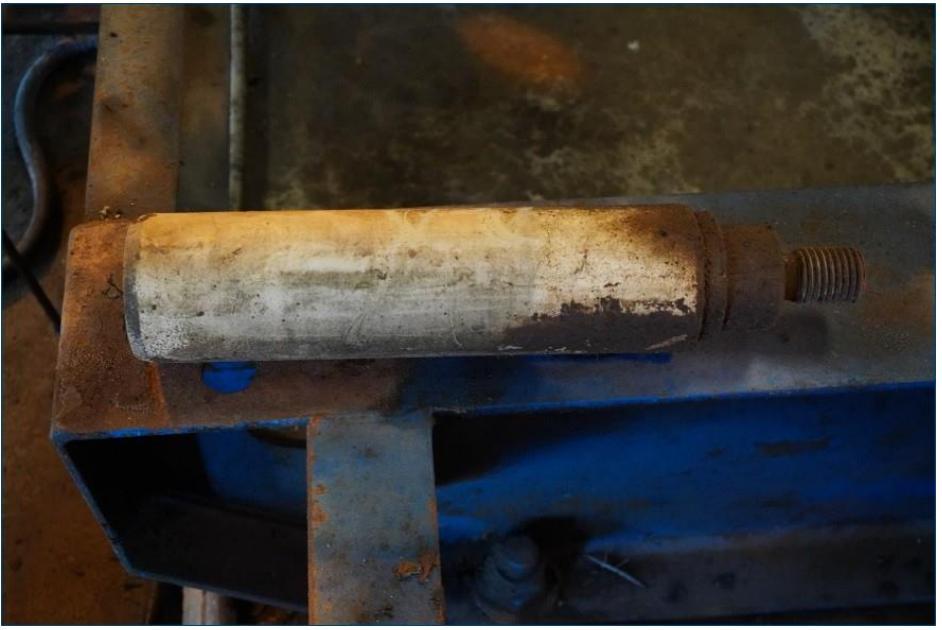
Between the gear end and the fluid end, inside the cradle, five ceramic plungers (**Figure 8**) pressurize the produced water. The gear end pulls the plungers into and out of the fluid end, which draws water from the suction tank and pressurizes the water into the discharge piping [3, p. 3]. The stuffing box is designed to seal around the plunger and prevent the produced water from leaking out of the fluid end. Shown in **Figure 9**, the stuffing box contains the components required to seal around the plunger to prevent any leaks. Valves inside the fluid end (orange highlight) open to allow water in from the suction line (light blue arrows), the plunger presses on the water, and another valve opens to allow the pressurized water to flow into the discharge line (dark blue arrows). Pump #1 had a maximum discharge pressure of 1,020 psig and was usually run at around 900 psig.

Figure 8. A spare ceramic plunger. (Credit: CSB)

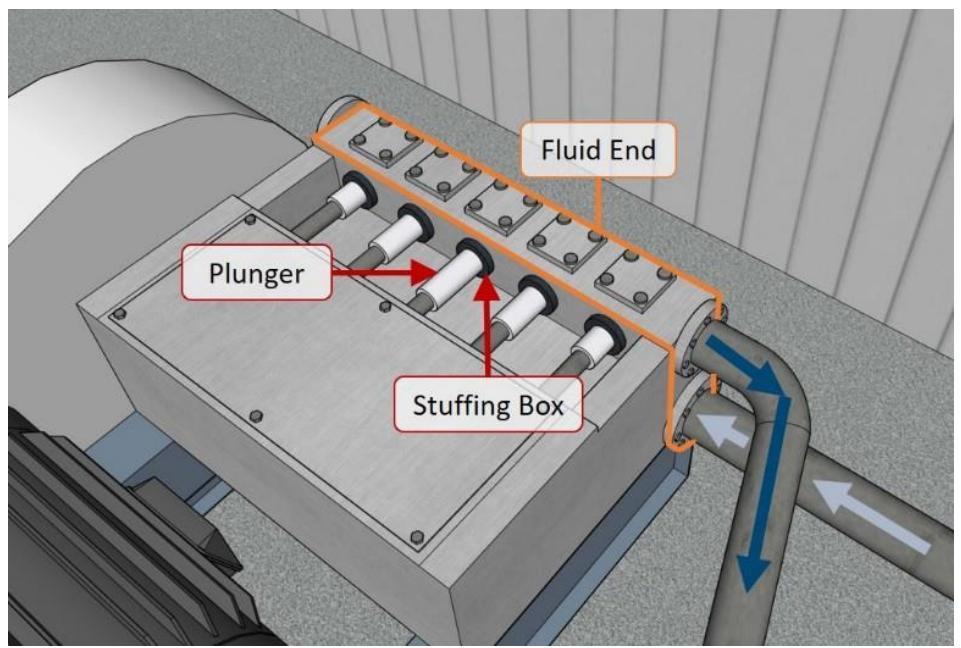
Figure 9. View of a plunger pump's main components. (Credit: CSB)

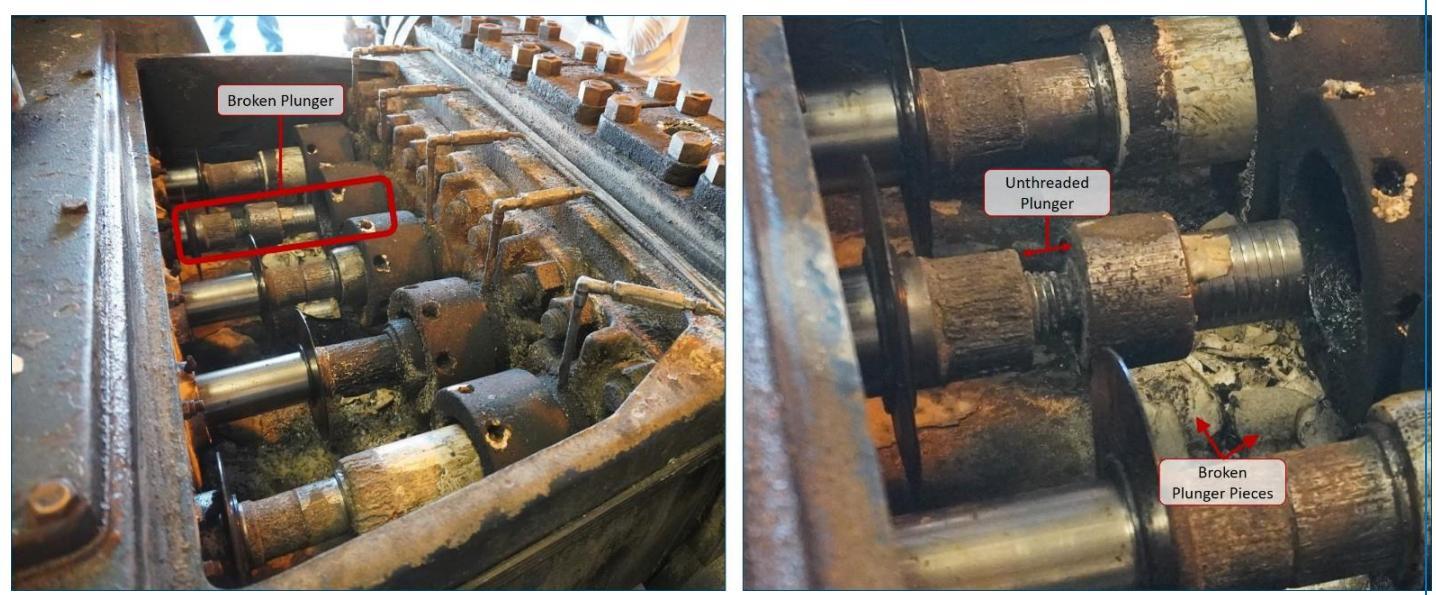
The CSB inspected Pump #1 after the incident. The inspection found that one of the pump's plungers had backed off its threaded connection to the gear end, and the ceramic was shattered. The fragments of the plunger could be seen in the bottom of the cradle (**Figure 10**). The inspection also revealed that the discharge valve handle for Pump #1 was in a position indicating approximately 95 percent closed and the position indicator on the suction valve for Pump #1 was about 50 percent closed (**Figure 18** and **Figure 19**).

Figure 10. Photos of Pump #1 cradle and visible broken plunger pieces. (Credit: CSB)

Maintenance was last performed on Pump #1 on October 4, 2019 to troubleshoot a packing leak. On that occasion, the entire fluid end of the pump was assessed including pulling all plungers, replacement of all suction and discharge valves, replacement of all wiper boxes, seals and gaskets and repacking and re-installation of all five ceramic plungers.

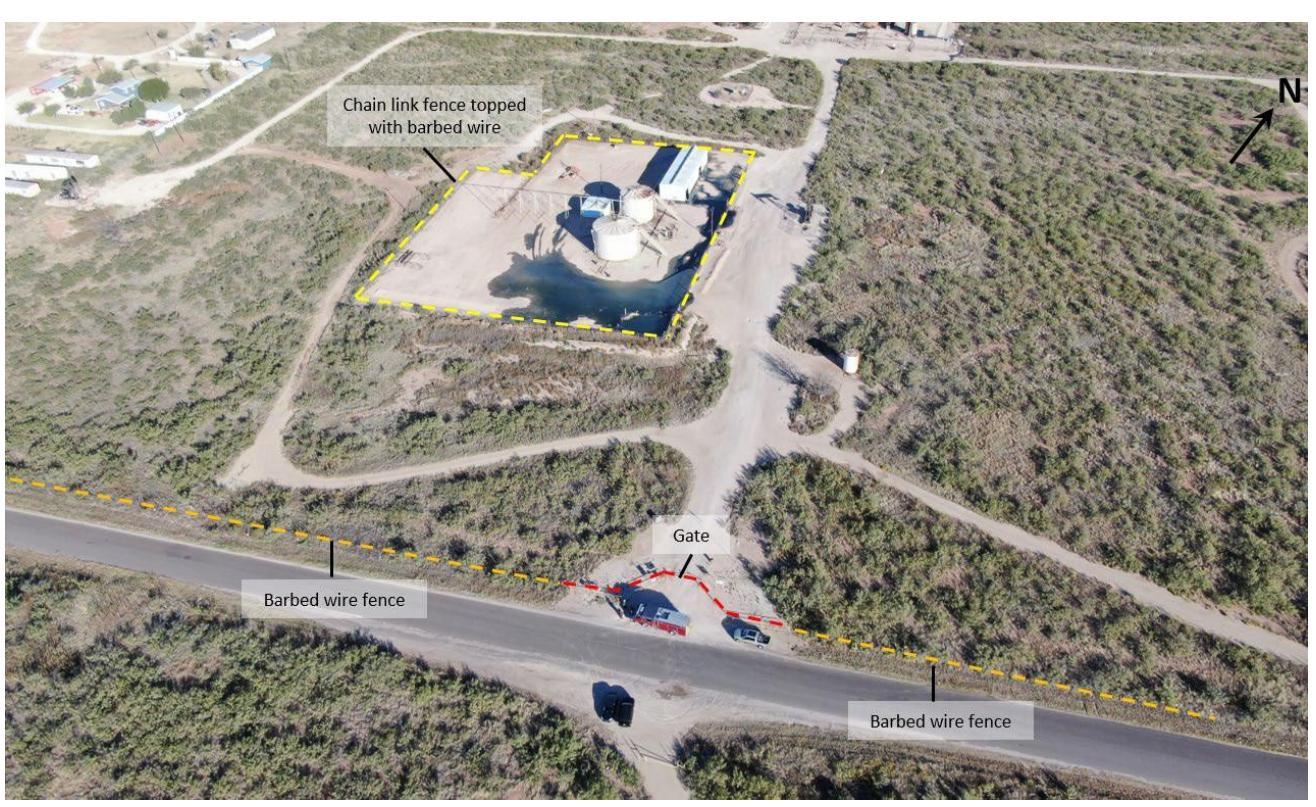
Site security at the facility consists of a gate at the entrance from the public road, a barbed wire fence around the perimeter, and a chain link fence topped with barbed wire around the waterflood station (**Figure 11**). Immediately to the left of the gate to the facility near the public road, signs list several warnings, including warnings about the potential for H_2S gas to be present (**Figure 12**). Additional signs, installed to the left the gate of the interior chain link fence topped with barbed wire, also warn of the potential presence of H_2S (**Figure 13**). Many of the H_2S warning signs were corroded. The signs were likely not non-corrosive, were not reflective, were not lit, and were likely difficult to read under low light conditions. Further, vehicles passing through these two open gates in night conditions may not have seen the signs at all, as they would not have been in the direct line of sight. For the internal fence, when the gates were open, a vehicle's headlights would not have been facing the signs upon entry. For the external fence, the vehicle's headlights would have only faced the signs if they arrived from the east.

Aghorn told the CSB they expect the waterflood station access gates to be locked each day after employees complete their tasks. While employees are present at facilities, the gates are typically left open and unlocked. On the night of the incident, both the gate and the chain link fence were left open since Pumper A was working in the pump house.

Figure 11. Aghorn waterflood station security. (Credit: CSB)

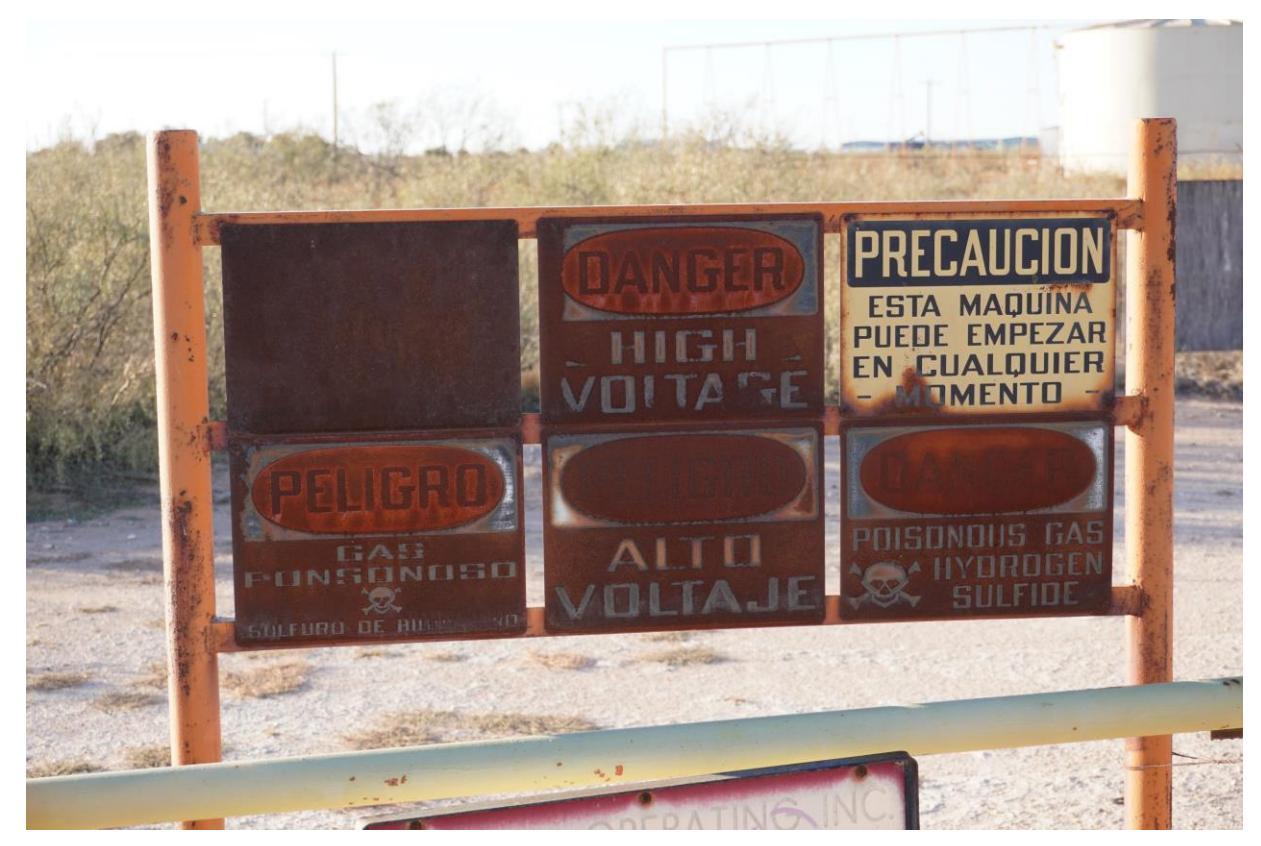
Figure 12. Warning signs to the left of the gate to the facility from the public road. (Credit: CSB)

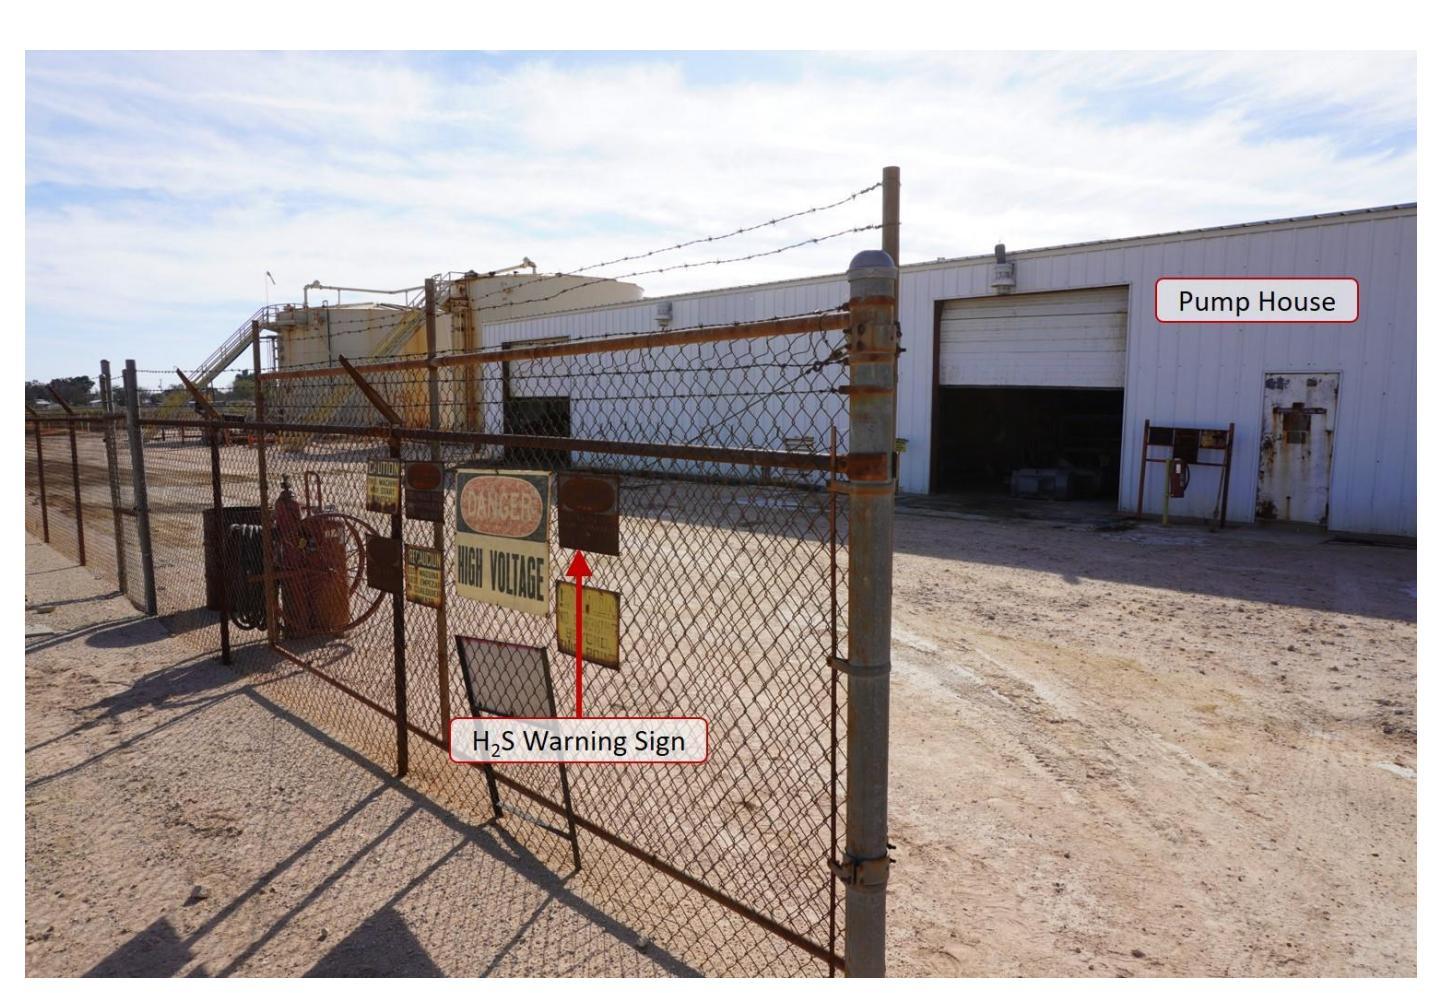
Figure 13. Warning signs and interior fence surrounding the waterflood station. (Credit: CSB)

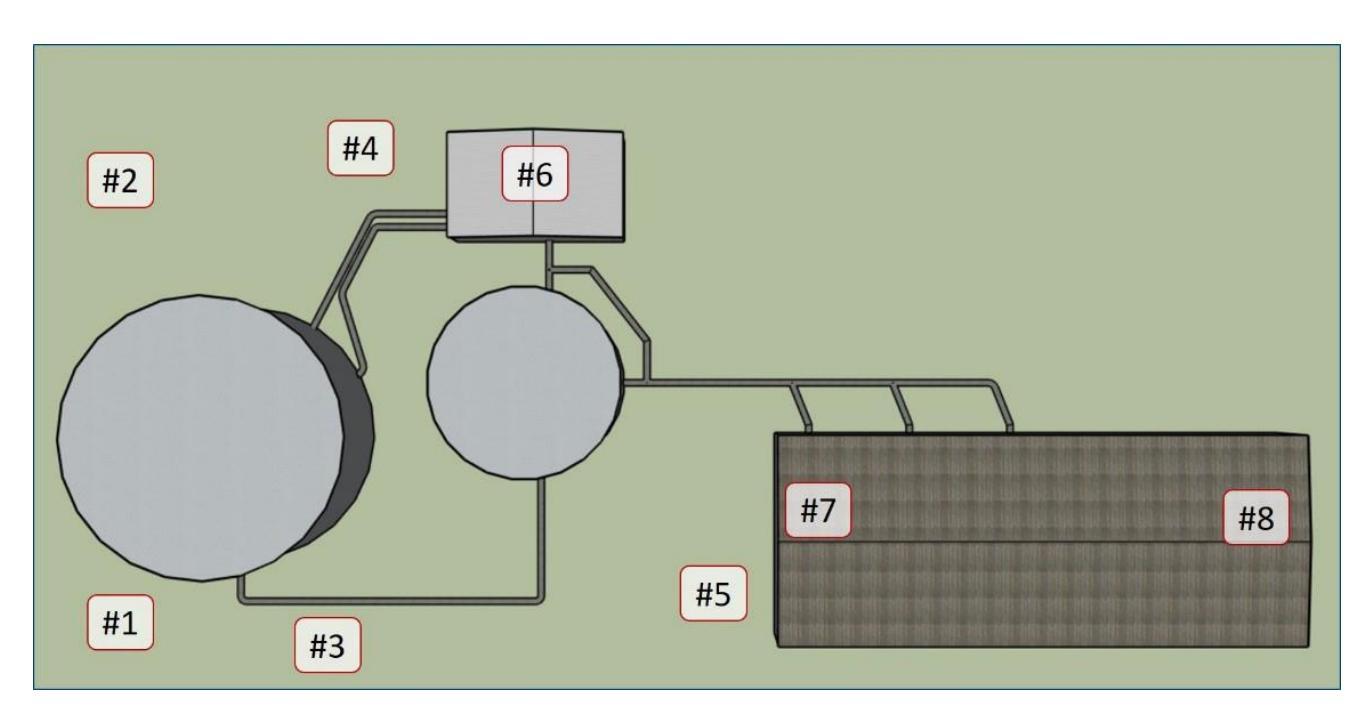
Figure 14. Locations of the eight H₂S point detectors at the waterflood station. (Credit: CSB)

The CSB requested from Aghorn all maintenance and calibration records for the H₂S detection and alarm system. Aghorn responded to the CSB stating that it did not locate any responsive documents.

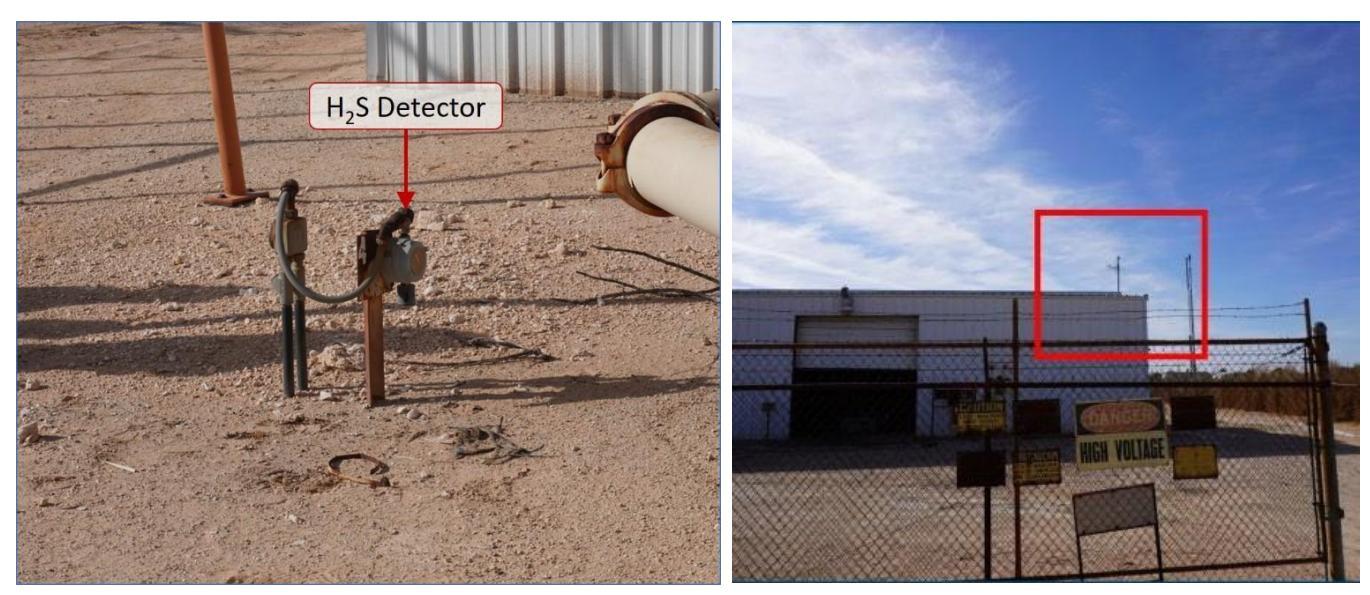
Results also indicated that, with a properly configured H_2S detection and alarm system, a test signal from the control panel was successful in illuminating the beacon light on the top of the building. Had the sensors and sensor element of the system been operational, the alarm element of the system would have been successful.

Figure 15. Image of an H₂S point detector. (Credit: CSB)

Figure 16. Light designed to illuminate when a dangerous concentration of H₂S is detected. (Credit: CSB)

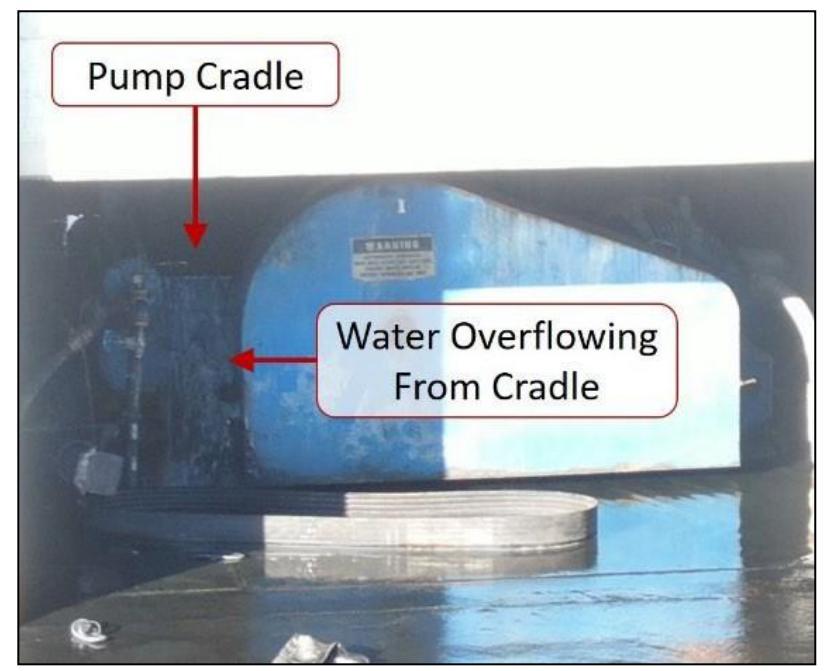
Figure 17. Image of Pump #1 taken on Saturday, October 27, 2019. (Credit: Ector County Sheriff)

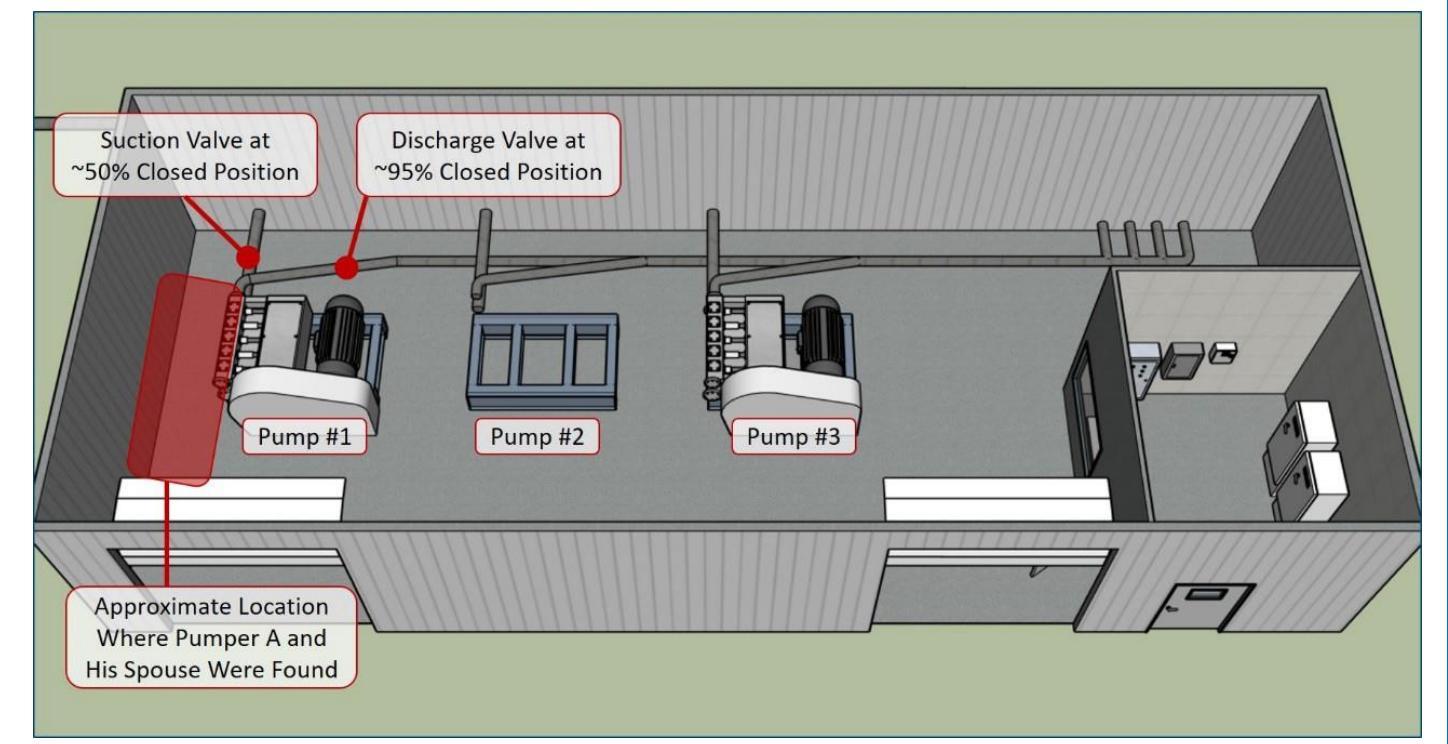
- 12. The position indicator on the suction valve for Pump #1 was about 50 percent closed (Figure 18 and Figure 19);
- 13. Pumper A's personal H₂S detector was found in his work truck. It was in an alarm state, meaning it had detected dangerous levels of H₂S;

- 14. Pumper A was found deceased near the suction valve of Pump #1 (Figure 18); and
- 15. Pumper A's spouse was found deceased next to the body of Pumper A.

Figure 18. Suction and discharge valve positions of Pump #1, and approximate location where Pumper A and his spouse were found. (Credit: CSB)

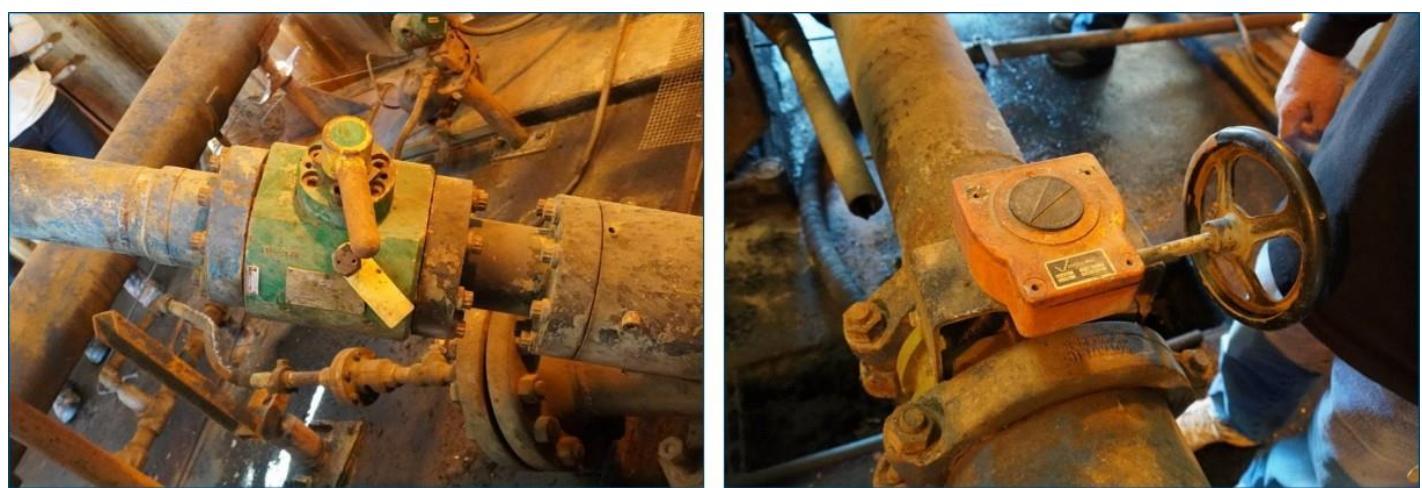
Figure 19. Position of the discharge (left) and suction (right) valves on Pump #1. (Credit: CSB)

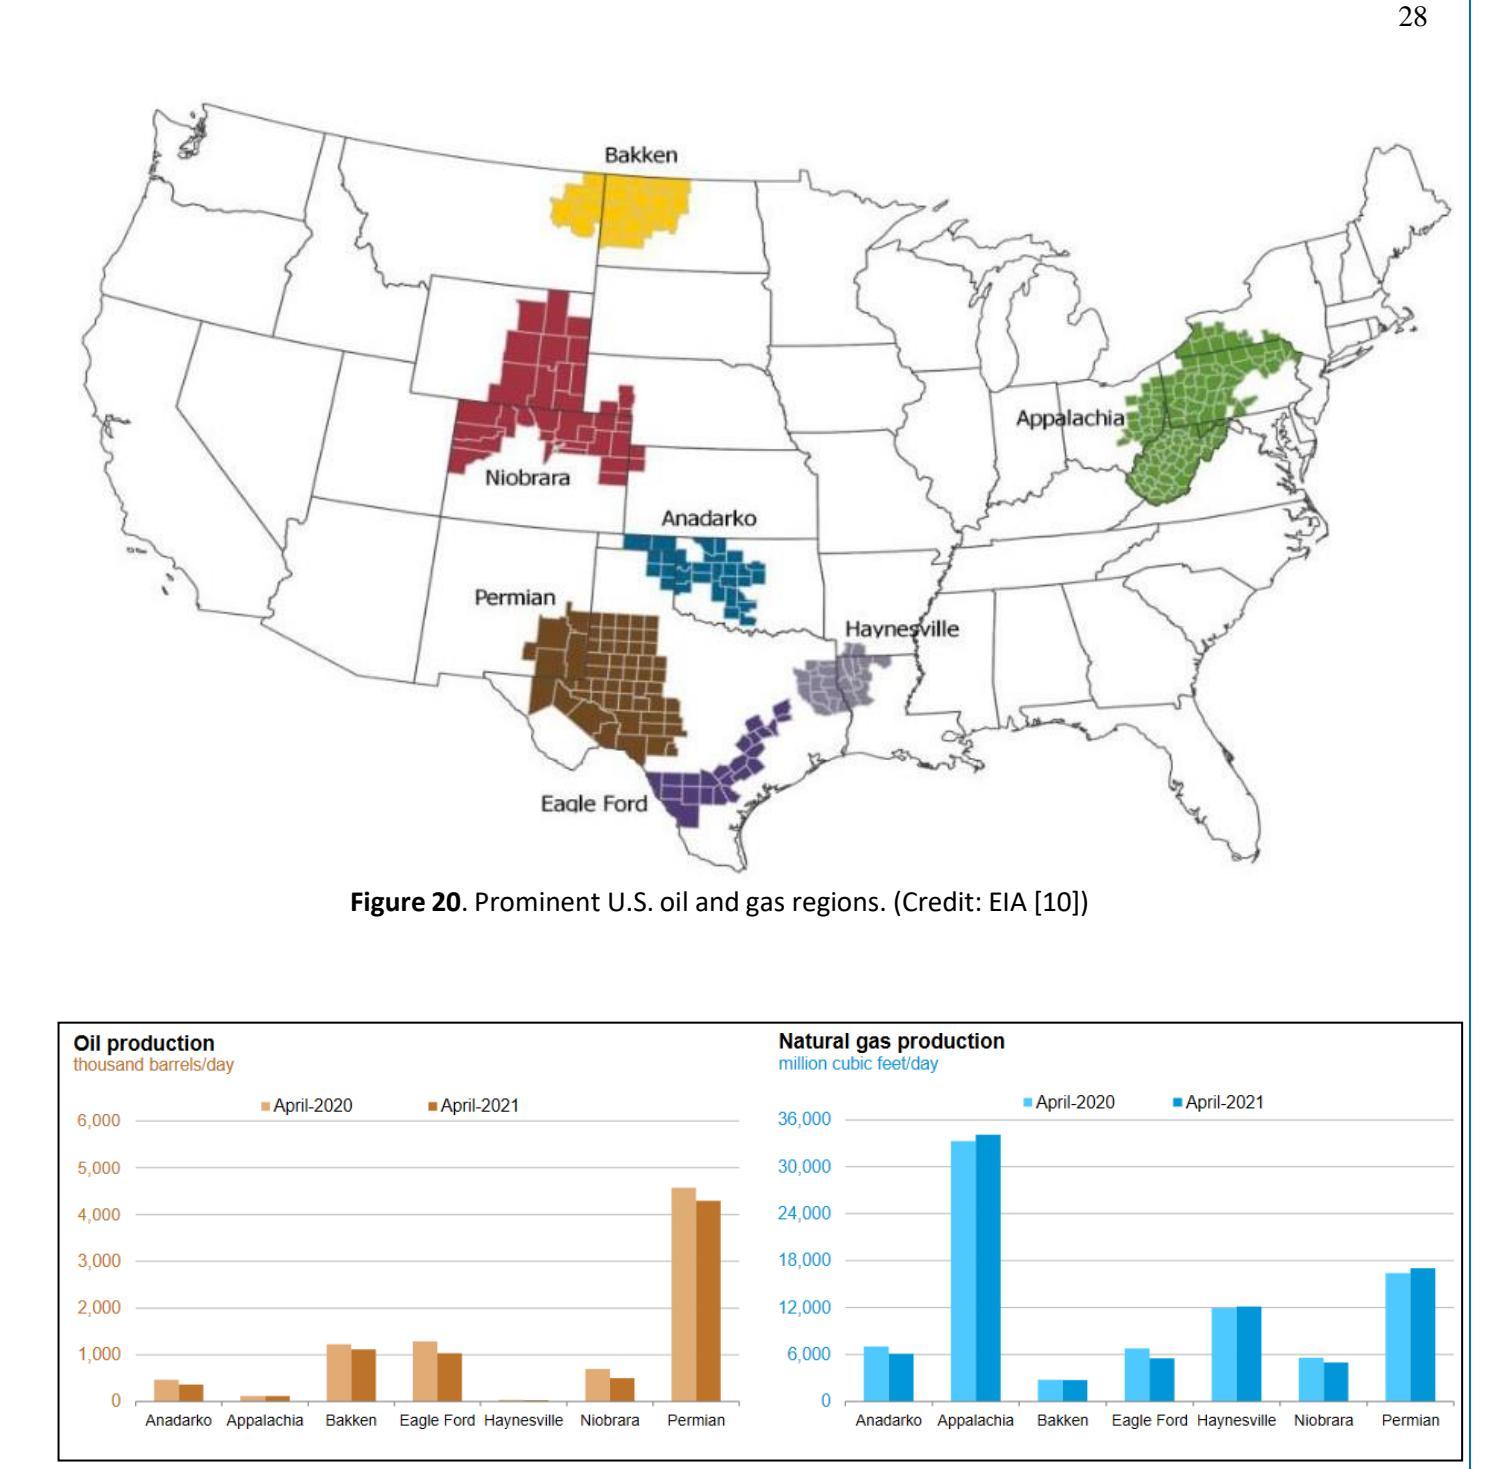
H_2S forms naturally in some geologic formations from decomposing underground organic matter, such as decaying plant matter [8, p. 17]. H_2S is found in underground formations throughout the United States, and is prevalent in the Permian Basin, an oil and gas basin located in west Texas and southeast New Mexico (**Figure 20**). A 2017 study found that over 85% of the natural gas produced from the Permian Basin contains greater than 100 ppm H_2S [9]. The U.S. Energy Information Administration (EIA) March 2021 Drilling Productivity Report indicates that U.S. oil production is highest from the Permian Basin—at over 4,000 barrels per day—and natural gas production is second highest from the Permian Basin—at almost 18,000 million cubic feet per day (**Figure 21**).

Figure 21. Oil and gas production in the United States. (Credit: EIA [10])

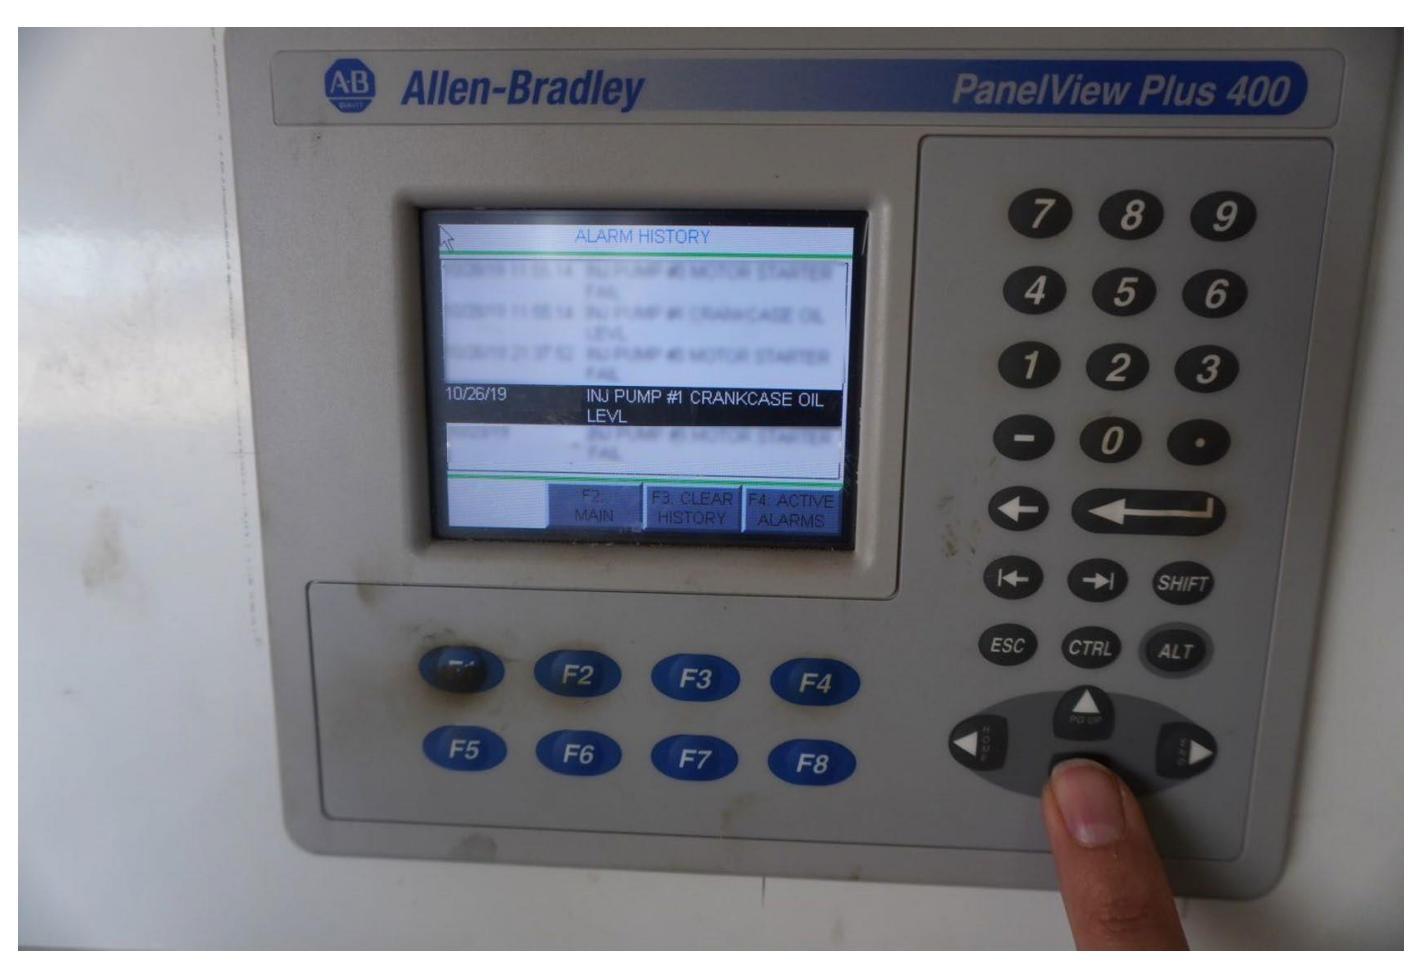
During the evening of October 26, 2019 after Pumper A's second visit to the waterflood station, at 6:38 p.m., the PLC triggered a Pump #1 crankcase oil level alarm on the control board. Five minutes later, at 6:43 p.m., the phone system sent an automated audio message to Pumper A, which stated, "Alarm Alert Condition 3. Please acknowledge." Alarm Alert Condition 3 indicates a pump malfunction of some kind. To determine the precise alarm, Pumper A was then required to go to the waterflood station and access the PLC in the control room to obtain more detailed information about the alarm. Pumper A then acknowledged the alarm on his phone by pressing "555."

Figure 22. PLC screen displaying Pump #1 crankcase oil level alarm. (Credit: CSB)
