Hydrogen Sulfide Release at Waterflood Station in Odessa, Texas

Professional Development Hours (PDH) or Continuing Education Hours (CE) Online PDH or CE course

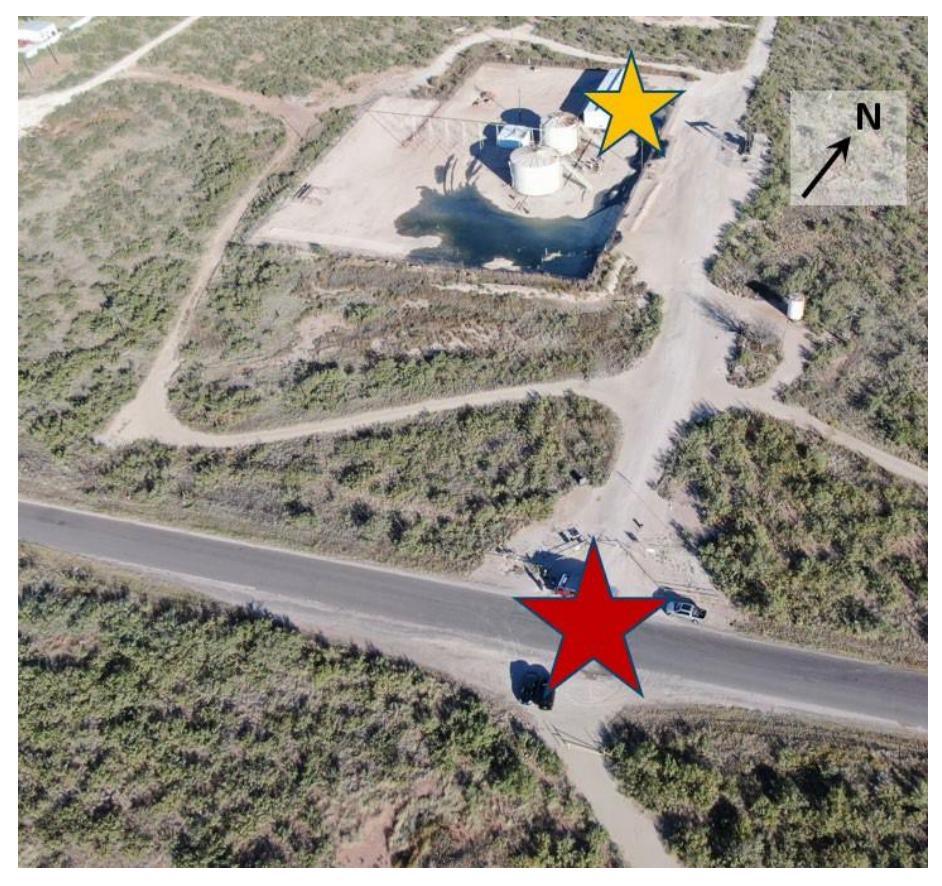
Figure 23. Location of the incident command post (red star) and incident location (gold star). (Credit: Ector County Sheriff's Office)

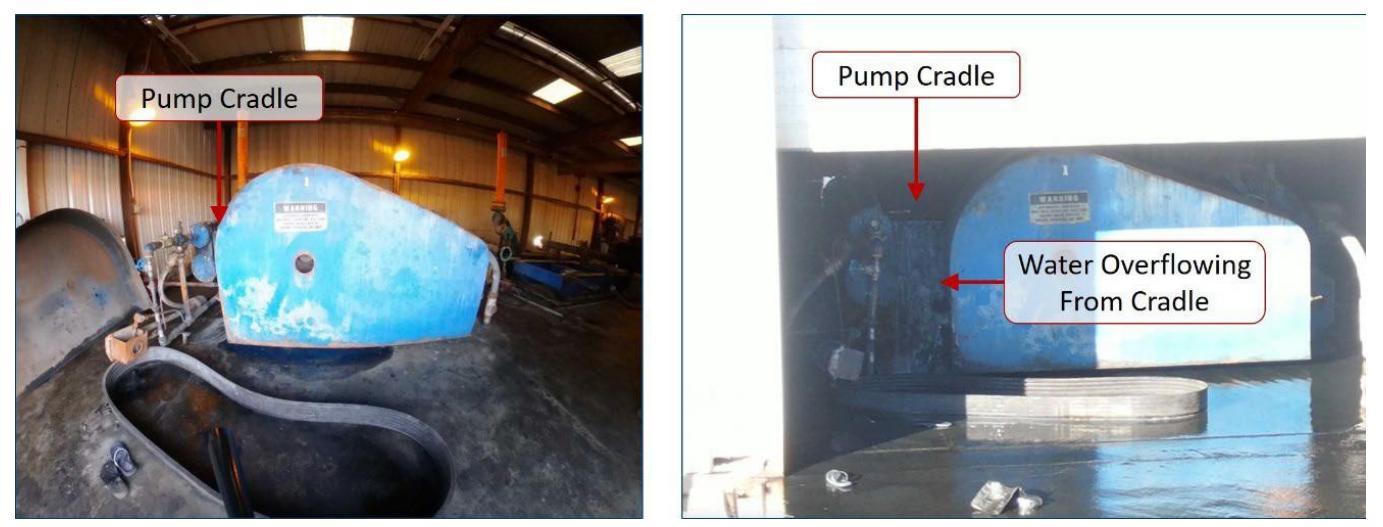
Aghorn employees started to arrive at the scene. One employee could see that Pump #1 was still running and water was pouring out of the pump's cradle (**Figure 24**). Via phone, the Aghorn vice president directed the employees to close valves to isolate all the wells connected to the waterflood station. After arriving at the site

Figure 24. Images of Pump #1. (Left Credit: CSB; Right Credit: Ector County Sheriff)

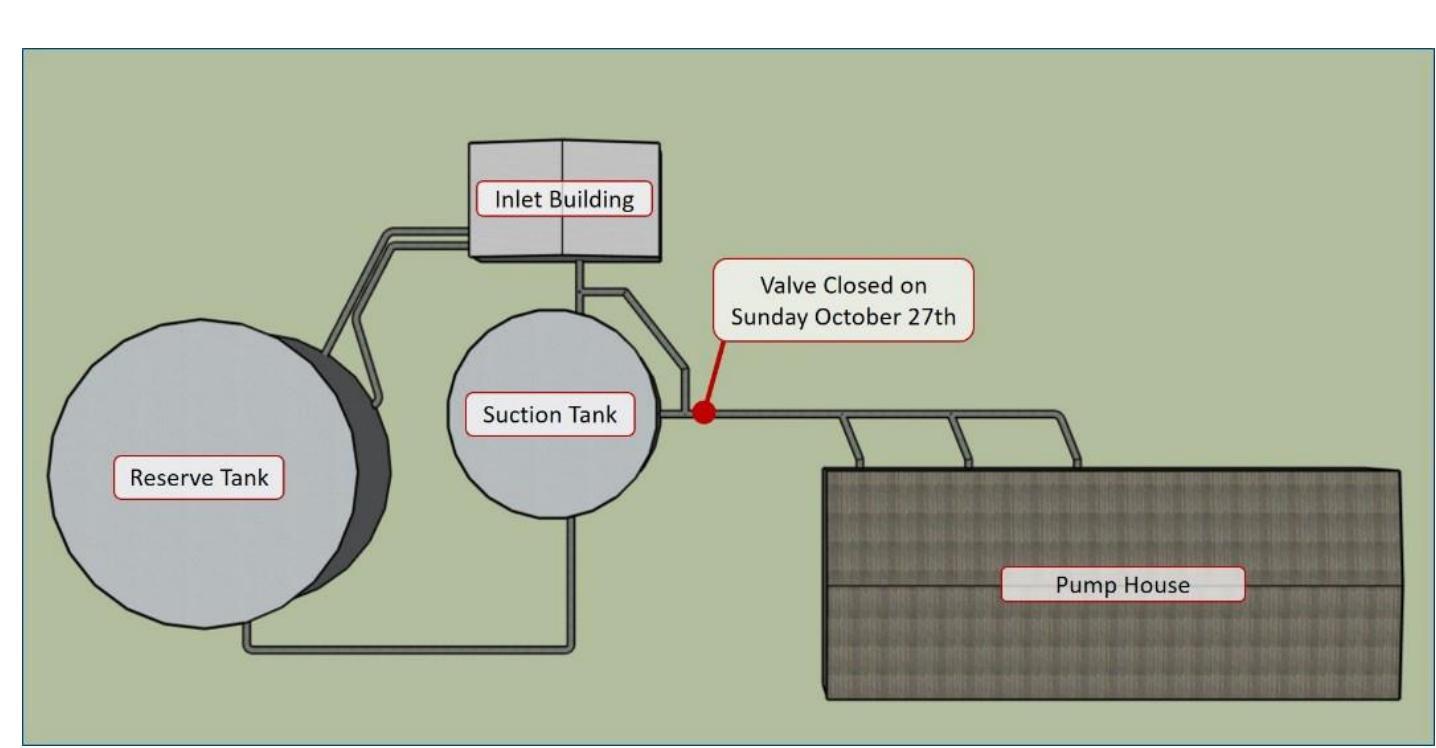
At approximately 9:00 a.m. on Sunday, October 27, 2019, the Aghorn vice president then met with Odessa Fire Rescue at the gate to the waterflood station. Several firefighters donned SCBA and walked to the waterflood station. They reported that they could still see water coming out of the pump and were measuring high H_2S gas levels. To stop the water flow, the vice president directed the fire department to close the valve at the bottom of the suction tank (**Figure 25**). The firefighters closed the valve, and the water stopped spilling from the pump.

Figure 25. Location of final valve closure that stopped the release of water from the failed Pump #1. (Credit: CSB)

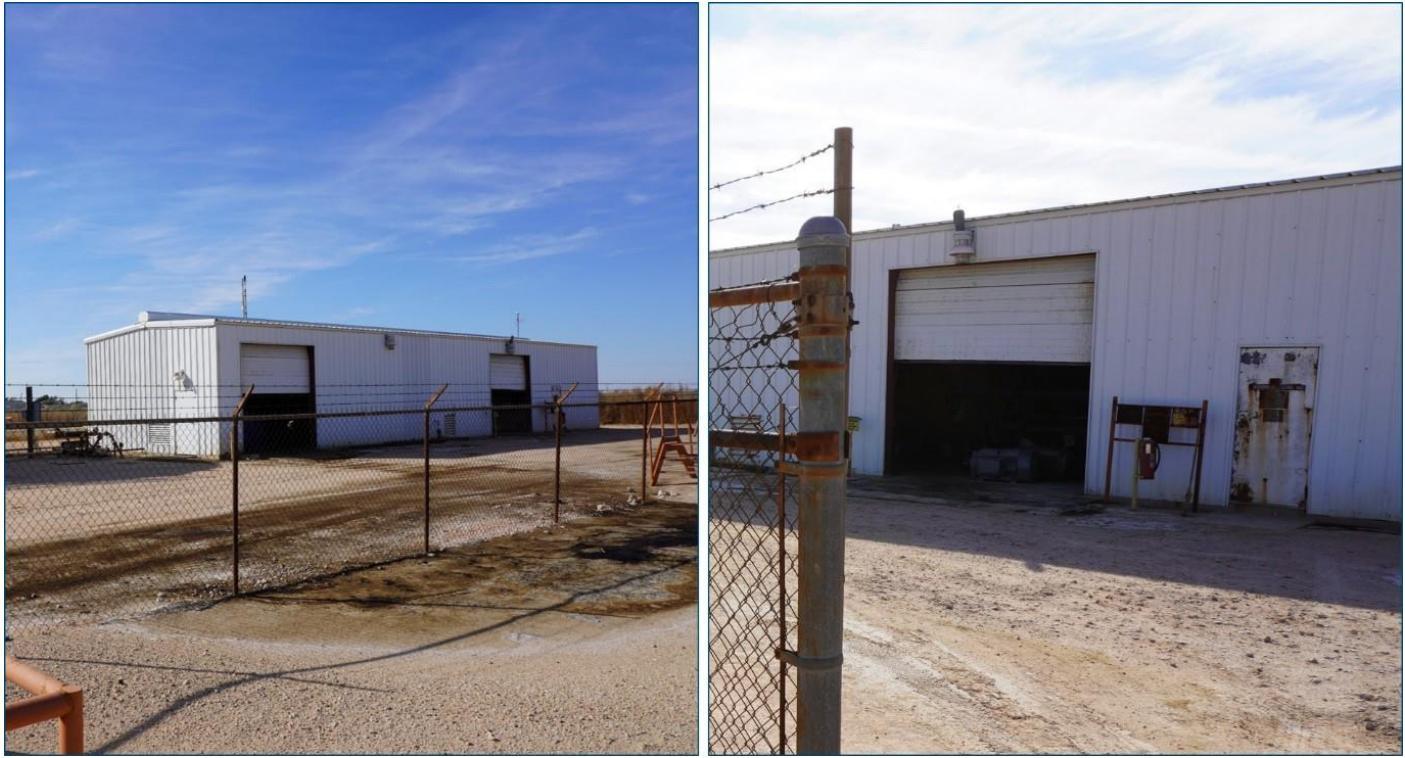
The pump house was ventilated by the two bay doors on the east side of the pump house (**Figure 26**). On the night of the incident, these doors were approximately 60% open. These open bay doors and any other available ventilation methods, however, did not adequately ventilate toxic H_2S gas from the building during the incident, contributing to the high H_2S levels to which Pumper A and his spouse were exposed. Due to the limitations of

the available evidence, the CSB was unable to confirm whether the pump house exhaust fans were operational at the time of the incident.

Figure 26. Photos showing bay door positions. (Credit: CSB)

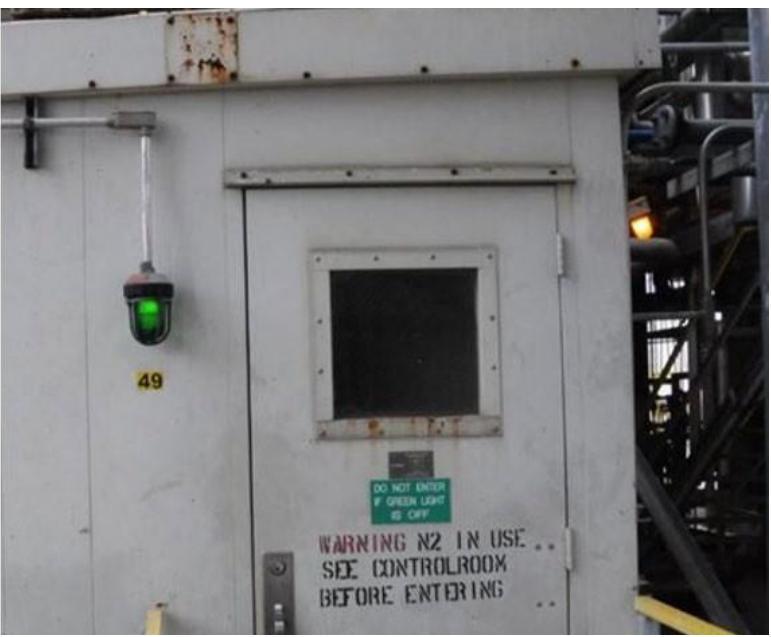
A fully functional alarm system should alert employees arriving to the facility of any potential H₂S danger. The visual component of the Aghorn system relied on a light to turn on when sensors detected an H₂S release. However, a weakness of this design is that a component failure, such as a burned-out lightbulb, could falsely indicate that a structure is safe to enter during a toxic gas release. Other designs avoid this problem; for example, CSB's DuPont Interim Recommendations Report describes a structure which uses a detection system that does not rely on a light to turn on. Detection systems inside DuPont's structure continuously monitor the atmosphere. If a leak occurs and the atmosphere inside is unsafe for people, an alarm sounds and a green light outside the door, which is normally continuously lit, turns off to indicate it is not safe to enter (**Figure 27**) [13]. A sign on the door states, "Do not enter if green light is off." When the light is off, employees must assume the environment inside the building is not safe.

Facilities that are not continuously occupied, such as the Foster D waterflood station, can implement a system similar to this DuPont design. If employees arrive at the facility and the light is off, they would be required to

Figure 27. An alternative detection system design. (Credit: CSB)

treat entering the structure as if the hazard, such as H_2S , exists at dangerous levels on the other side of the door. Installation of this type of design would significantly increase safety at facilities where equipment processes toxic fluids.
