Designing for Earthquakes

A Manual for Architects

FEMA 454 / December 2006

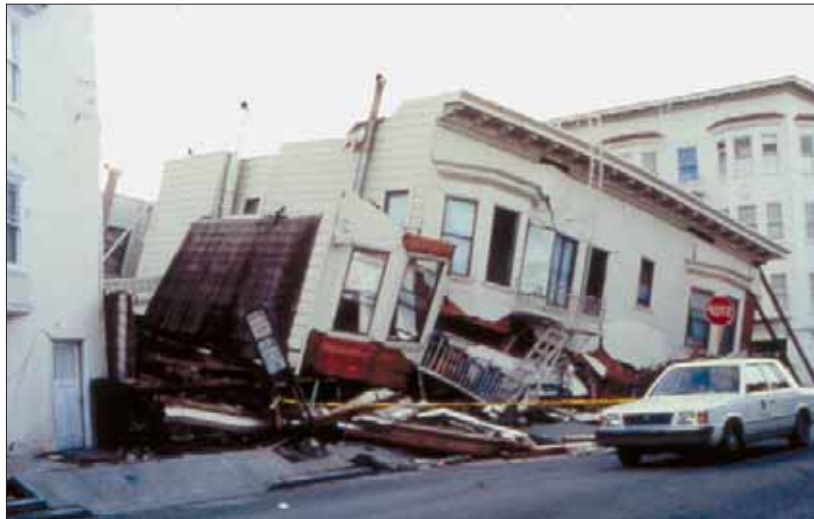
Collapsed apartment house in the Marina District of San Francisco, caused by a combination of amplified ground motion and a soft story.

ground motion at the site (Figure 1-2). The United States does not rate very high in deadly earthquakes compared to other countries. In the entire history of the United States, the estimated number of earthquake-related deaths is only about 3,100, of which some 2,000 are accounted for by the 1906 San Francisco quake.

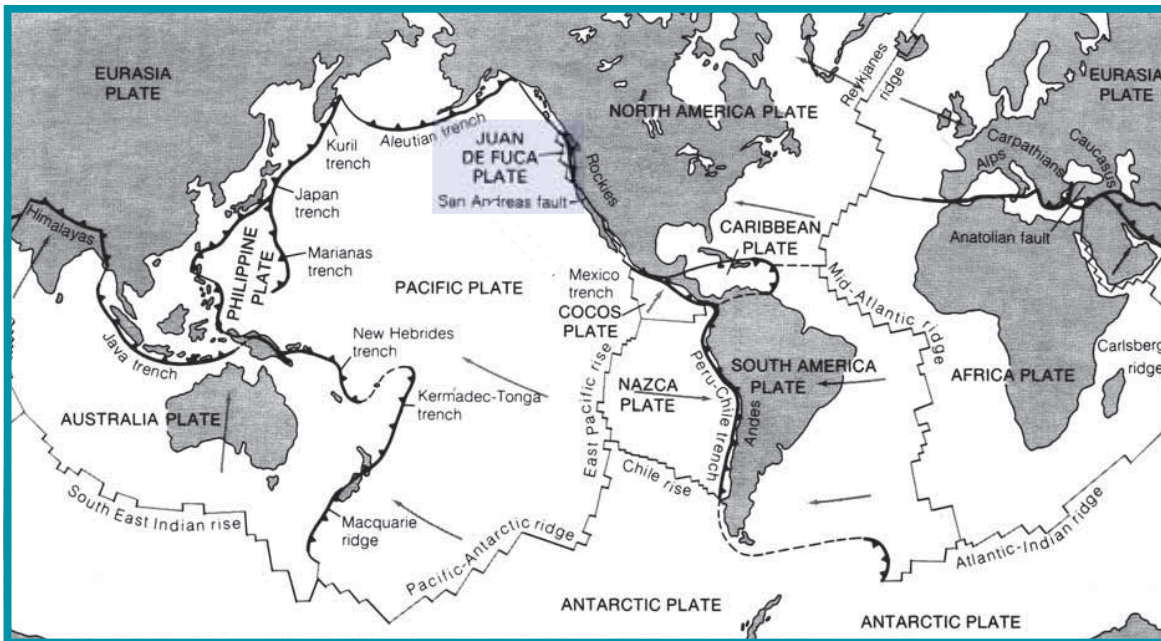
Figure 2-2: The major tectonic plates, midoceanic ridges, trenches and transform faults.

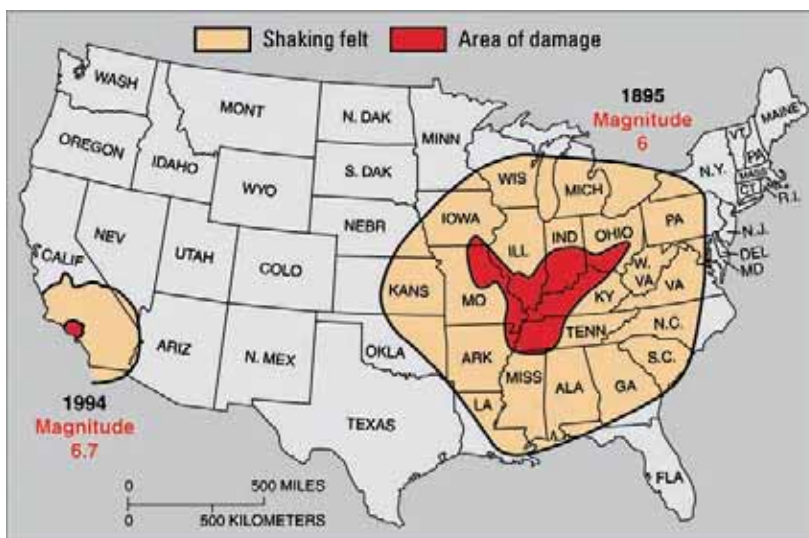
Figure 2-6: Map comparing curves of MMI 3 (shaking felt) and MMI 8 (area of damage) for the magnitude 6.7 1994 Northridge, California, earthquake and a magnitude 6 near New Madrid, Missouri, in 1895. Although the difference in magnitude implies an 11-fold difference in scalar seismic moment, the areas of shaking intensity for the smaller earthquake are substantially larger due to differences in seismic wave attenuation in the non-tectonic region of New Madrid compared to the western U.S. (discussed in section 2.6.1).

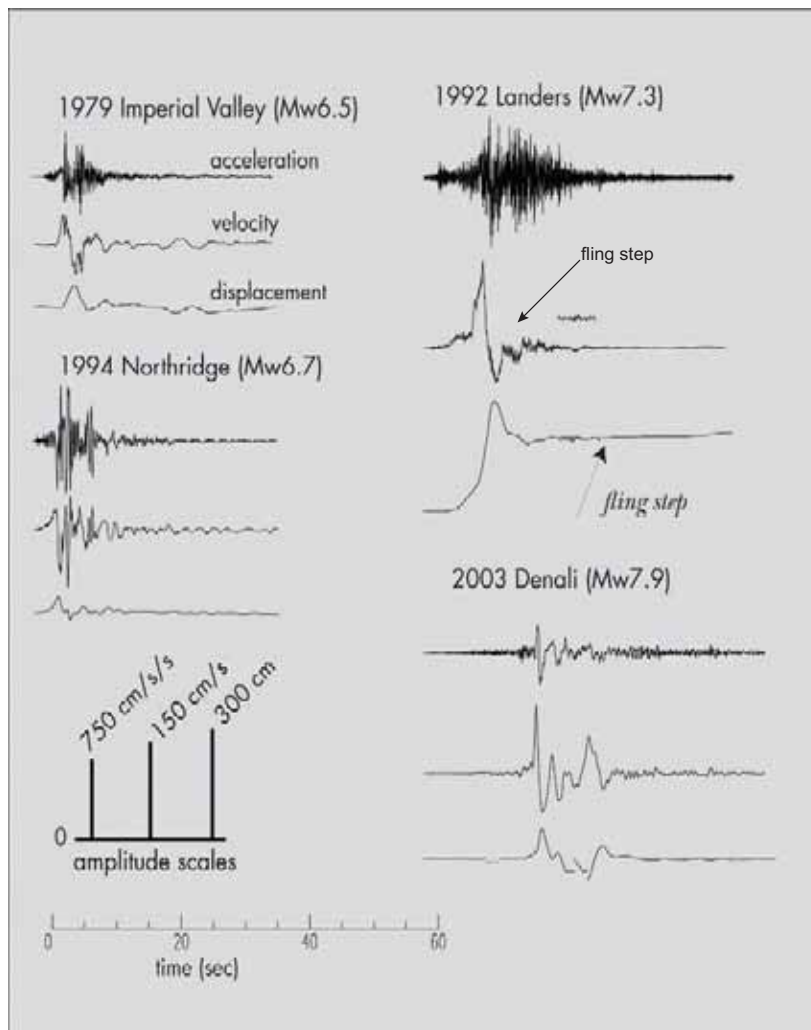
Figure 2-9: Examples of near-fault, large amplitude seismograms (time-histories).

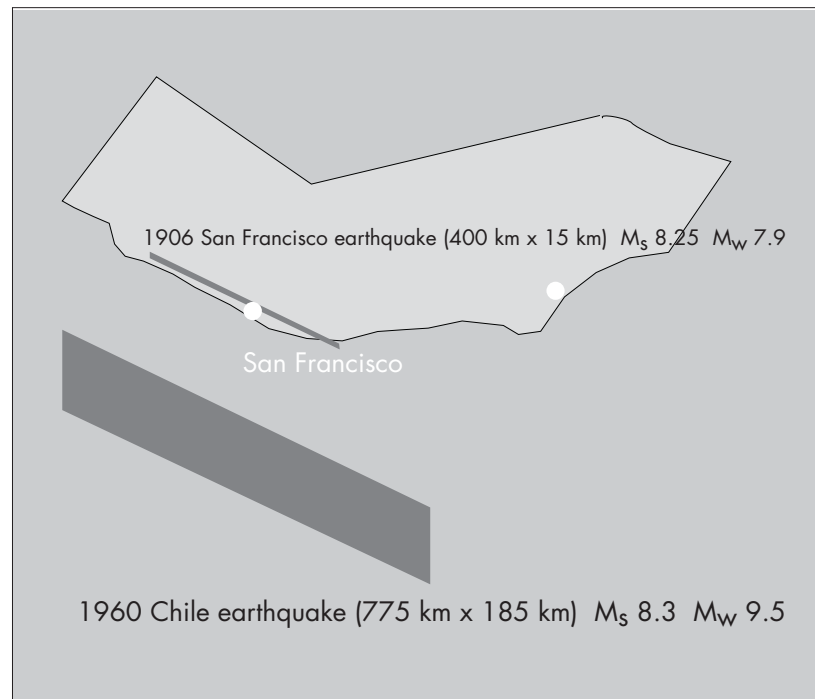
Figure 2-10: Two earthquakes may have equal magnitudes but be distinctly unequal in other respects.

The 1906 San Francisco, California, earthquake ruptured rock over a shorter length and shallower depth - only about 1/25 the area - as the 1960 Chilean earthquake. Although the surface wave magnitudes are the same, the moment magnitude for these two earthquakes (Table 2-1) are distinctly different. A sketch of the outline of California is shown for scale.

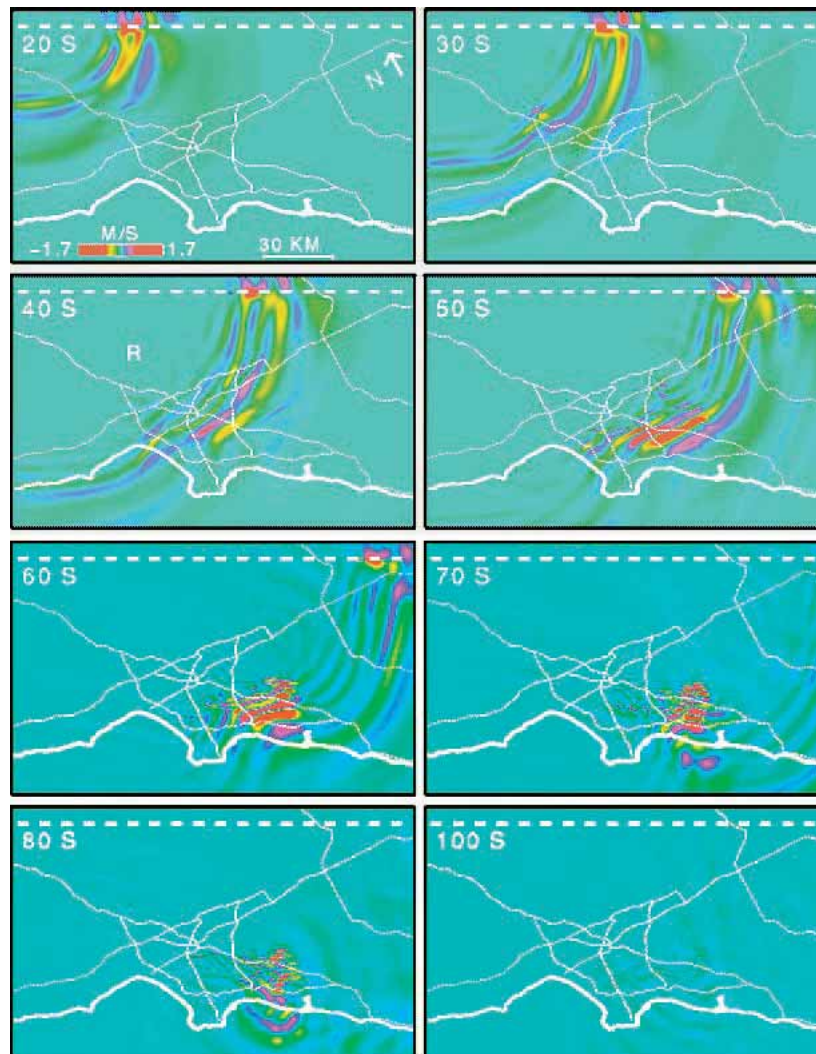
Figure 2-11: Aerial snapshots of a simulated wave propagation in the Los Angeles area.

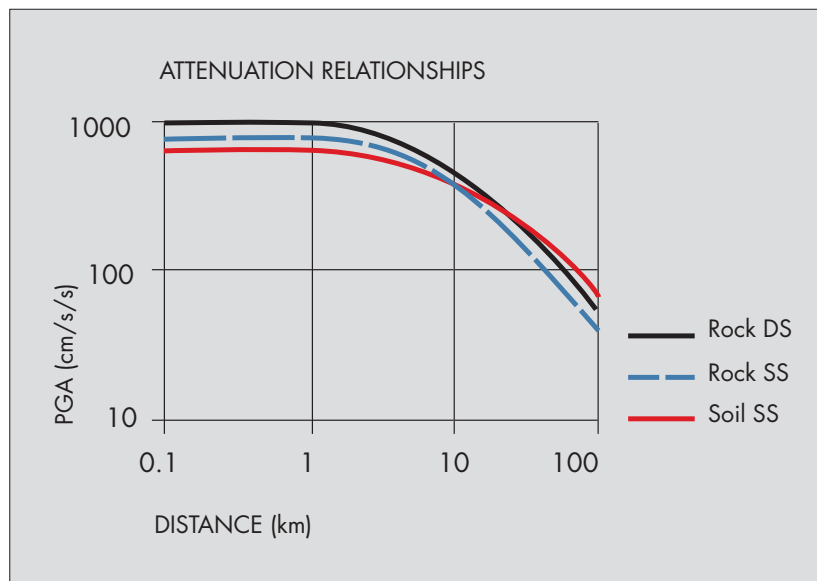
Figure 2-12: Examples of attenuation curves for a $M_w 7$ earthquake obtained by data regression, illustrating the effects of a **site** type: rock (blue dashed) vs. deep soil (red), and **event** type: strike-slip fault (blue dashed) vs. reverse fault (black)

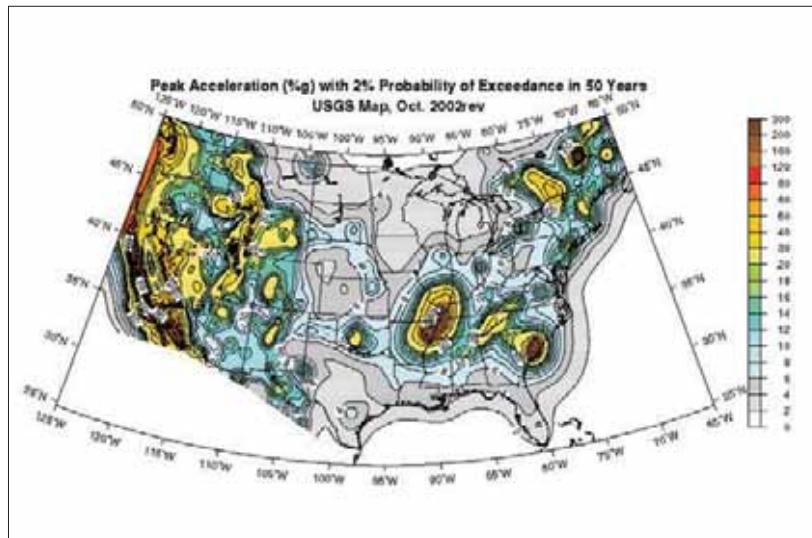
Figure 2-13: Spectral Acceleration values in %g with a 2% Probability of Exceedance in 50 years for the coterminous United States. The color scale to the right relates to the %g values.

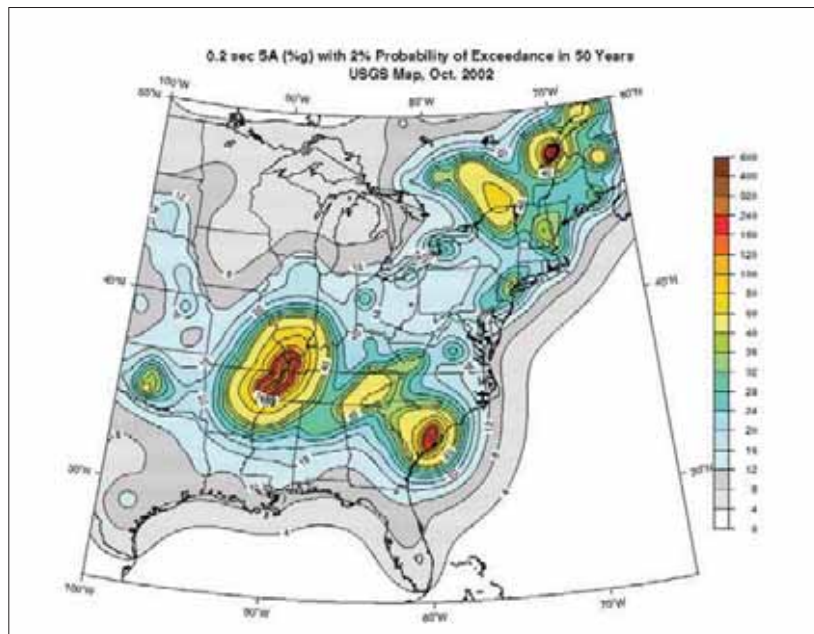
Figure 2-14: 0.2 second (short) period Spectral Acceleration values in %g with a 2% Probability of Exceedance in 50 years for Central and Southern United States.

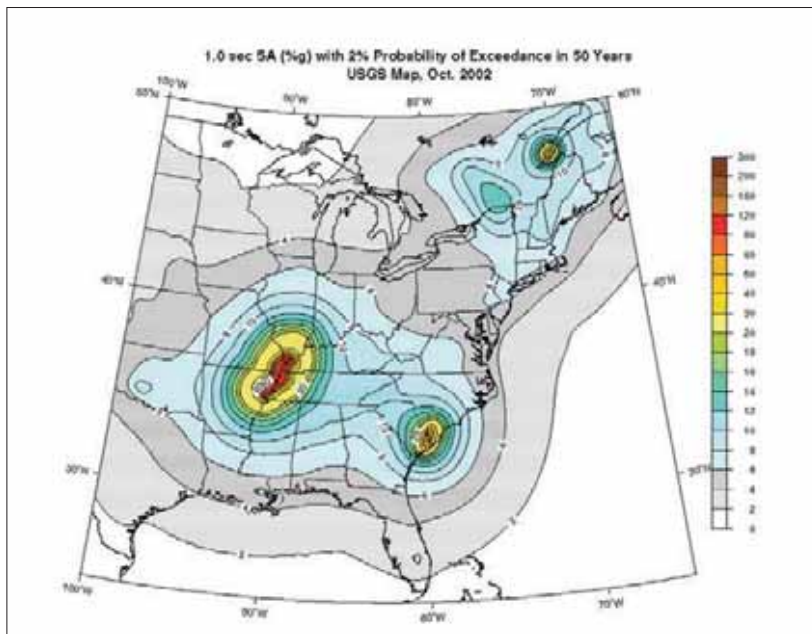
Figure 2-15: 1.0 second (long) period spectral acceleration values in %g with a 2% probability of exceedance in 50 years for central and southern United States.

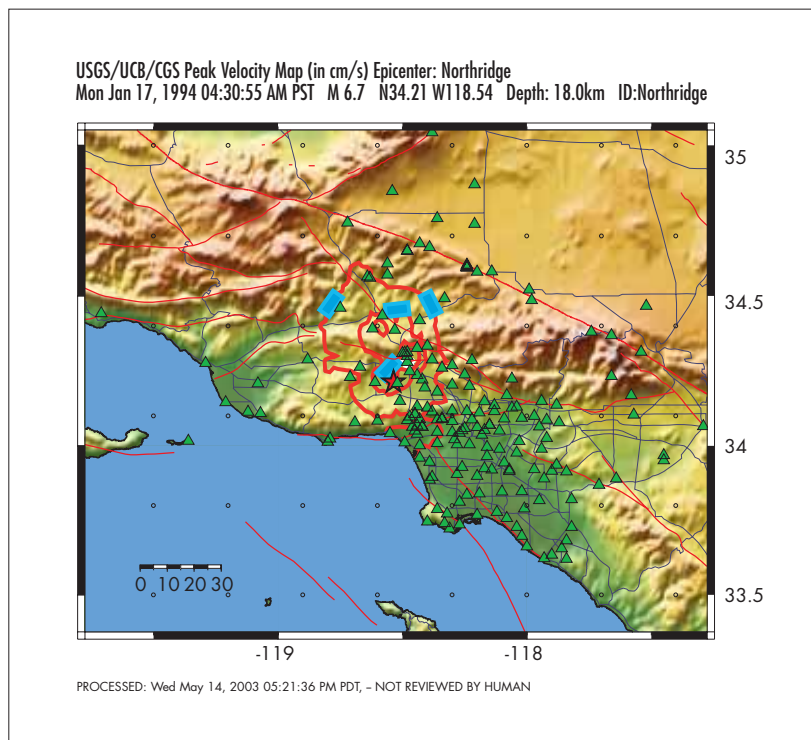
Figure 2-16: Example of a peak ground velocity (PGV) ShakeMap for the 1994 $M_w=6.7$ Northridge earthquake.

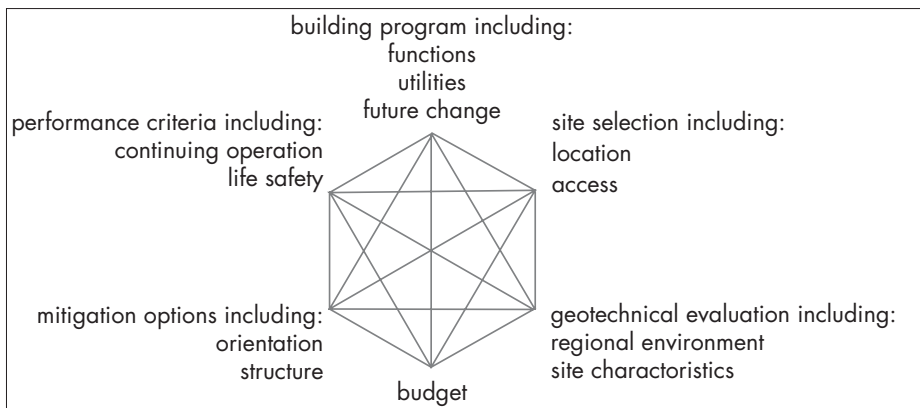
Figure 3-1: Interrelationships of performance expectations, building program and site characteristics.

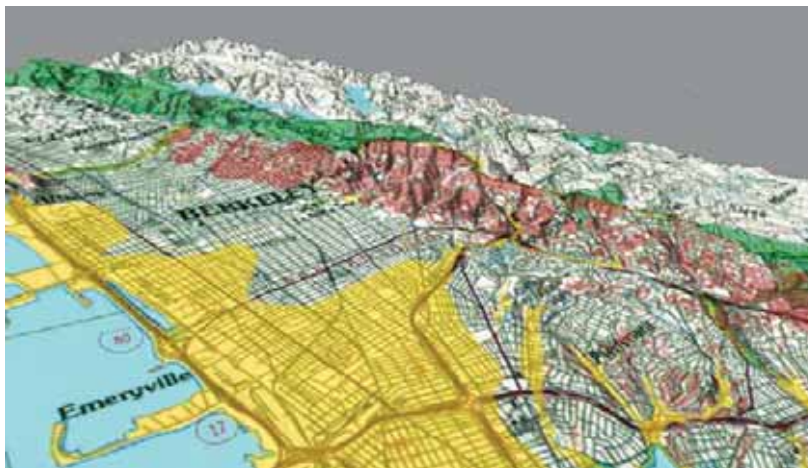
Figure 3-12: 3-D image of Liquefaction and Landslide Hazard Zone Map for Berkeley and Emeryville. Yellow indicates liquefaction, which is related to soil type and proximity to ground water.

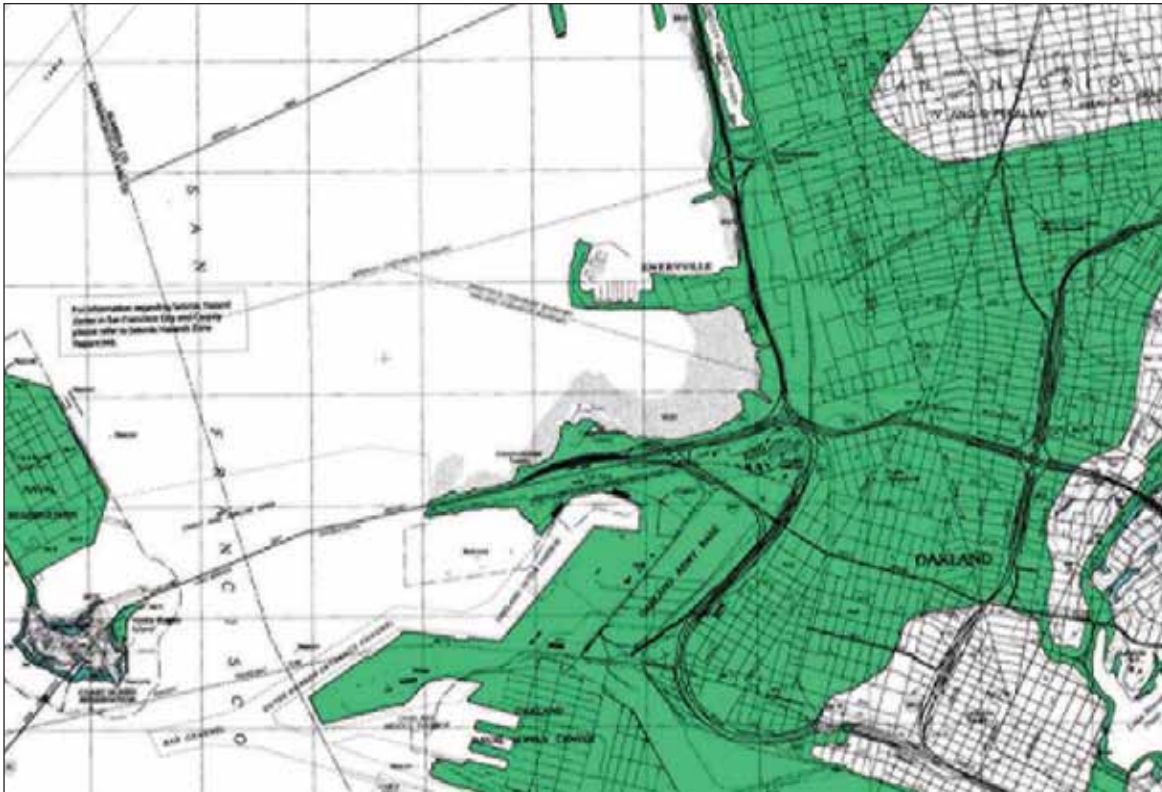
Figure 3-13: Liquefaction Hazard Zone Map for West Oakland and Emeryville.

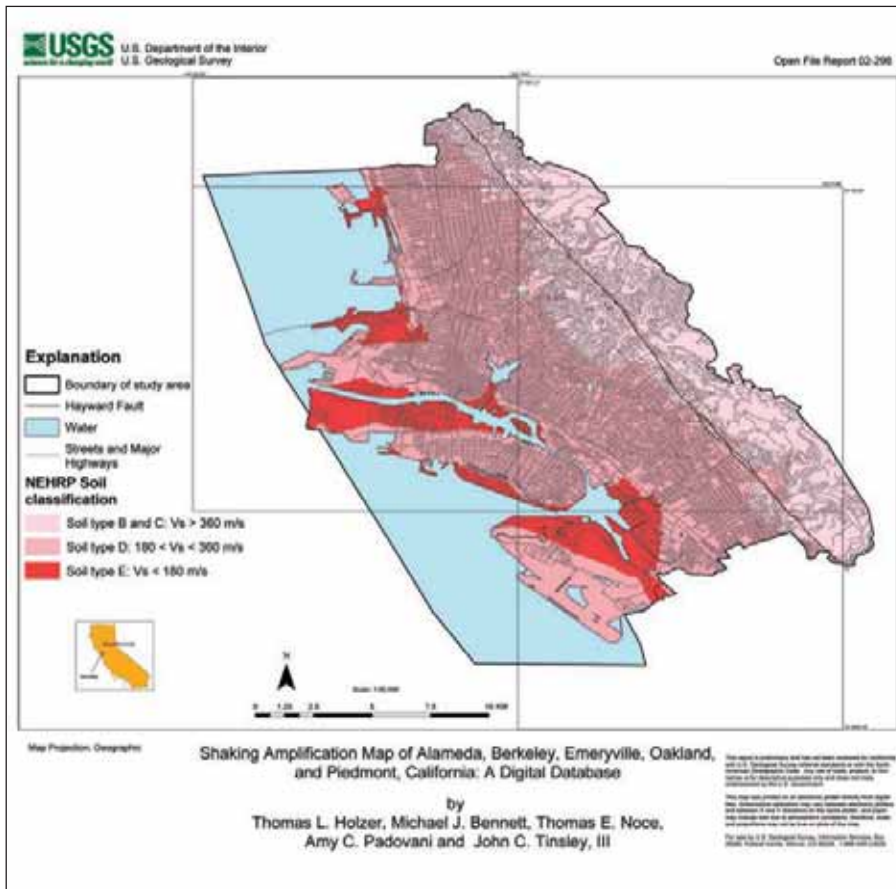
Figure 3-15: USGS Shaking Amplification Map of Alameda, Berkeley, Emeryville, Oakland and Piedmont, California. SOURCE: USGS (HOLZER ET AL.)

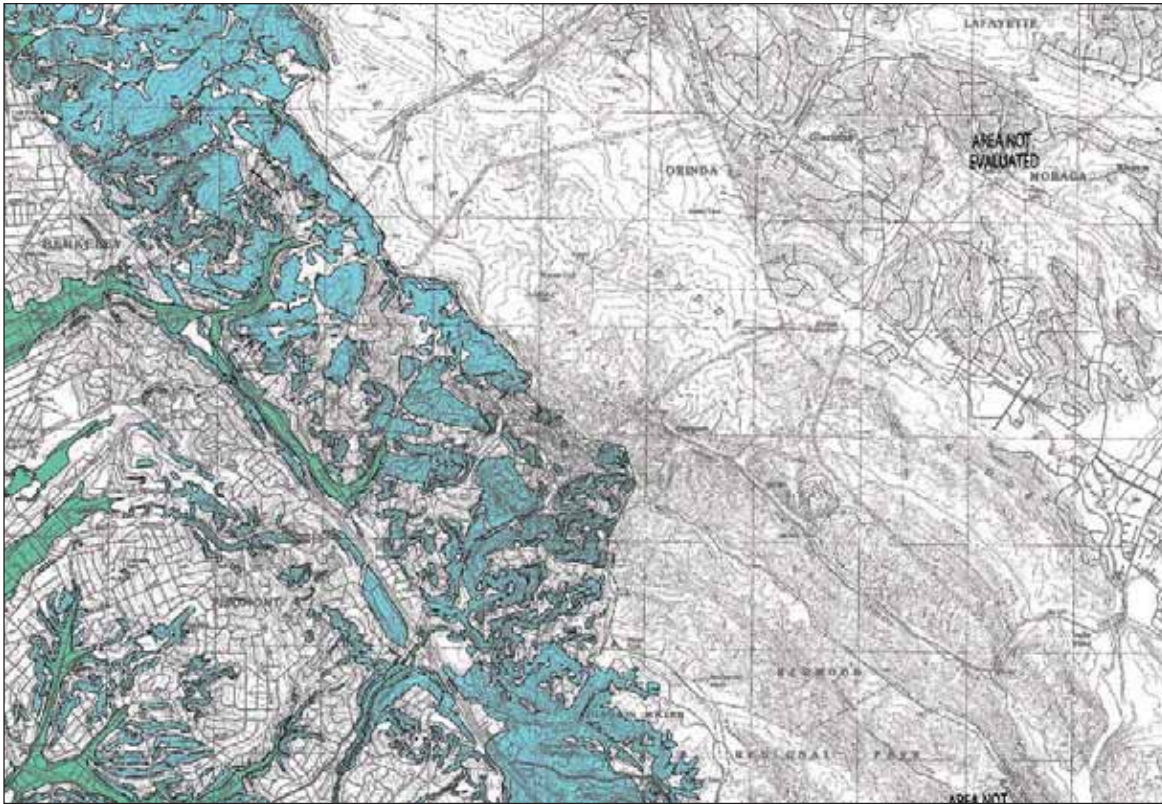
Figure 3-16: Landside Hazard Zones for Berkeley and Oakland, California. Blue areas are those that are susceptible to earthquake-caused landslides.

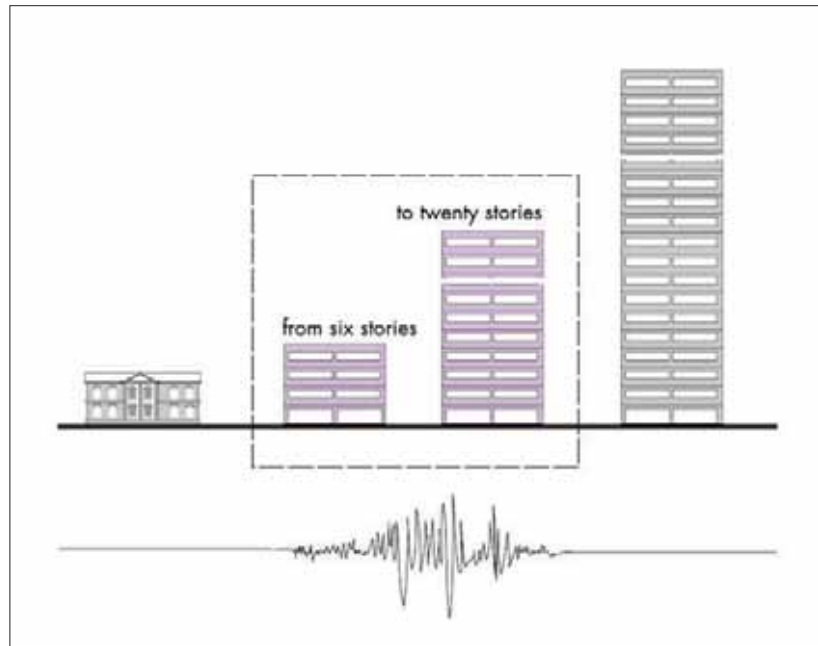
Figure 4-5: The vulnerable group: Mexico City, 1985. The periods of buildings in the 6 to 20 story range resonated with the frequency content of the earthquake.

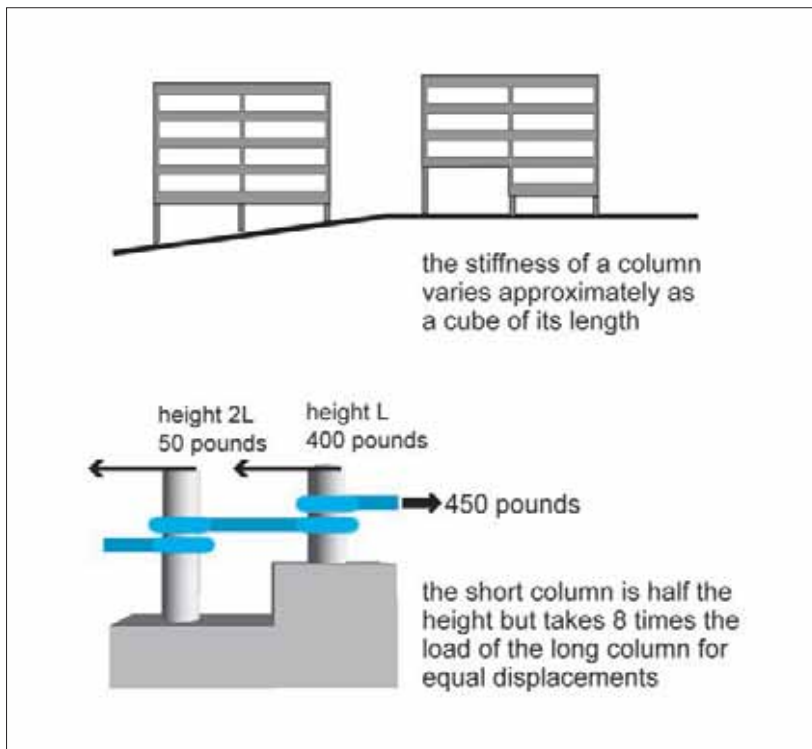
Figure 4-15: The short column problem.

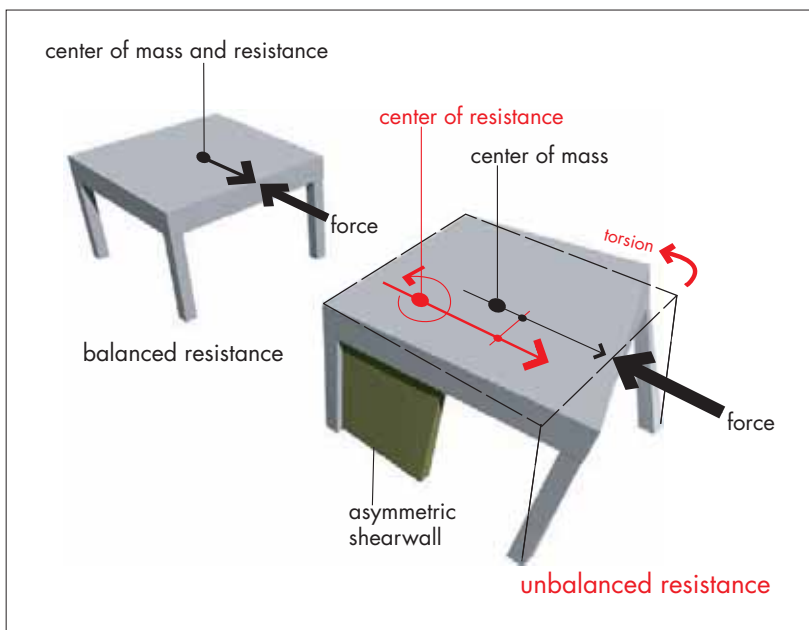
Figure 4-17
Torsional forces.

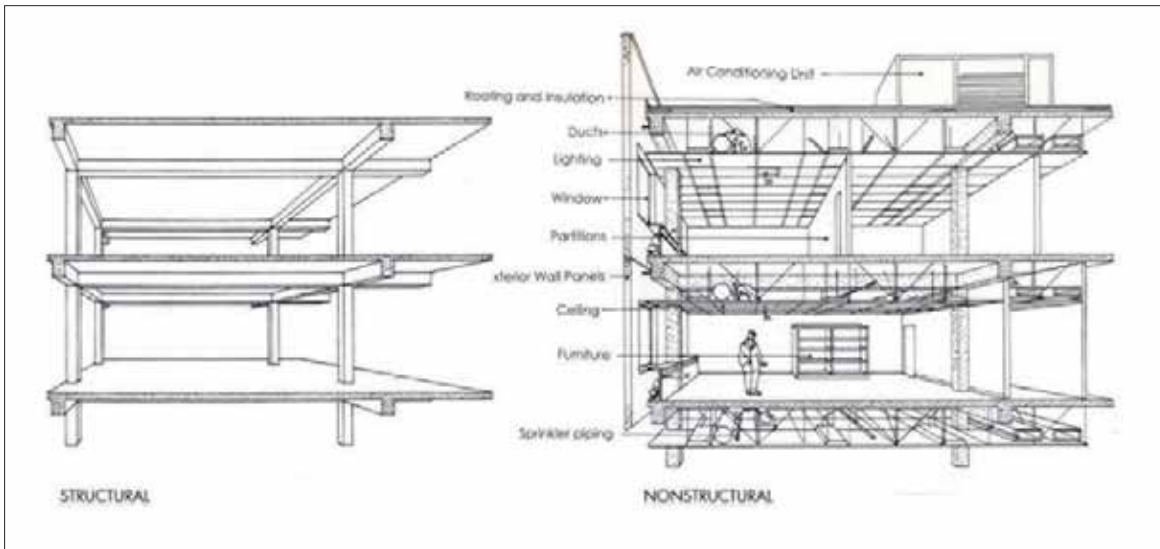
Figure 4-18: Structure (left), nonstructural components and systems (right).

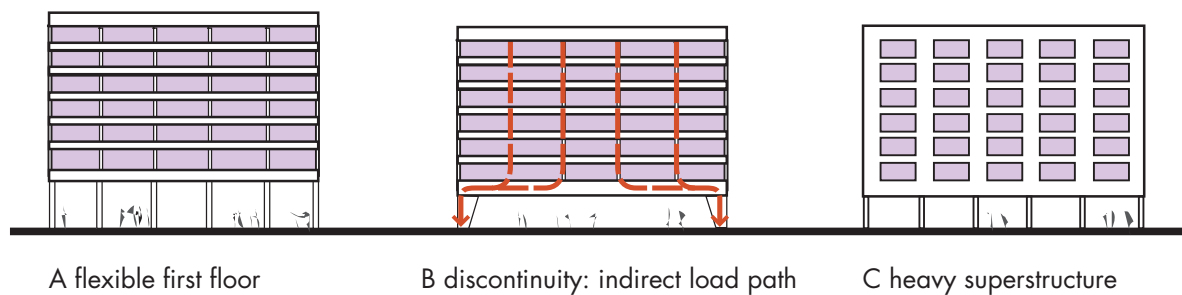
Figure 5-8: Three types of soft first story.

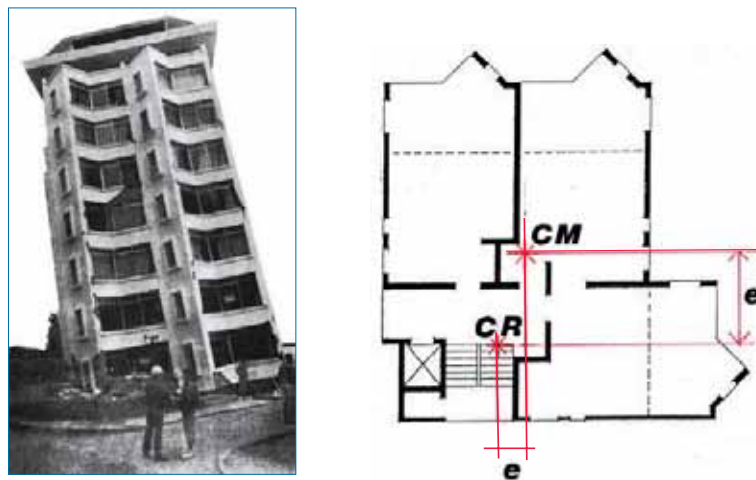
Figure 5-16: Left, the building after the earthquake. Right, typical floor plan showing the Center of Mass (CM), Center of Resistance (CR), and Eccentricity (e) along the two axes. PHOTO SOURCE: EERI

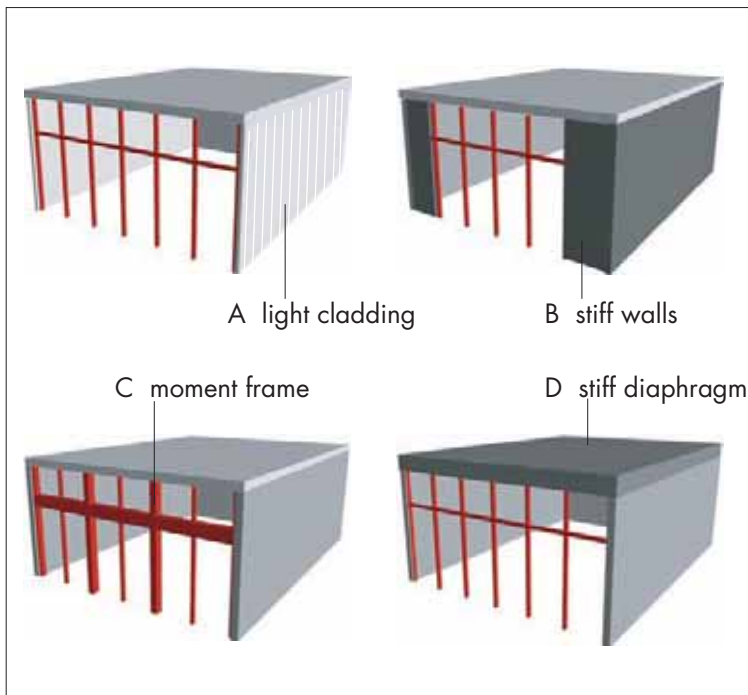
Figure 5-19
Some solutions
to store-front type
unbalanced-perimeter-
resistance conditions

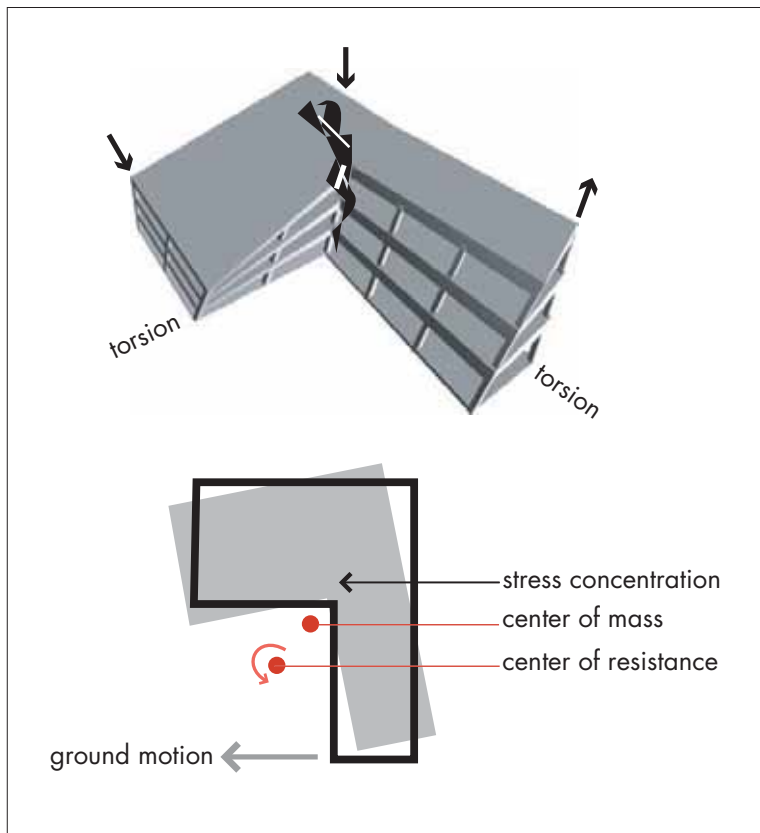
Figure 5-21
Re-entrant corner plan forms.

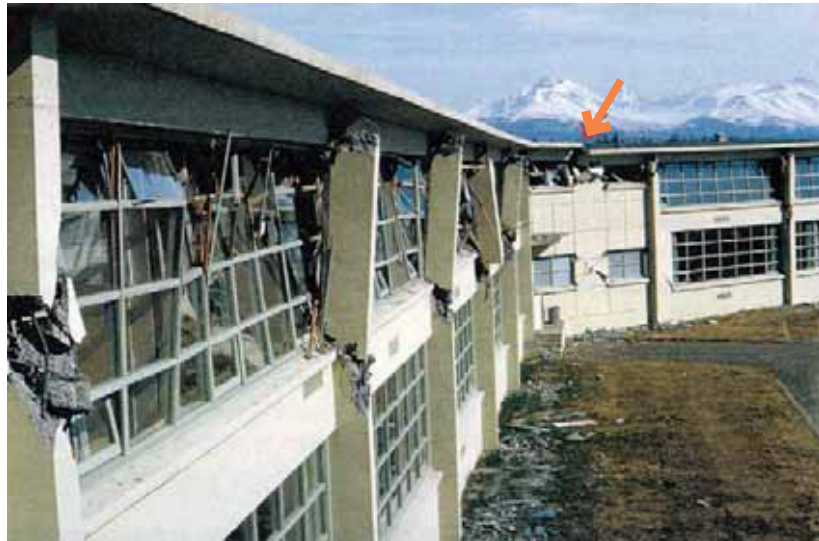
Figure 5-22: West Anchorage High School, Alaska earthquake, 1964. Stress concentration at the notch of this shallow L-shaped building damaged the concrete roof diaphragm.

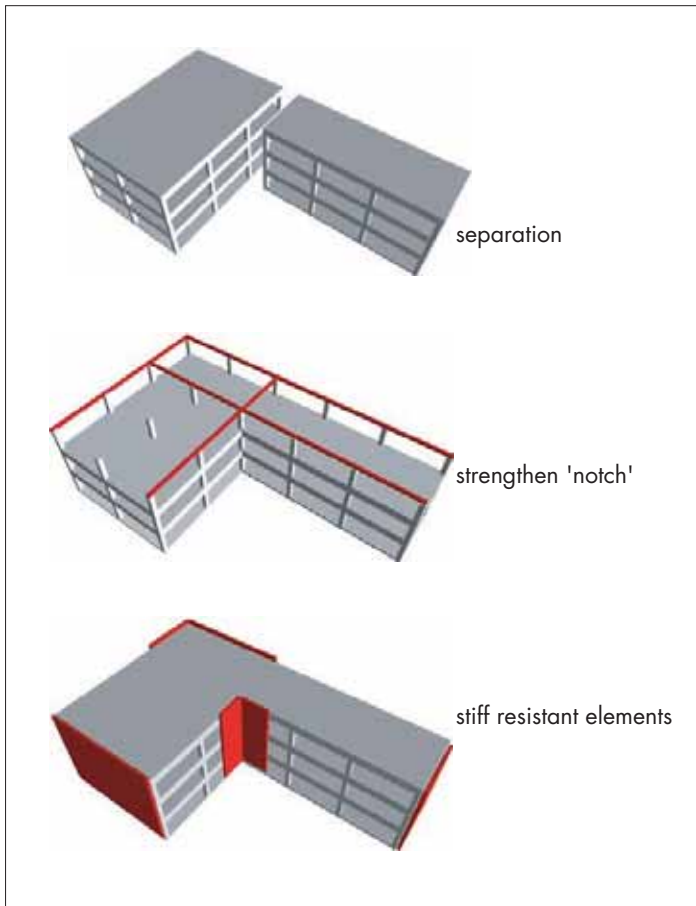
Figure 5-23
Solutions for the re-entrant-corner condition.

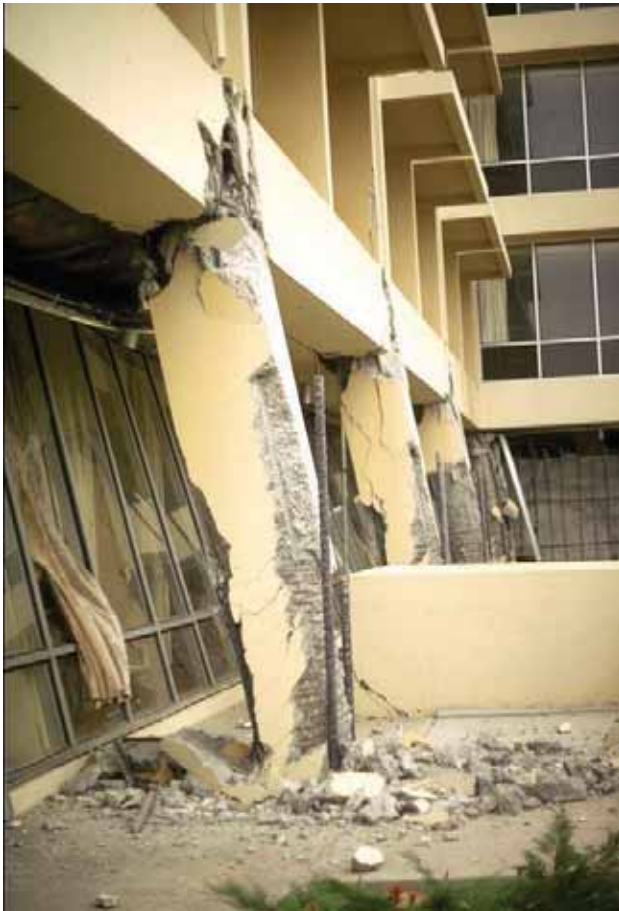
Figure 6-4: Sylmar, 1971, Damage to engineered building at Olive View Medical Center.

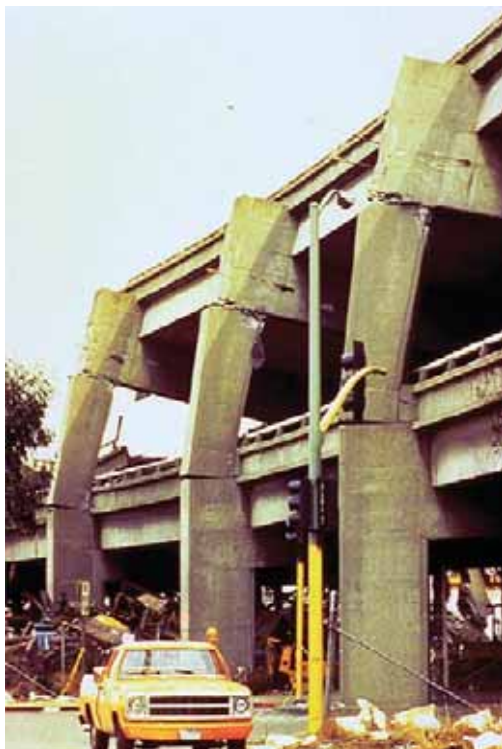
Figure 6-6: San Francisco, 1989, elevated highway support bents, an example of failure of engineered structures.

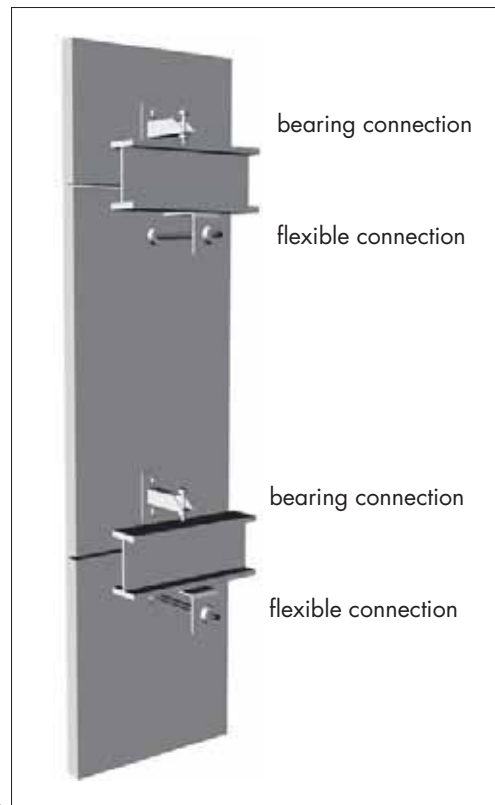
Figure 6-10
Typical floor-to-floor push-pull panel connections. Each beam has a bearing connection at the bottom of a panel and a flexible, or tie-back, connection for the panel below.

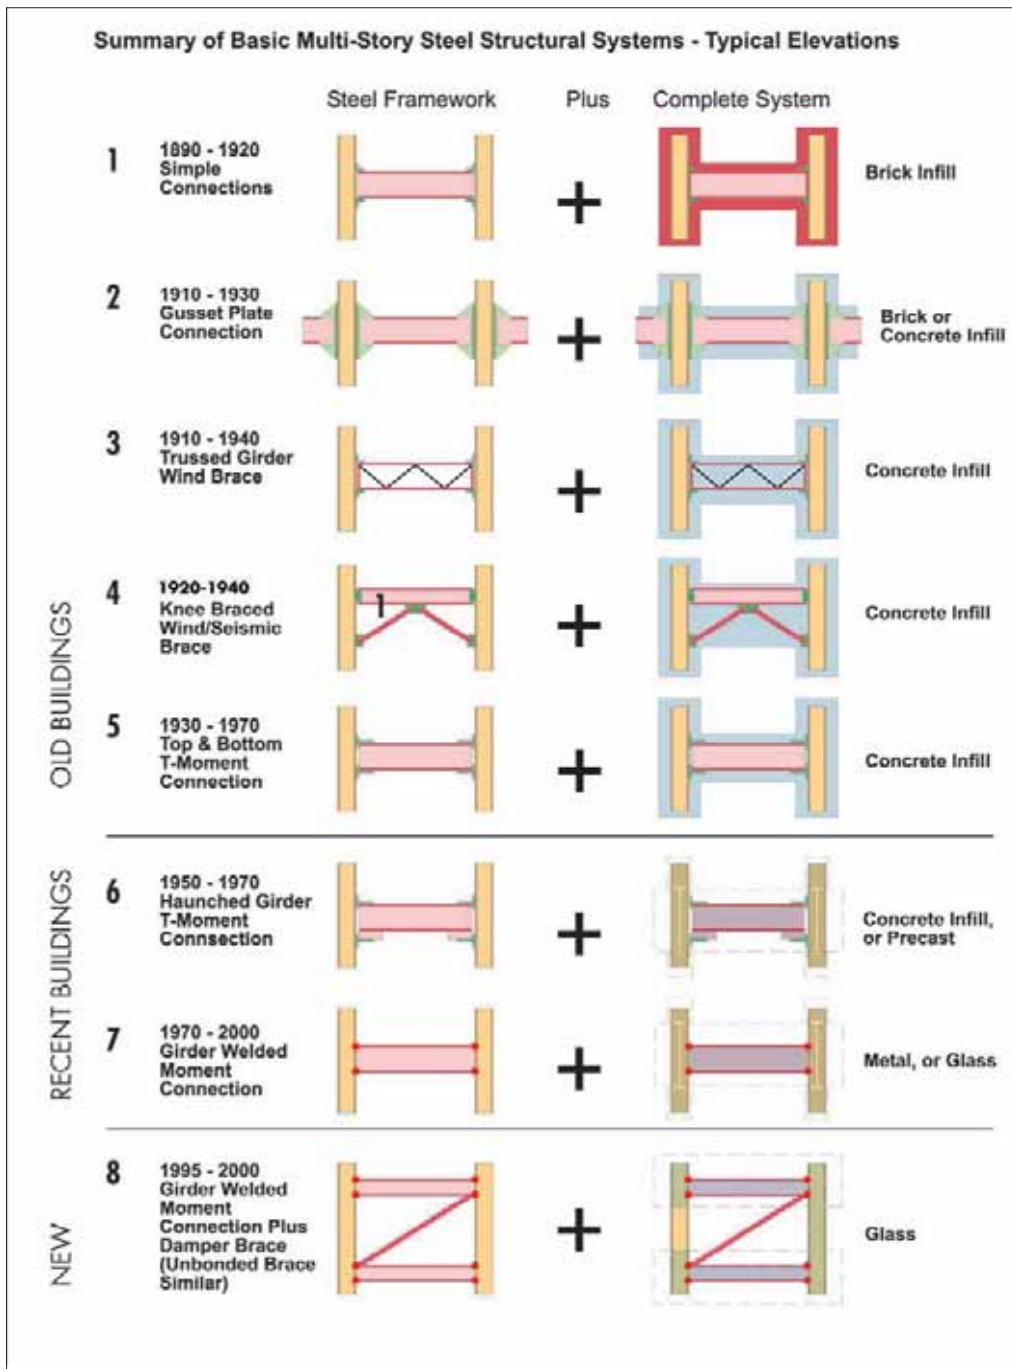
Figure 7-2: Steel building frameworks.

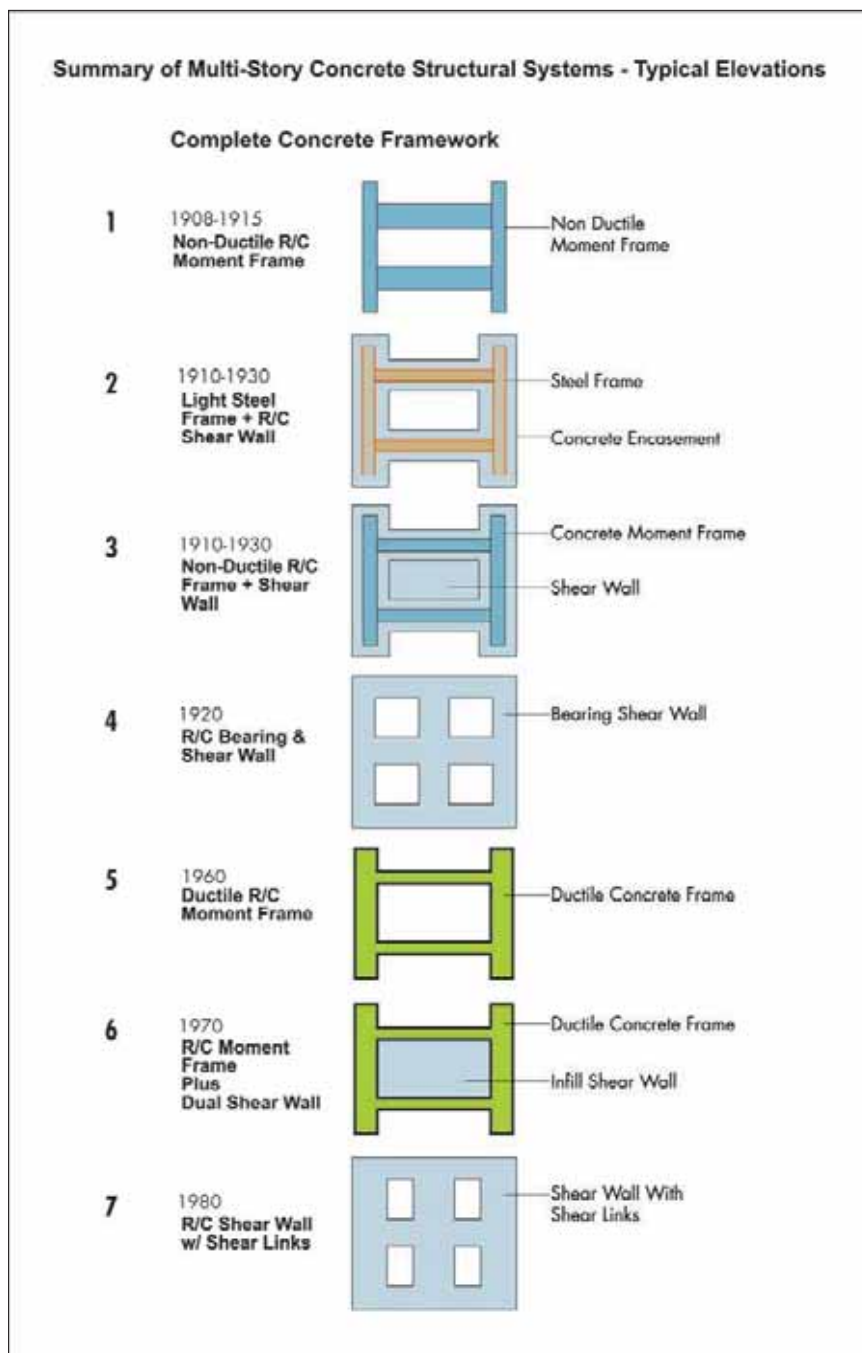
Figure 7-3: Concrete building frameworks

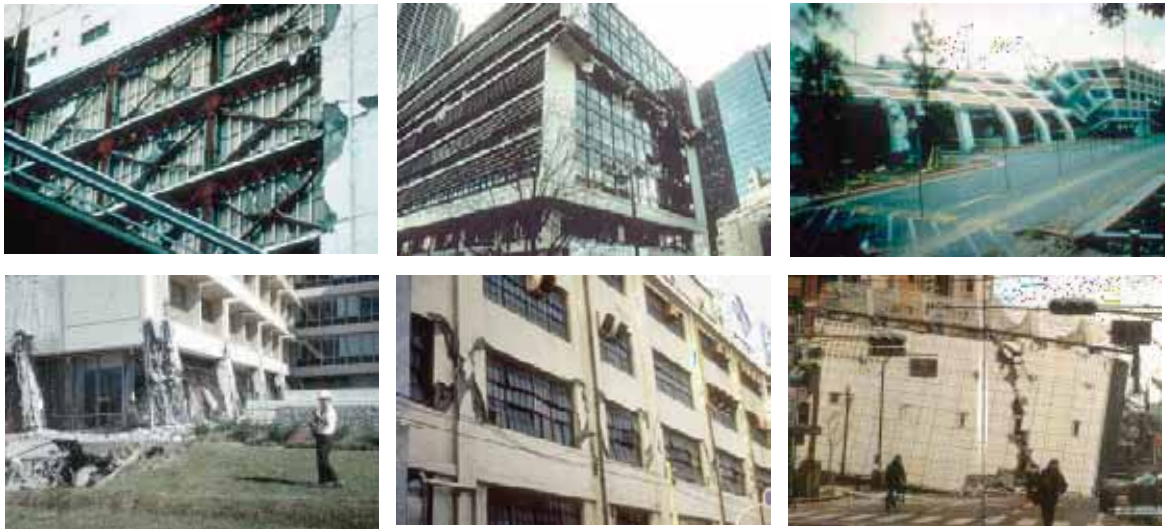
Figure 7-12: Examples of typical earthquake damage.

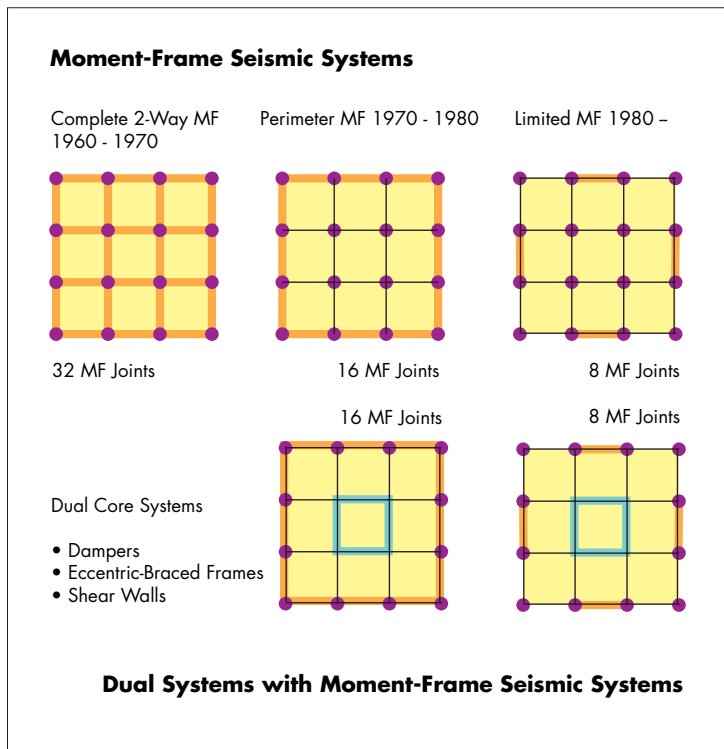
Figure 7-18: Single and multiple system concepts.

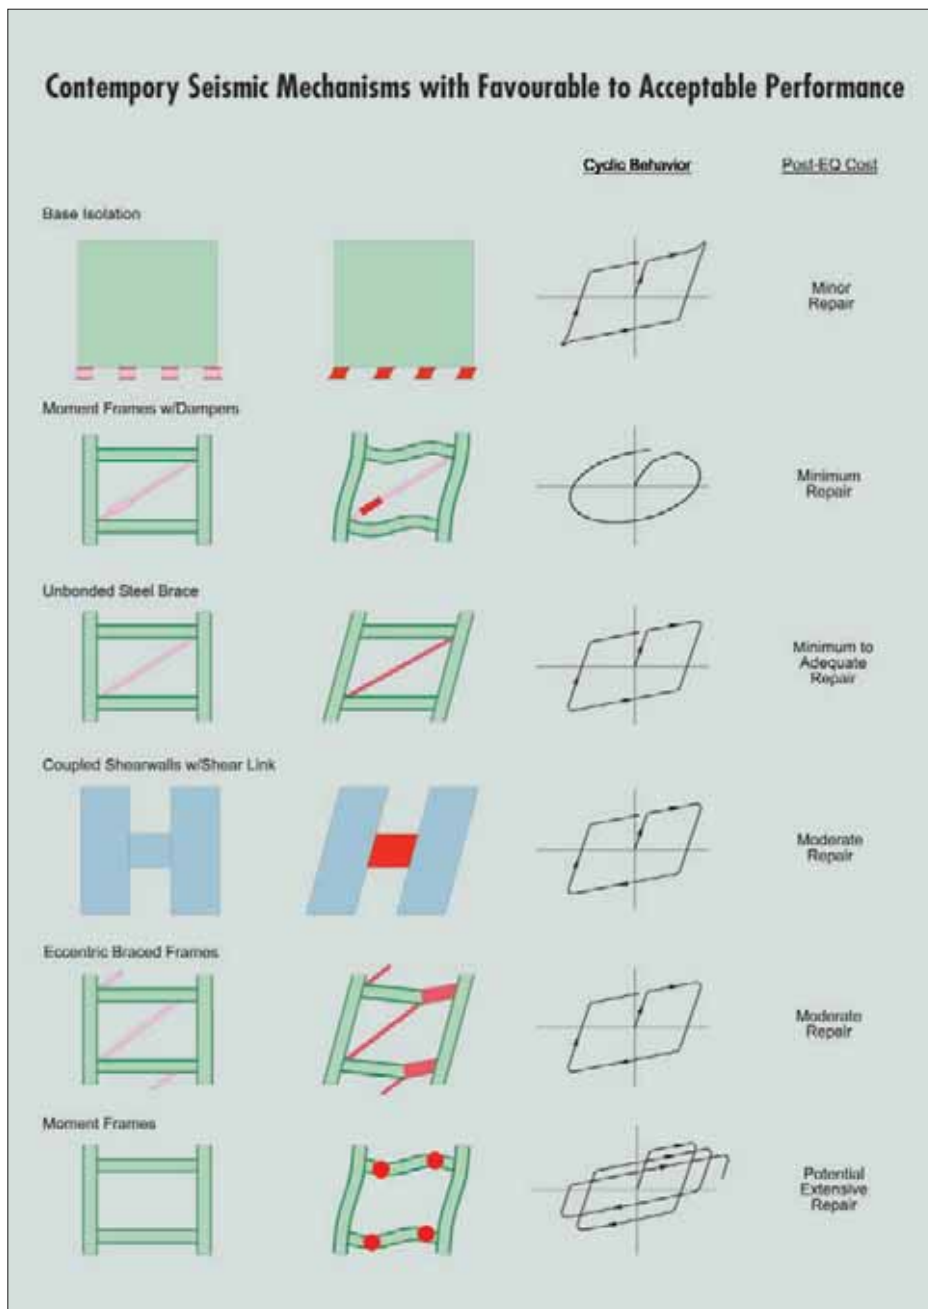
Figure 7-19: Six high-performance seismic structures.

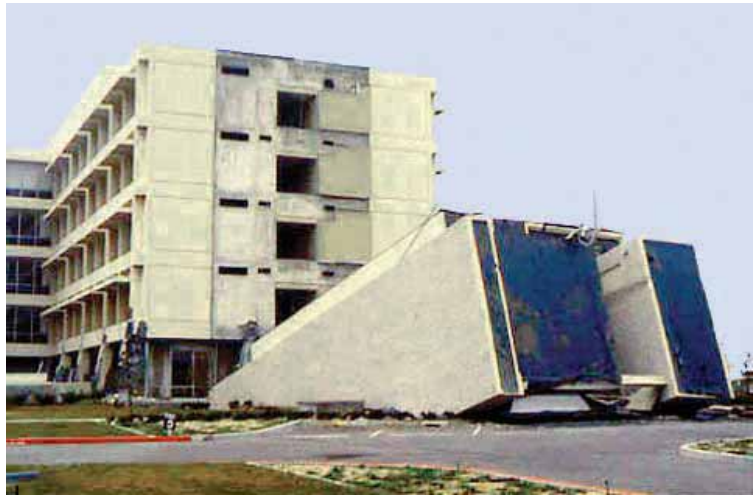
Figure 8-2: Olive View Hospital. A brand new facility that was damaged beyond repair in the 1971 San Fernando earthquake due to a shaking intensity that exceeded what was expected at the site and a design that, although technically complying with code at the time, contained several structural characteristics now considered major deficiencies. The lateral system contained nonductile concrete frames, discontinuous shear walls, and a significant weak story.
