Designing for Earthquakes

A Manual for Architects

FEMA 454 / December 2006

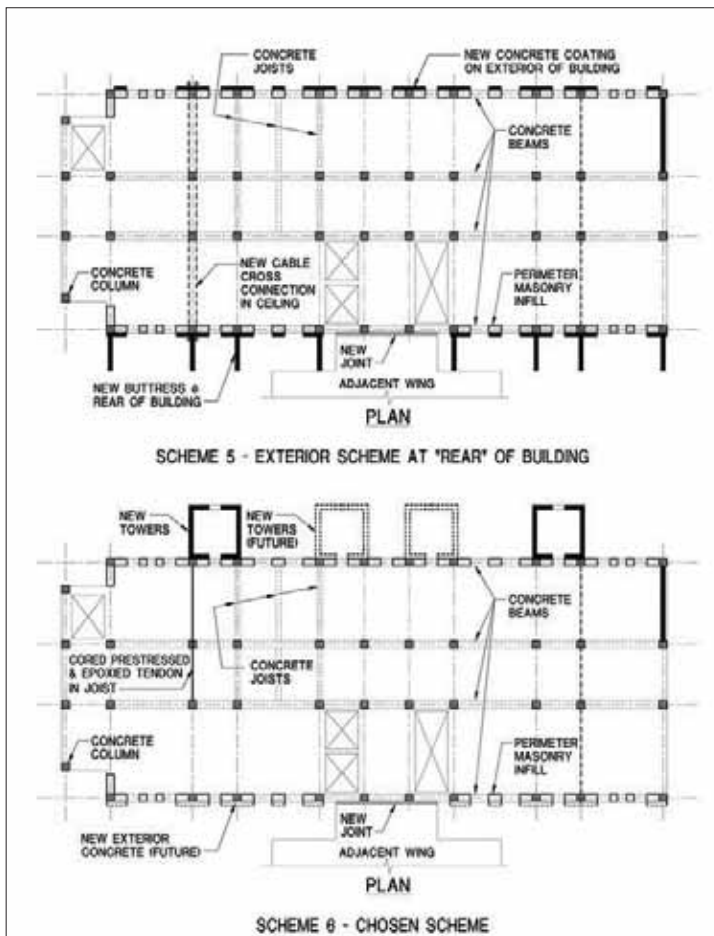
Figure 8-9c: Example of effect of non technical issues on retrofit schemes.
